# Inverloch Coastal Resilience Project

## Inverloch Beach Monitoring Report

August 2018 to June 2020

South Gippsland Conservation Society Inc.

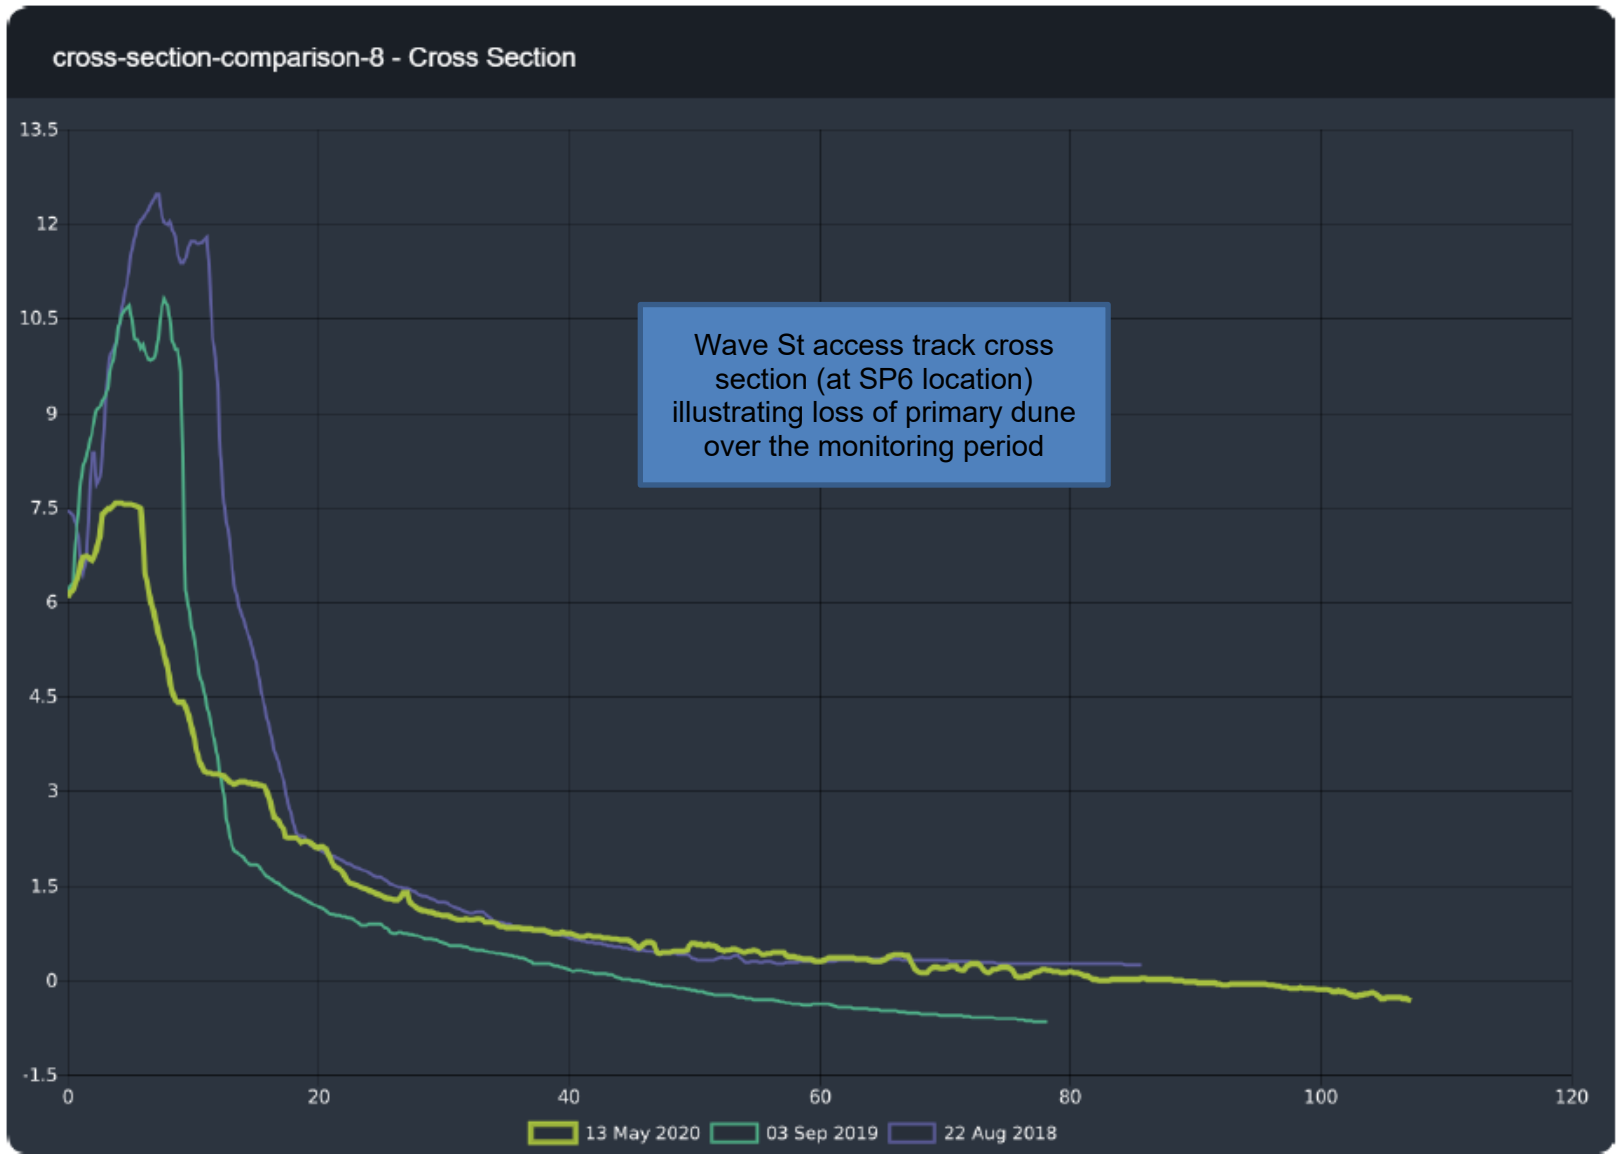
Figure 1 Propeller Aero Cross Section Wave St (Source: Propeller Aero software)

- Surf Club: 8.6m dune recession over the monitoring period, comprising:
  - 5.4m recession between 22/08/18 and 03/09/19
  - 3.2m recession between 03/09/19 and 13/05/20
    - including 3.3m recession between 28/01/20 and 13/05/20
  - This cross section was taken at approximately the same location as laser level monitoring position SP 5 (refer next section).
- Between Surf Club and Wave Street track: 10.1m dune recession over the monitoring period, including:
  - 9m recession between 22/08/18 and 03/09/19
  - 1.7m recession between 28/01/20 and 13/05/20
- Wave Street access track: 12.1m dune recession over the monitoring period, including:
  - 10.8m recession between 22/08/18 and 03/09/19
  - 2.1m recession between 28/01/20 and 13/05/20

The cross section below was taken at this location, extracted from the Propeller Aero website. This cross section is at approximately the same location as laser level monitoring site SP 6.

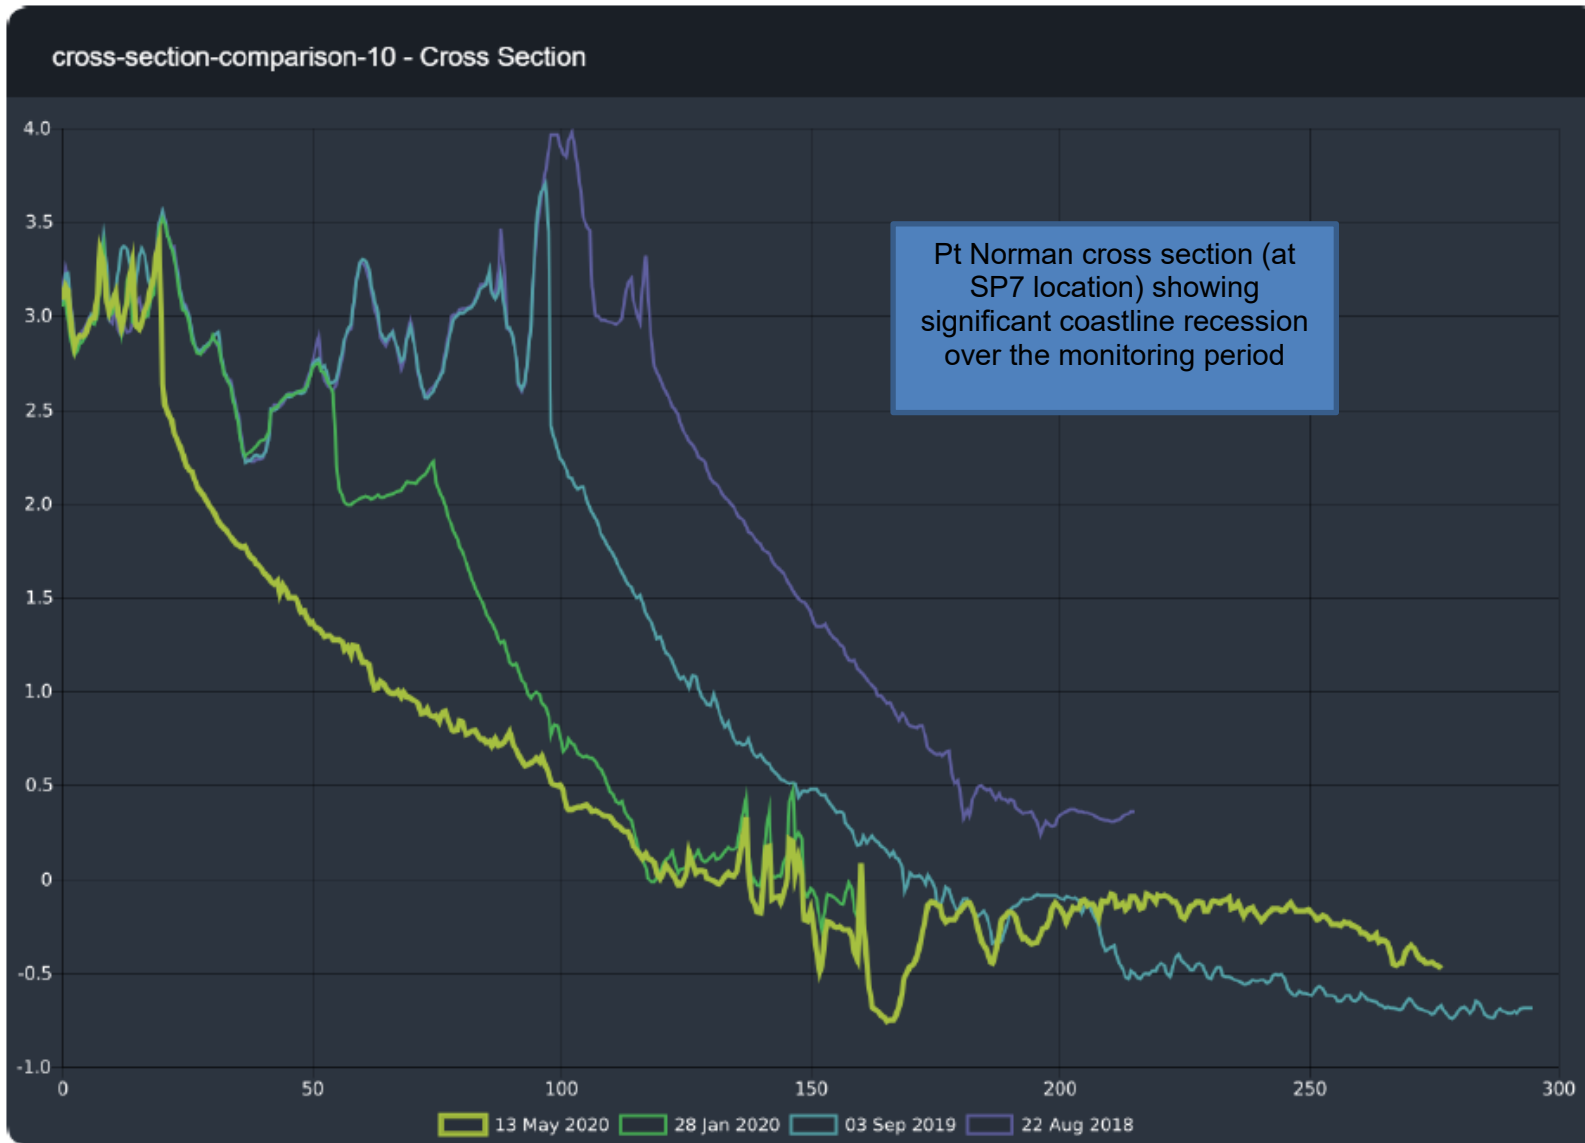
Figure 2 Propeller Aero Cross Section Pt Norman (Source: Propeller Aero software)

- Ozone Street track: 19.7m dune recession over the monitoring period, including:
  - 12.4m between 22/08/18 and 03/09/19
  - 1.6m between 28/01/20 and 13/05/20
- Pt Norman: 80m dune recession over the monitoring period, including:
  - 16m recession between 22/08/18 and 03/09/19
  - 48 m recession between 03/09/19 and 28/01/20
  - 16m recession between 28/01/20 and 13/05/20

The cross section below was taken at this location, extracted from Propeller Aero website. This cross section was taken at approximately the same location as laser level monitoring site SP 7.

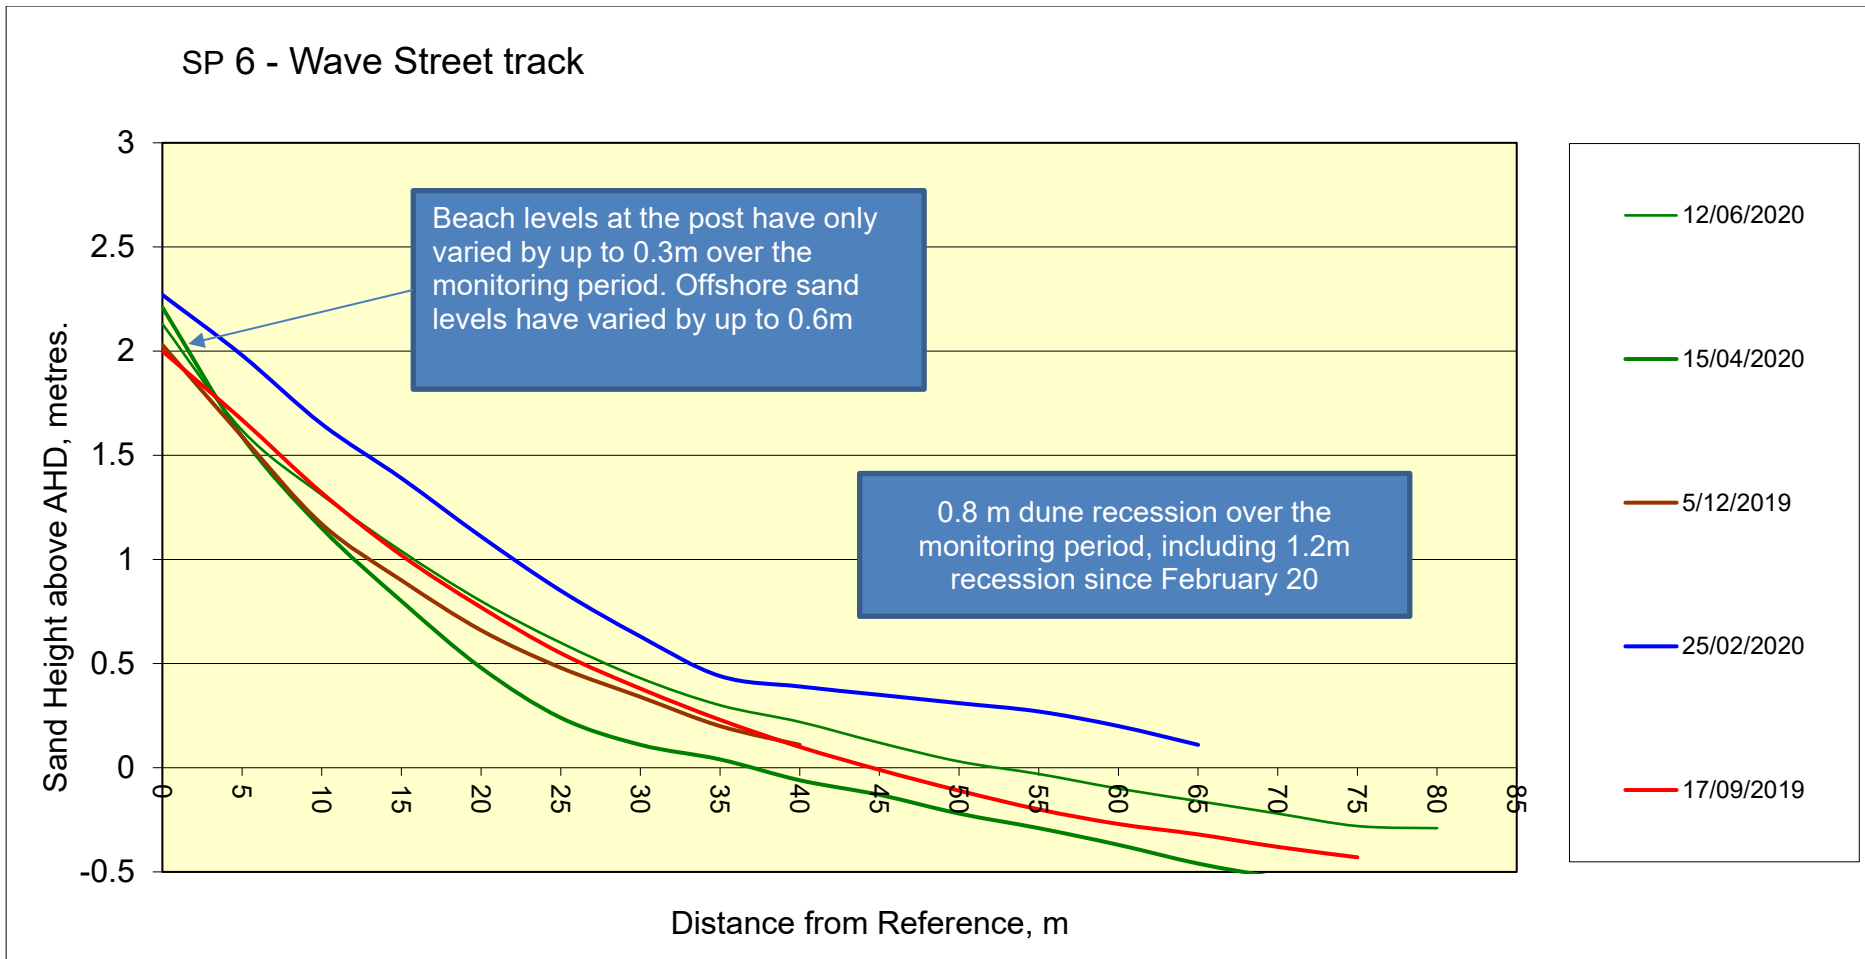
Figure 8 Laser Level Monitoring Chart SP6 – Wave Street Track

- Toe of dune receded by 0.8m between 17/09/19 and 12/06/20, including:
  - 0.6m recession between 17/09 and 05/12
  - 1m accretion between 05/12 and 25/02
  - 1.2m recession between 25/02 and 12/06
- Sand level at the post increased by 0.1m between 17/09/19 and 12/06/20
  - This includes a 0.1m drop between 25/02 and 12/06
- Sand level from 5-40m on the seaward side of the post rose by 0.1m overall in the period, including:
  - 0.2m drop in level between 17/09 and 05/12
  - 0.5m rise in level between 05/12 and 25/02
  - 0.6m drop in level between 25/02 and 15/04
  - 0.2m rise in level between 15/04 and 12/06

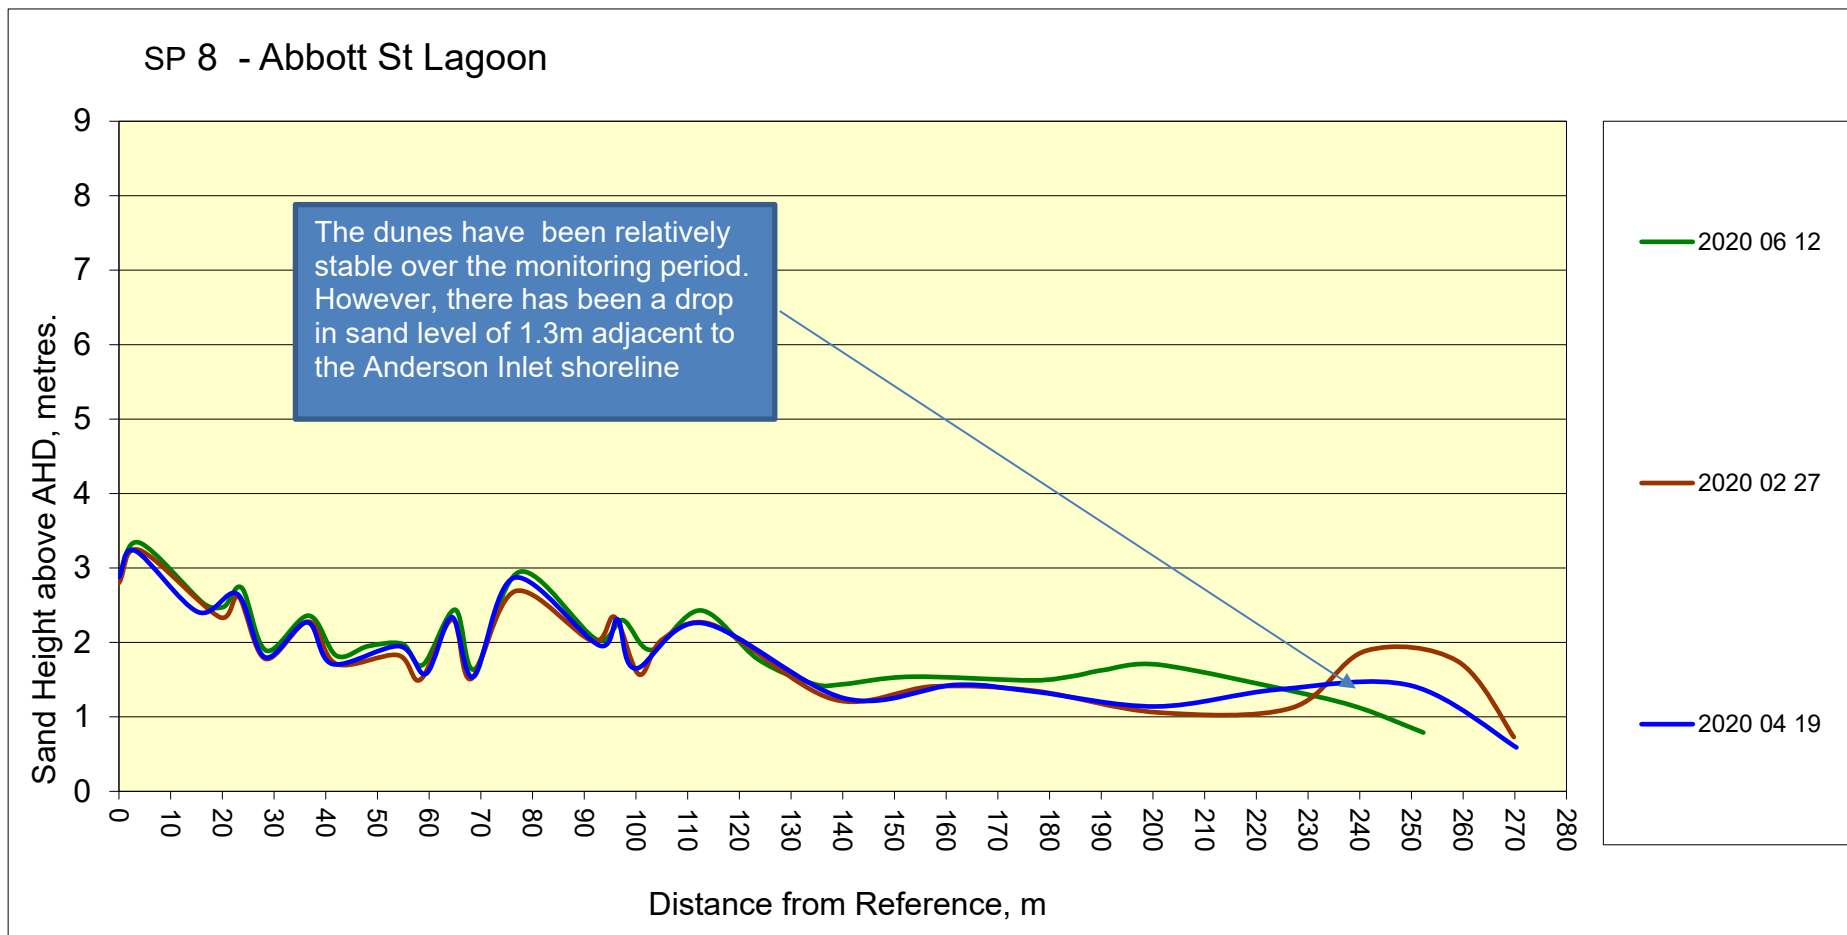
Figure 10 Laser Level Monitoring Chart SP8 – Abbott St Lagoon

- The dune system profile has generally been stable over the monitoring period, except for:
  - Drop in sand level of 1.3m close to the Anderson Inlet shoreline

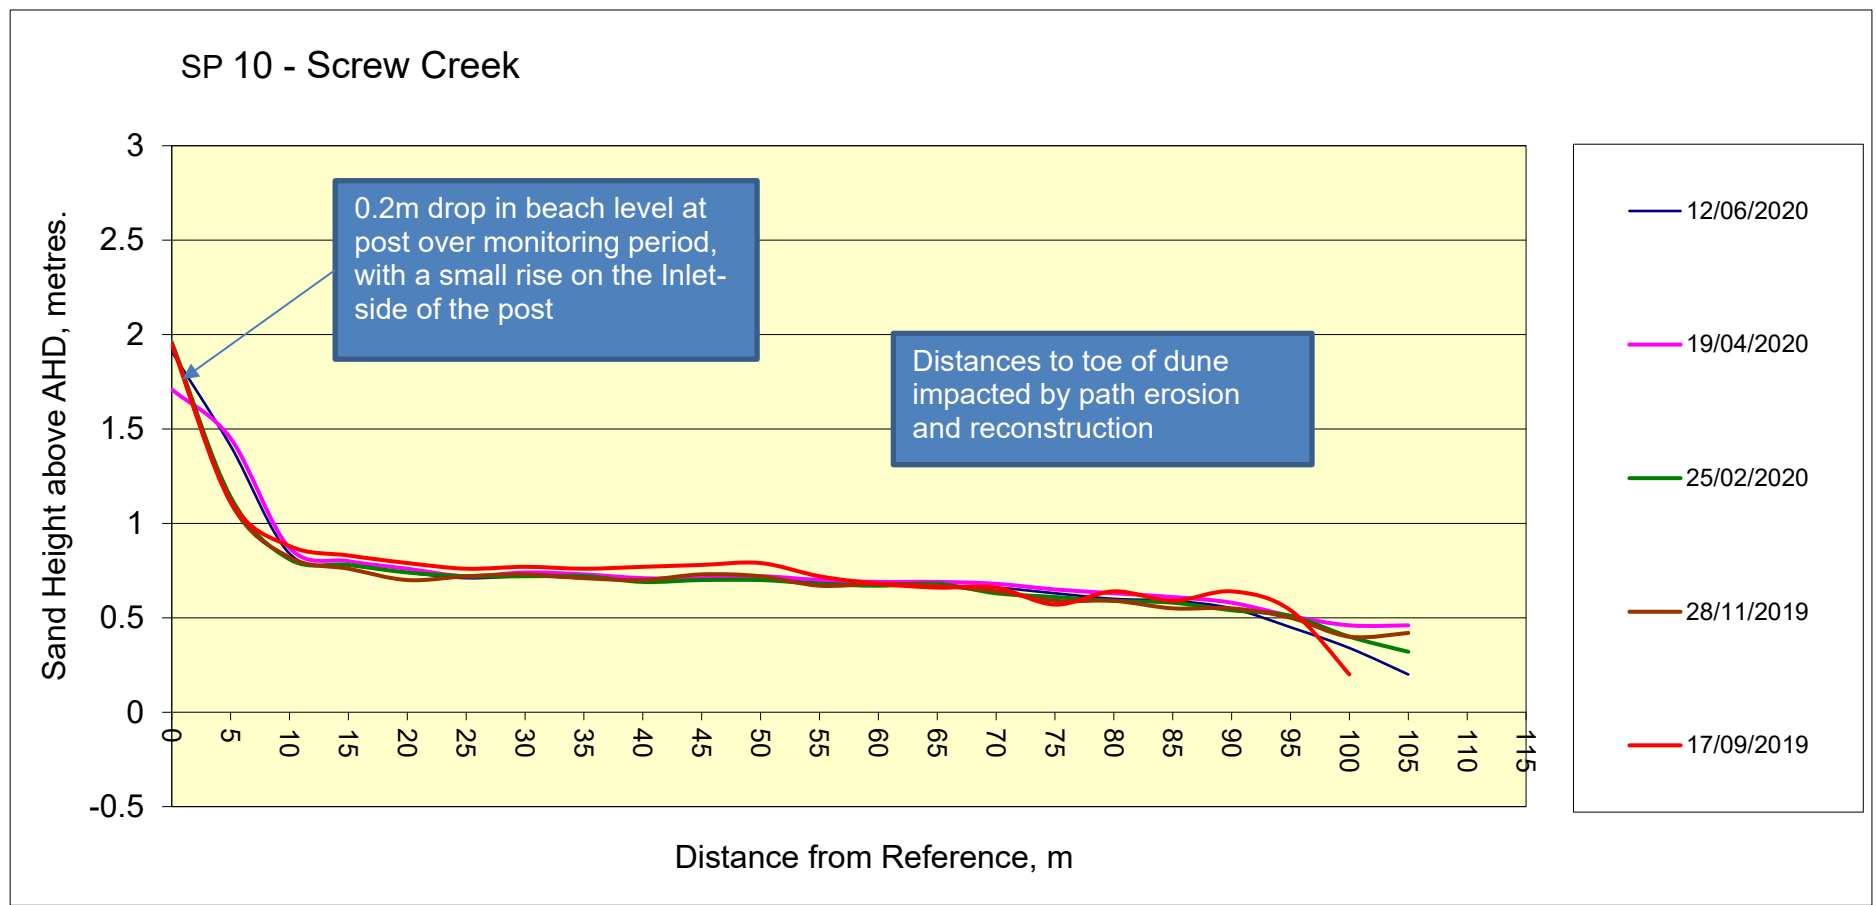
Figure 12 Laser Level Monitoring Chart SP10 – Screw Creek

- Distances to toe of dune impacted by reconstruction of path
- 0.2m drop in sand level at post between 17/09 and 19/04, including:
  - A rise in level between 2-10m from post.

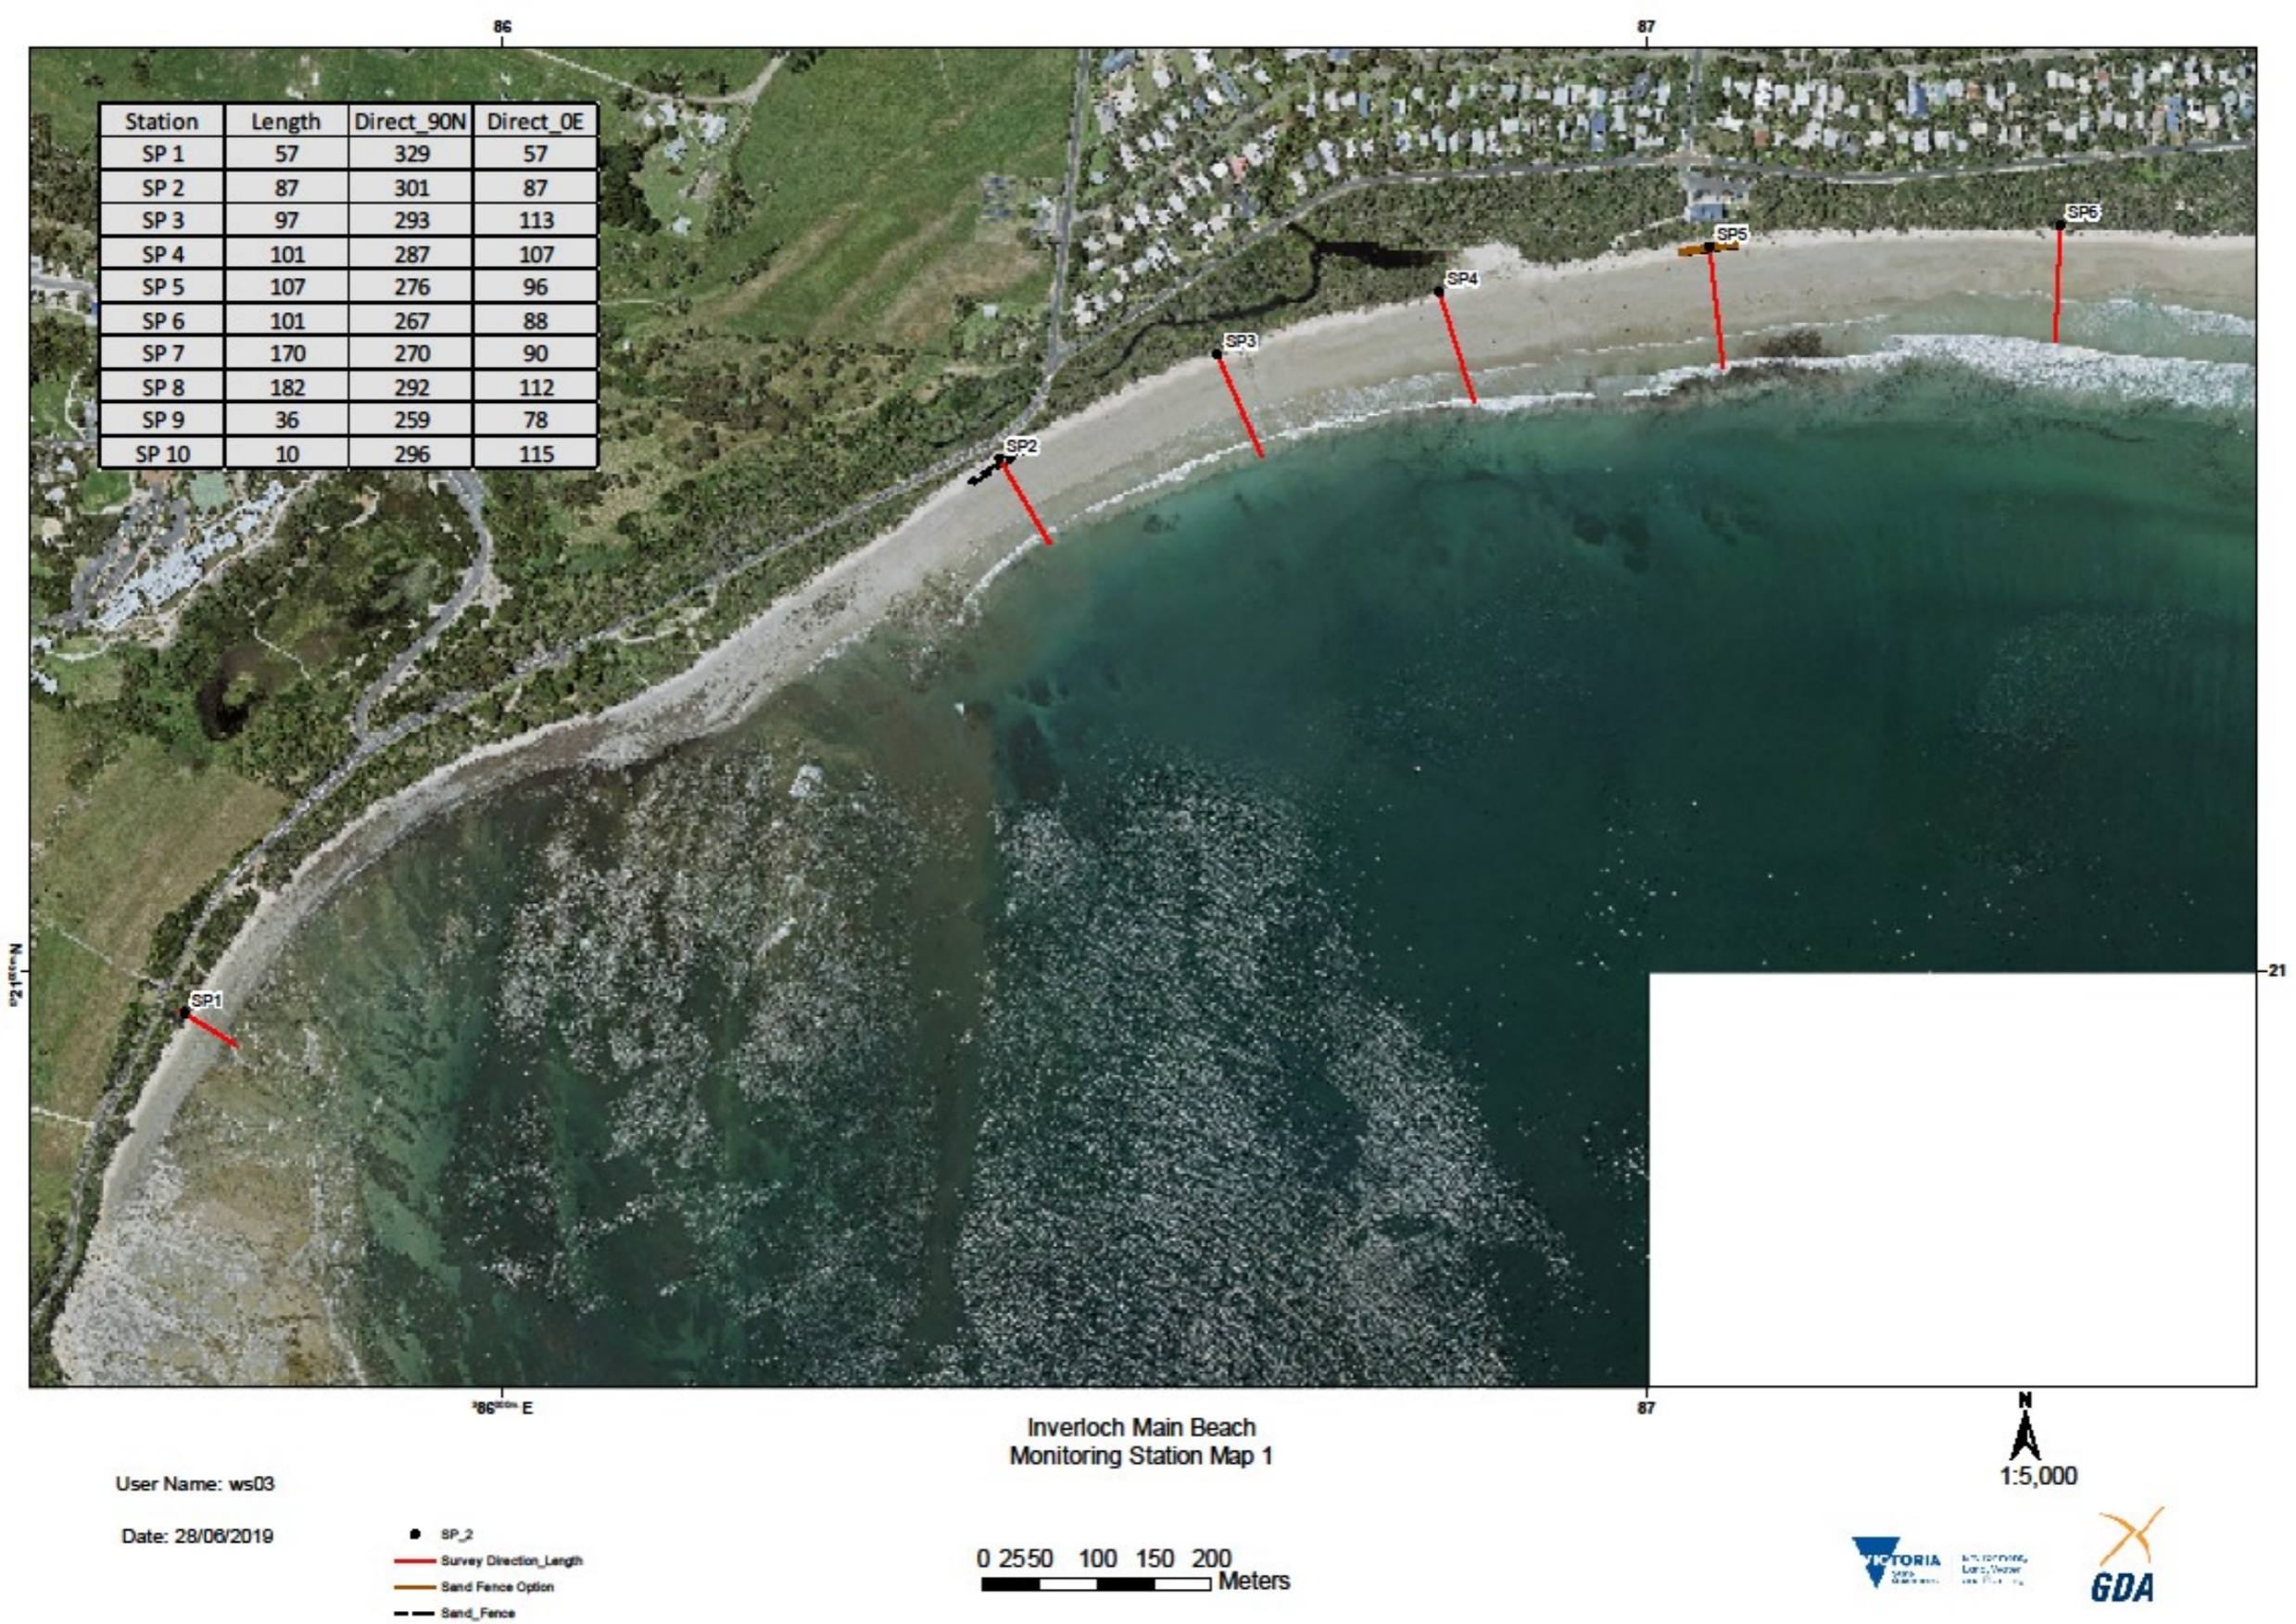
APPENDIX A - Laser Level Monitoring Sites

Station	Length	Direct 90N	Direct OE
SP 1	57	329	57
SP 2	87	301	87
SP 3	97	293	113
SP 4	101	287	107
SP 5	107	276	96
SP 6	101	267	88
SP 7	170	270	90
SP 8	182	292	112
SP 9	36	259	78
SP 10	10	296	115

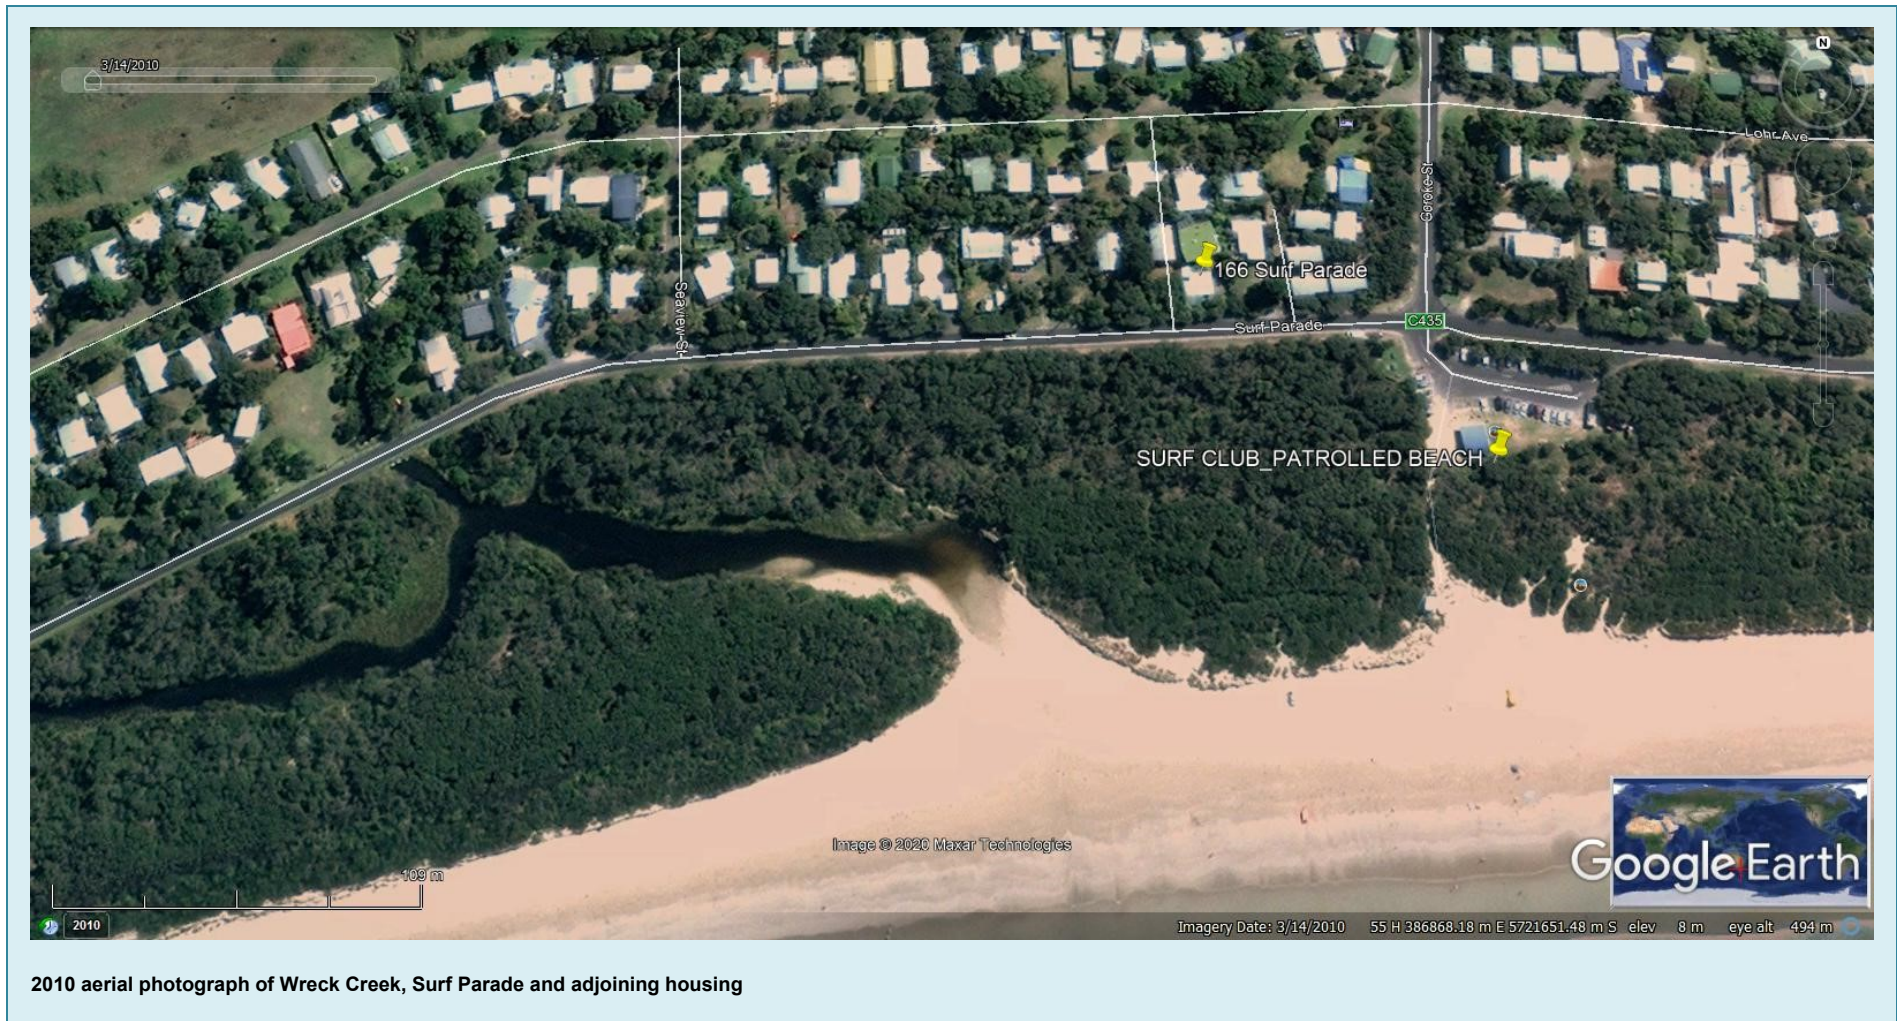
2010 aerial photograph of Wreck Creek, Surf Parade and adjoining housing

Following the coastline recession that occurred during April and May 2020, the width of the remaining dune between Wreck Creek and the high water mark varies between 3-10 metres, with a new breakthrough from the creek to the ocean having occurred since Easter 2020. Review of historical aerial photography indicates that this is the narrowest width of vegetated dune at this location since 1968. The narrow remaining dune, combined with the new breakthrough, means that not only are the ecological values of the Wreck Creek estuarine system threatened, but Wreck Creek itself is highly vulnerable and at risk of being swept away completely along this section of beach. Loss of the creek would not only mean the loss of the significant ecological values outlined, but threaten Surf Parade and adjoining low-lying housing with inundation.

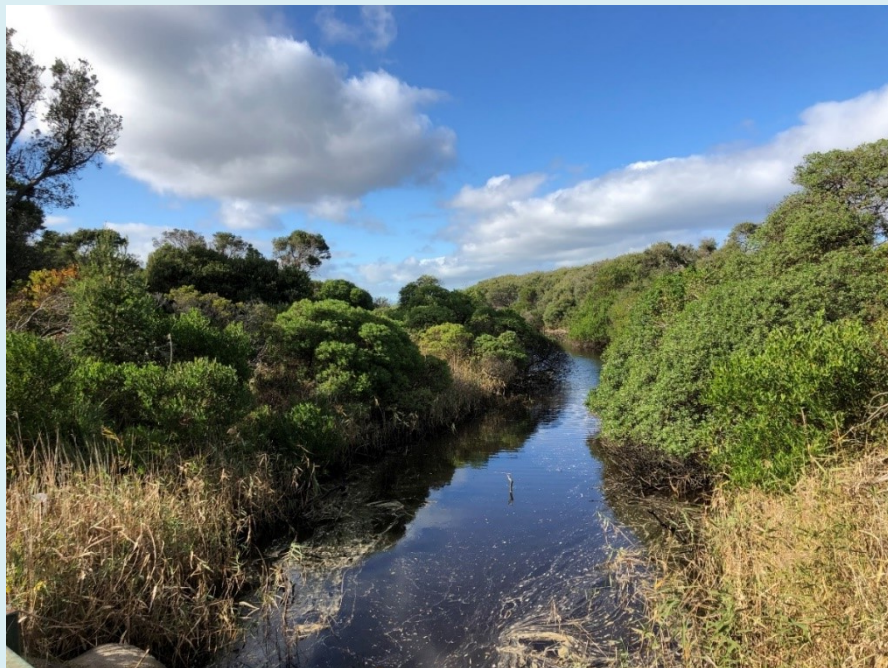
Wreck Creek and riparian vegetation, June 2020

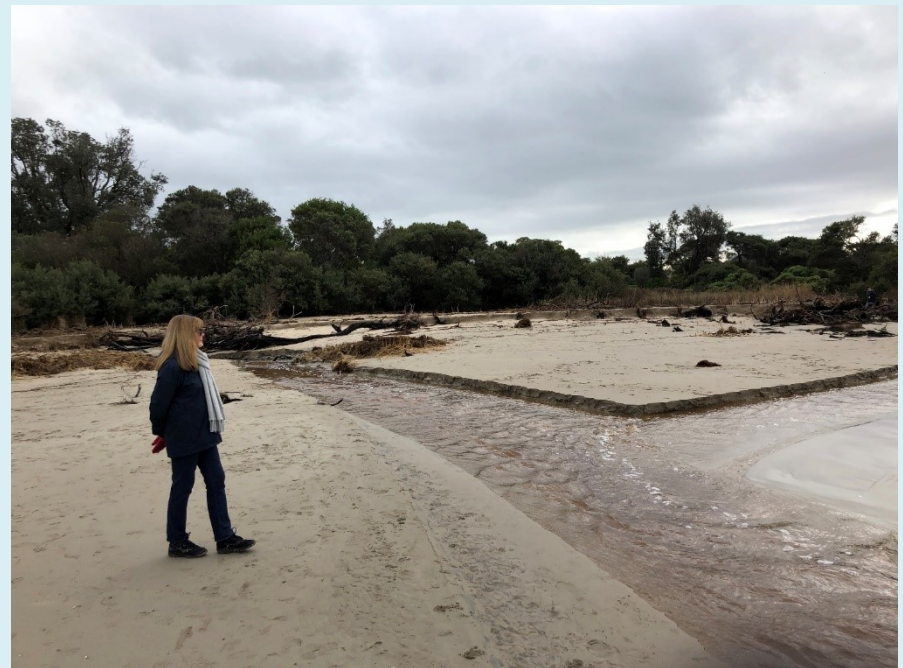
New twin channel opening of Wreck Creek in June 2020

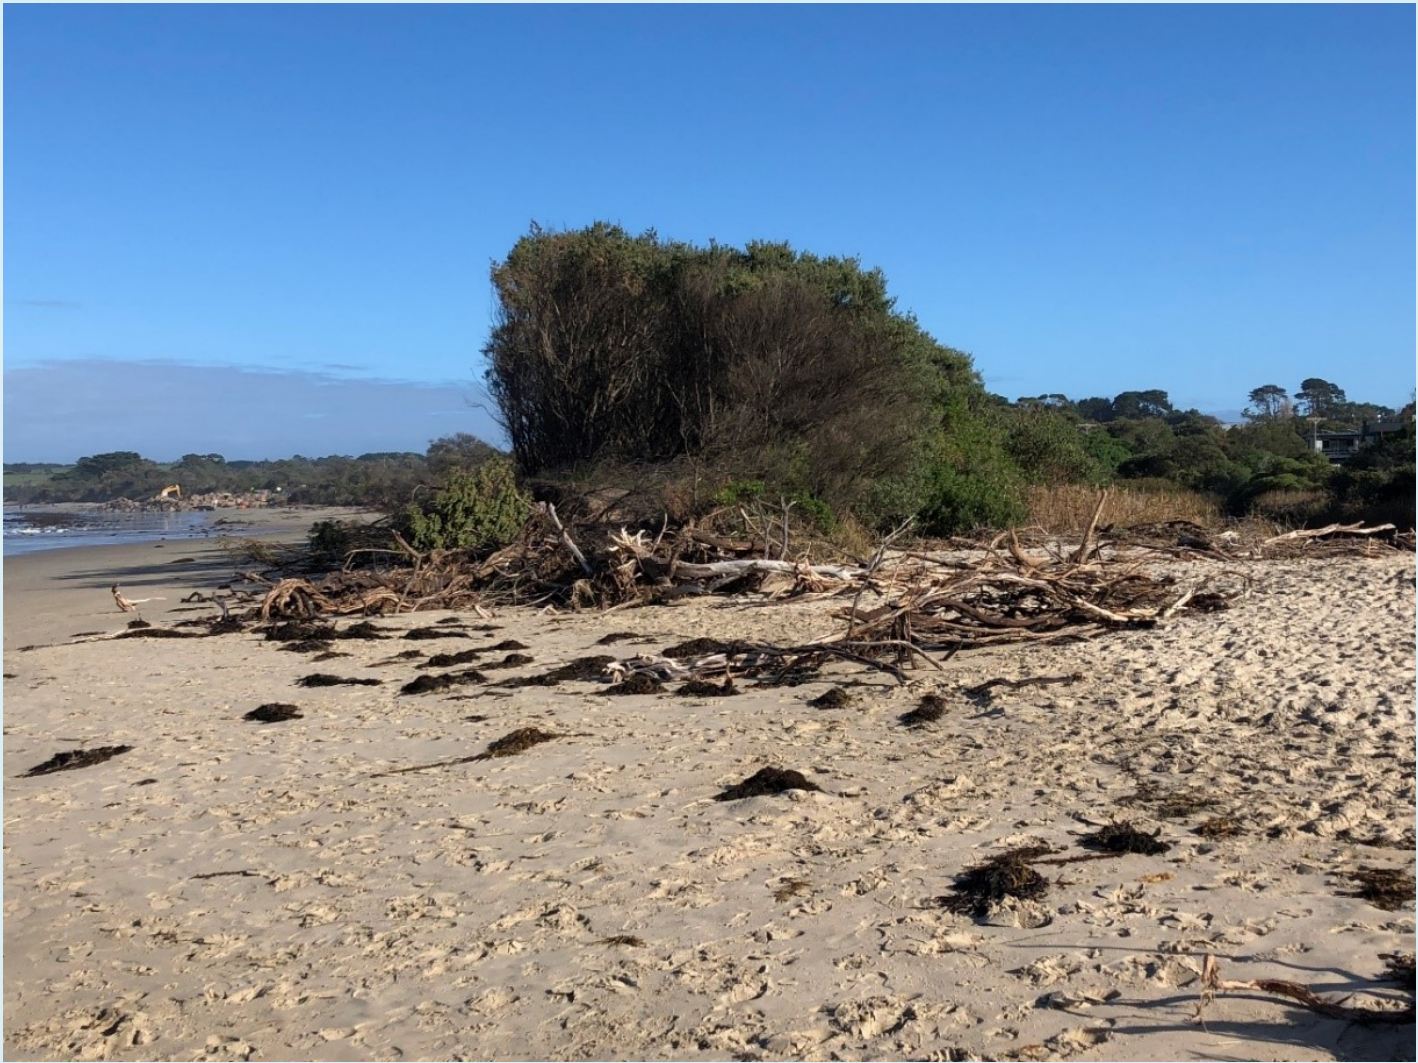
**Narrow strip of vegetated dune between Wreck Creek and the ocean at June 2020**

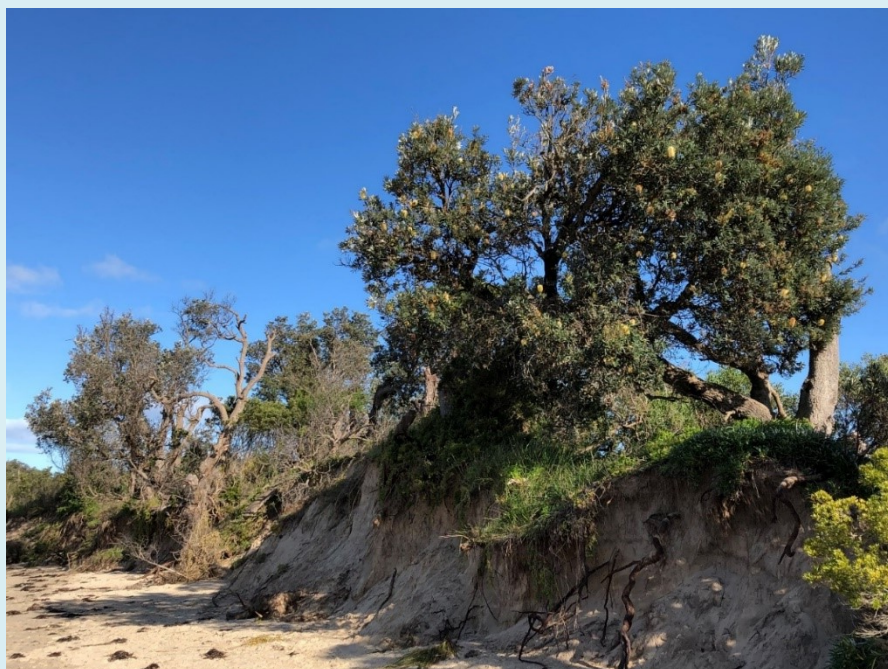
Around 15 mature Coast Banksia trees remain, in varying degrees of vulnerability, with their root systems being progressively undermined through the loss of beach sand. Loss of these remaining trees and associated understorey vegetation would represent a significant loss of ecological values and would leave the adjacent section of Cape Paterson Road, west of the turnoff to the RACV resort, more vulnerable.

Threatened mature Coast Banksias at Flat Rocks, May 2020

3. The remaining mature Coast Banksia Woodland trees at Flat Rocks are in varying degrees of vulnerability, with more than 25% of the stand already having been undermined by coastline recession since 2013. If the rate of recession is maintained or accelerates, the majority of the remaining Coast Banksia trees will be lost within the next two years. Removal of the mature Coast Banksias and associated understorey will leave Cape Paterson Road vulnerable to undermining adjacent to Flat Rocks. Active short-term management is recommended at this location over the next 12 months.

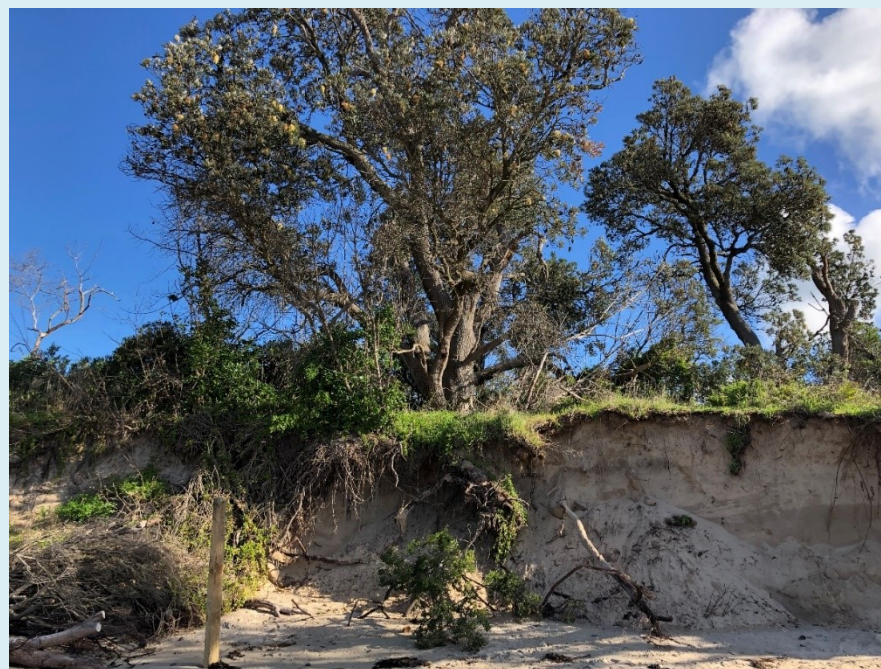
Threatened mature Coast Banksias at Flat Rocks, May 2020

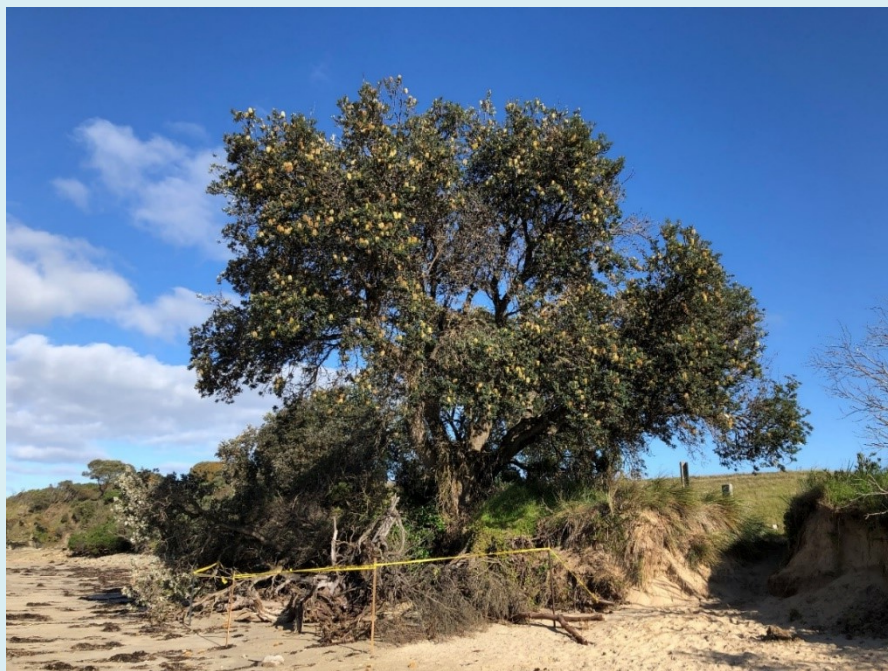
Threatened mature Coast Banksias at Flat Rocks, May 2020

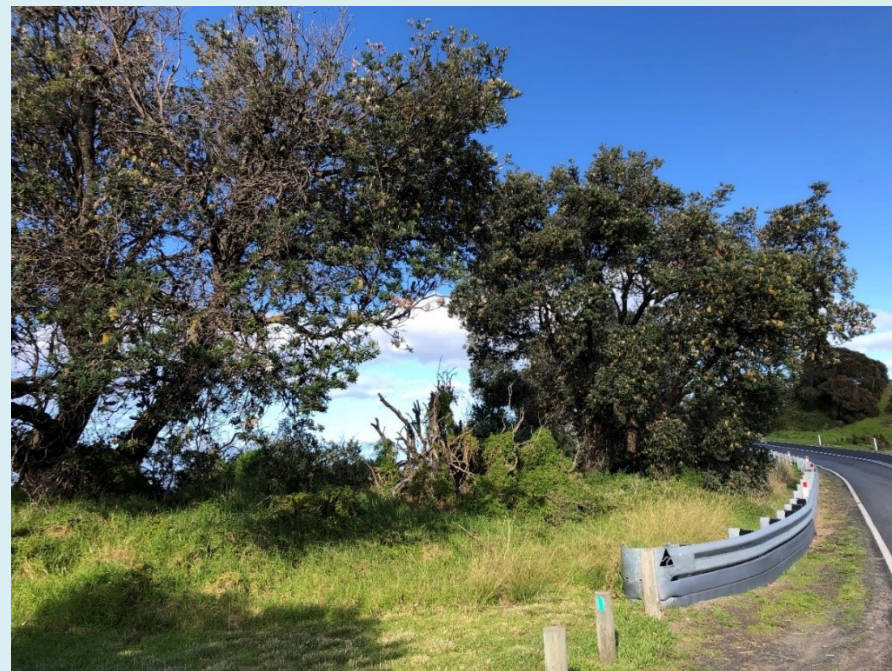
Threatened mature Coast Banksias and Cape Paterson Road, June 2020

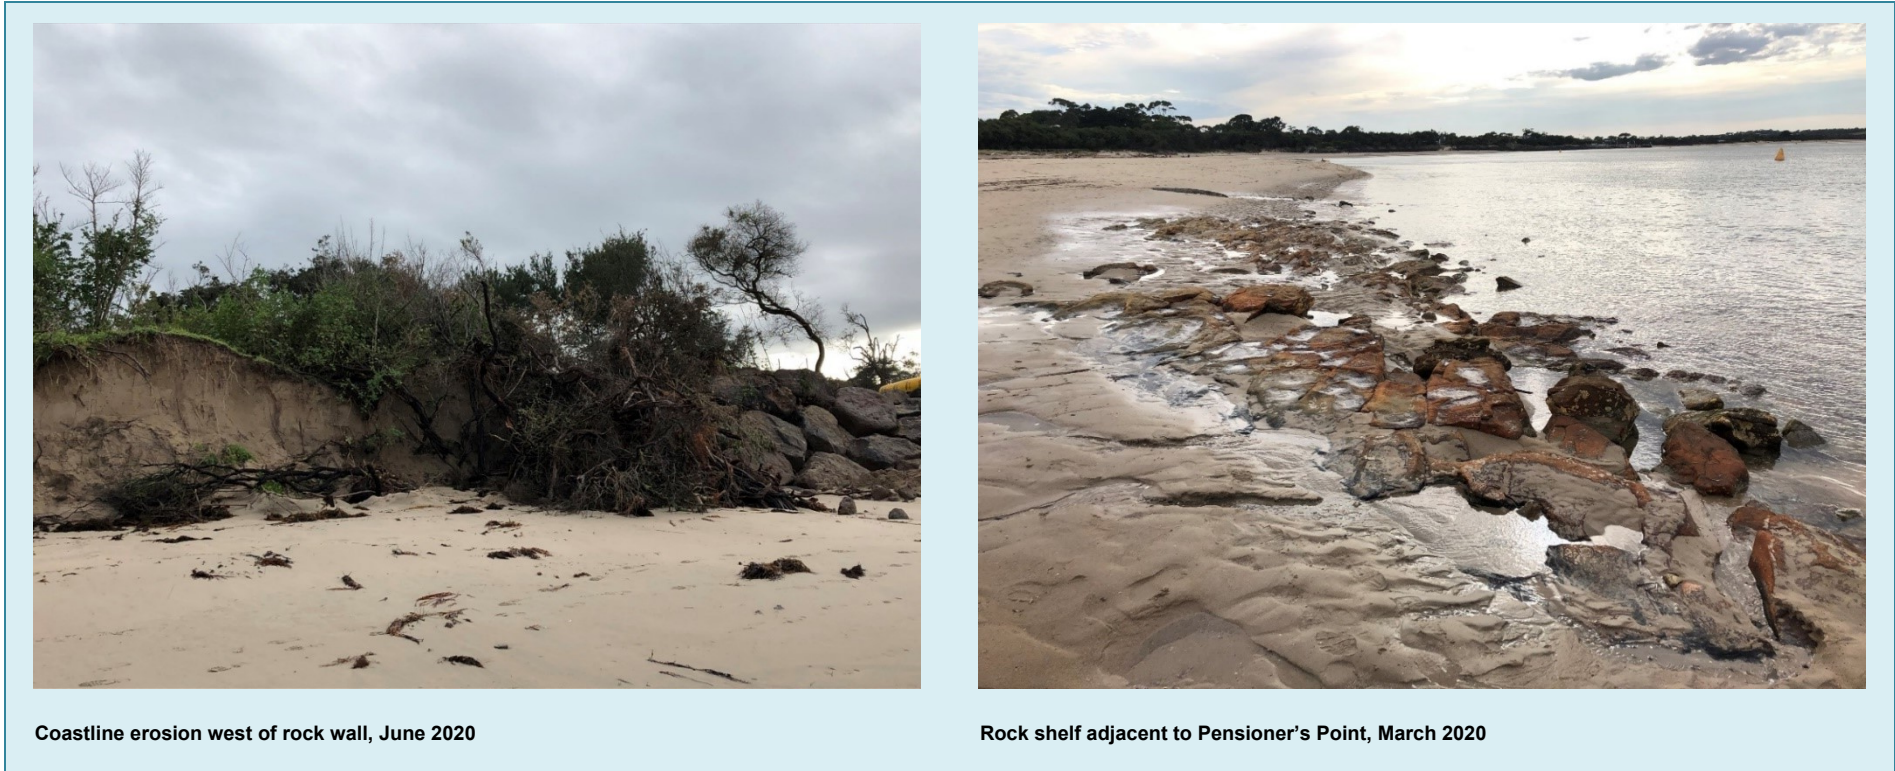
**Coastline erosion west of rock wall, June 2020**
