# Inverloch Coastal Resilience Project

## Inverloch Beach Monitoring Report

August 2018 to June 2020

South Gippsland Conservation Society Inc.

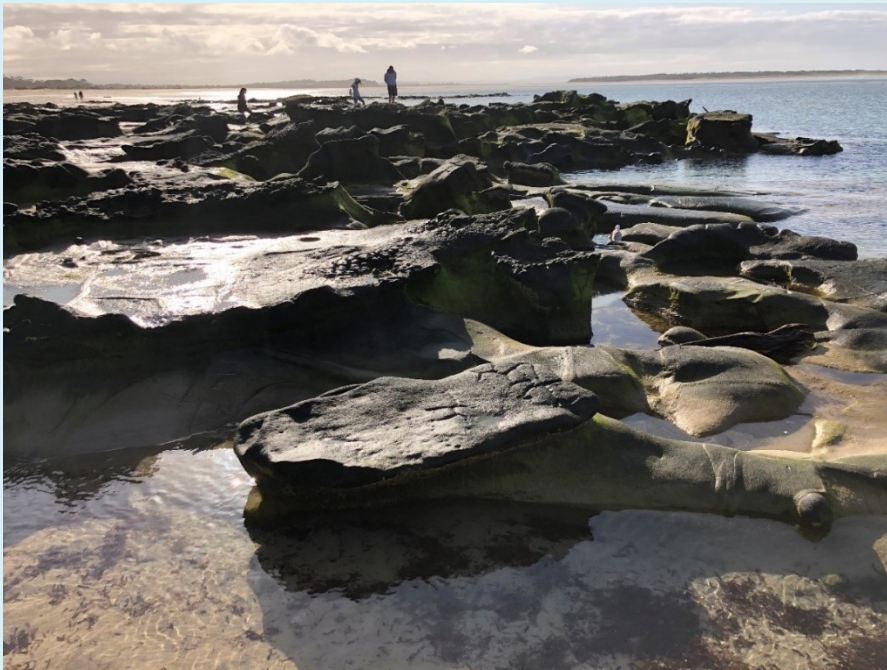
Pt Norman – as noted elsewhere in this report, the rock shelf at Pt Norman became progressively more exposed between January and May 2020. This was recorded in photographs taken during inspections on 30/03/20, 05/05/20 and 25/05/20 and coincided with a period of south-easterly winds that may have acted to counteract the longshore, easterly movement of sand along the surf beach. The 28/06/20 inspection revealed that the rock shelf was not as exposed, possibly caused by the longshore movement of sand that had been removed from the surf beach during the April and May 2020 storms (see Appendix D). It was also noted that a sand spit had re-formed off Pt Norman. This coincided with the advent of prevalent northerly winds over May and June 2020.

Pt Norman rock shelf, April 2020

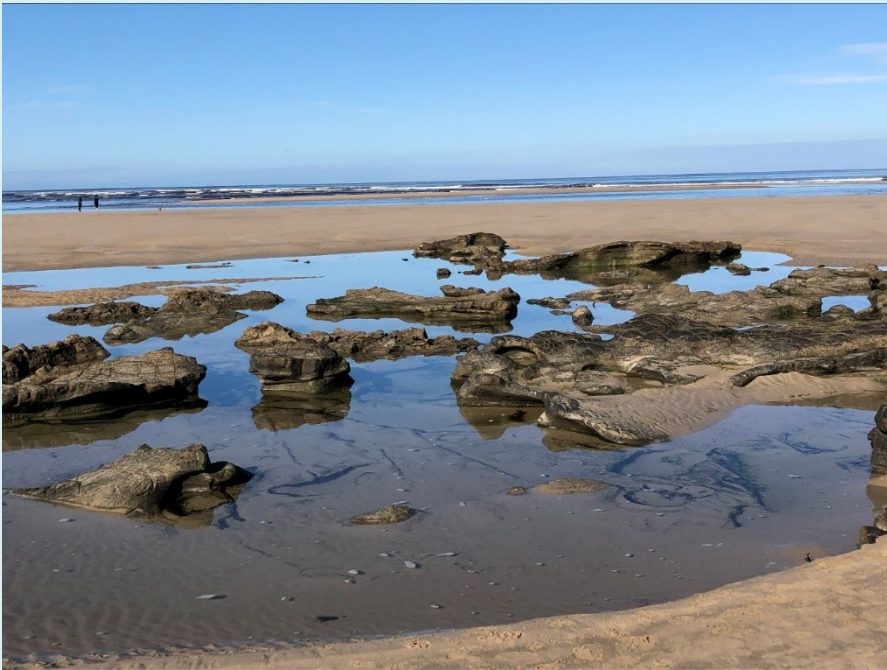
Benign weather conditions (northerlies predominating) during May/June 2020 meant that the rock shelf has acted as a partial anchor, with sand accumulating further at Pt Norman, and a sand spit forming off Pt Norman. The anchoring function of the Pt Norman rock shelf is explained further in '*Geomorphic & Ecological Investigation between Western St and Cape Paterson- Inverloch Road, Inverloch*' (Water Technology, July 2019).

Pt Norman rock shelf, June 2020

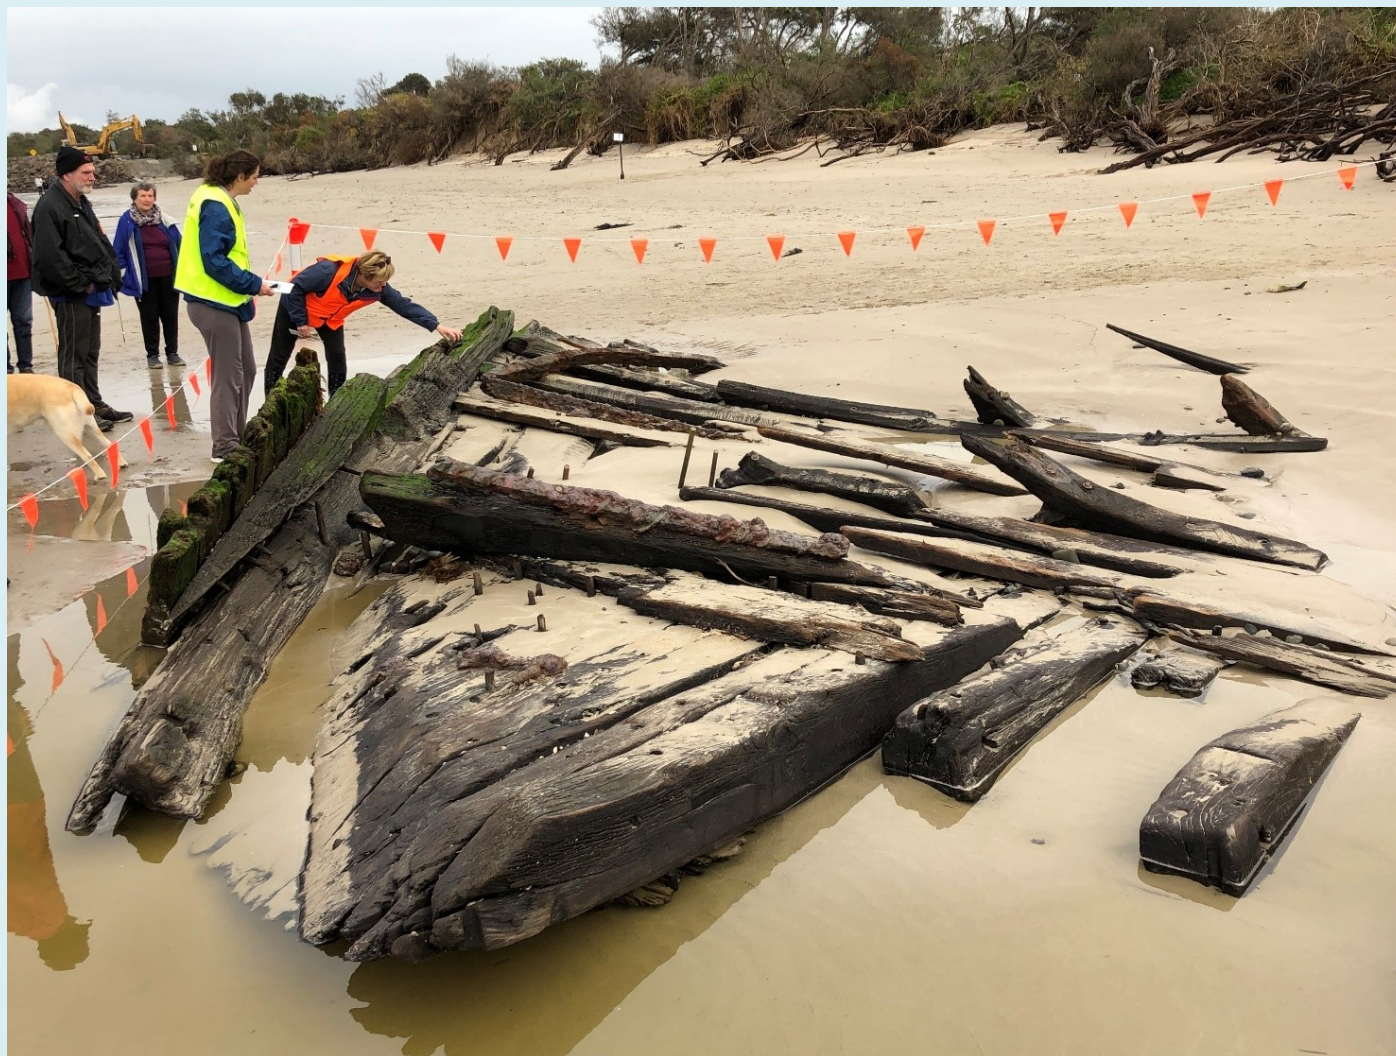
Wreck Creek- some accretion was observed at the dune adjacent to Wreck Creek on 27/03/20, with the Amazon shipwreck less exposed than previously. This situation had reversed by 05/05/20, with appreciable dune recession having occurred, the Amazon being much more exposed and a new opening of Wreck Creek to the ocean occurring west of the previous opening, adjacent to the Amazon. The extent of the new opening continued to widen in June 2020, with two channels now evident (late June 2020). On 27/06/20 inspection, the minimum width of the remaining dune between Wreck Creek and the ocean was measured at 3 metres. The Estuarine Reedbed along Wreck Creek, dominated by Common Reed (*Phragmites australis*) has died back significantly since the new breach, most likely due to the tidal influence and resultant high concentrations of salinity.

Amazon Shipwreck, June 2020
