Andersons Inlet Evolution and Surf Beach Erosion

**Griffith Centre for Coastal Management
Report No. 274**

December 2020

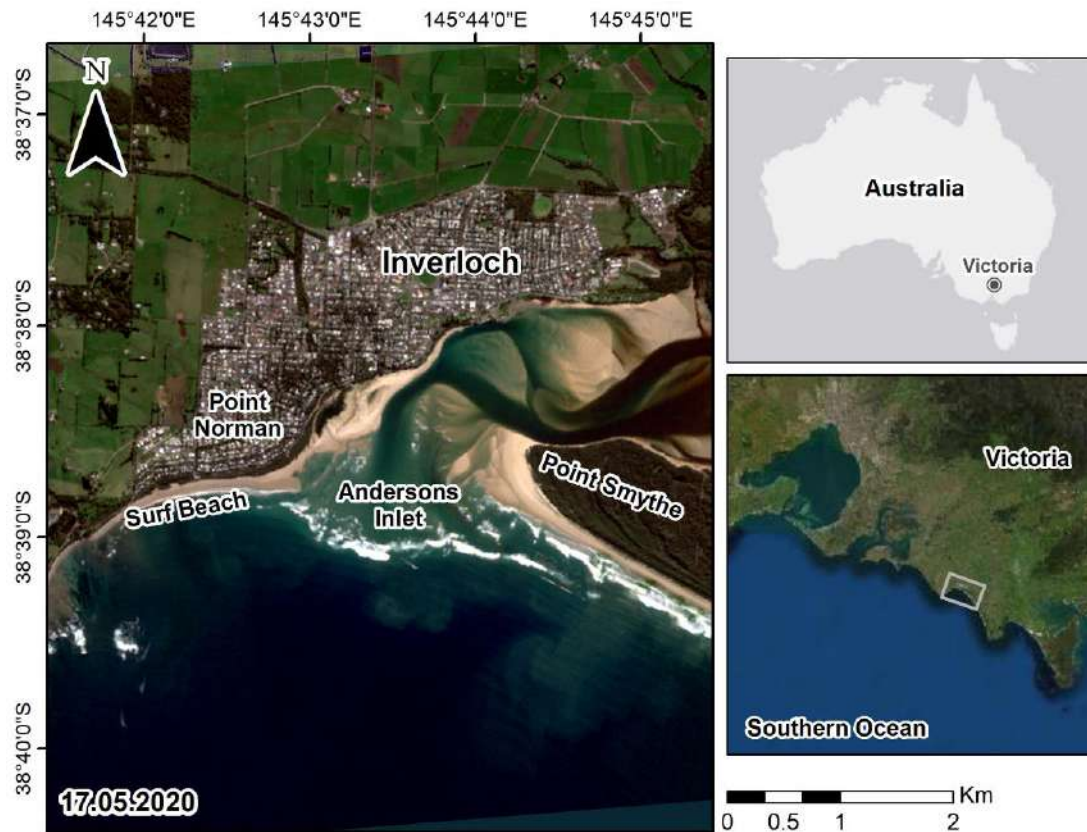
Figure 1: Study area location (Source: Image from 17 May 2020 - Sentinel-2; Google Earth base maps – EsriArcG’s: Digital Globe, GeoEye, USGS).

Inverloch is a well-loved tourist destination and regional centre on the coast of Victoria. The town is located on the northern shore of Andersons Inlet (Figure 1) with both the inlet and the open coast beaches being major attractions. Moreover, besides the tourism and economic aspect, the region has great geomorphological, ecological and cultural heritage value associated to its coastal barrier.

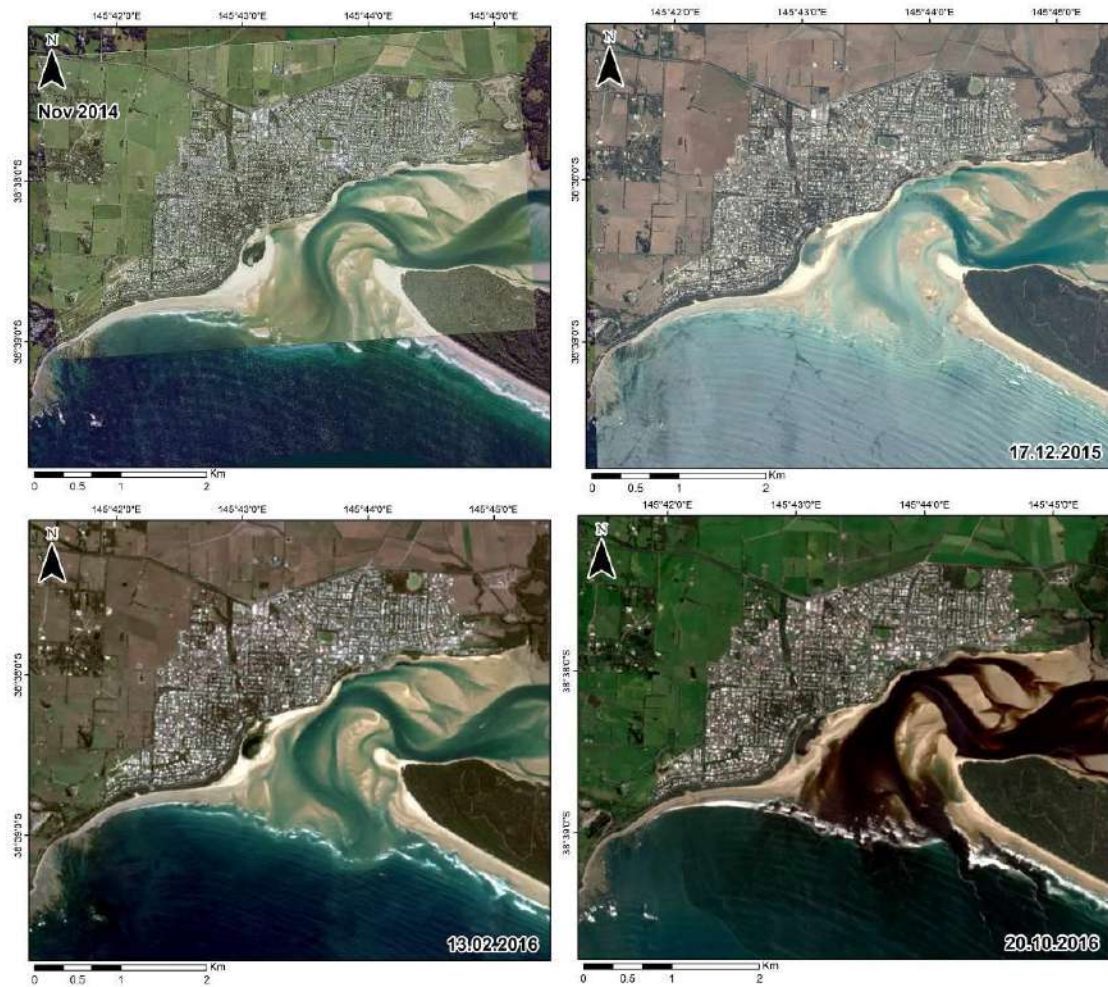
Figure 8: Aerial image (2014) and satellite images showing Andersons inlet variability between 2014 and 2016. Point Smythe sand deposit builds up towards north while Point Norman sand spit is formed towards east, creating a complex meandering system and moving the inlet eastward. In 2016, however, a flood breaks through Point Norman sand spit.

Between 2014 and 2016, this sediment building around Point Norman increased and forced the inlet eastward (Figure 7). In the meanwhile, Point Smythe sand deposits kept growing onshore, creating a more complex meandering system close to the entrance (Figure 7). Moreover, the sand bank that now is welded to the Inverloch shoreline created an estuary sandy beach with an enclosed lagoon (Figure 8). By the end of 2016, a freshwater flood (identified by the dark brown colour of the estuary water) washed out the sand spit forming at Point Norman (Figure 8).

Around 2014, the sand deposits that were detached from Point Smythe started to merge with the coastline on the western side of the estuary channel (Figure 8). The development of the estuary sandy beach is firstly observed near Point Norman and gradually develops at the upstream transects (Figure 12b). By the end of 2016, the sand deposit was completely emerged, and the new shoreline position stabilized (Figure 12b).

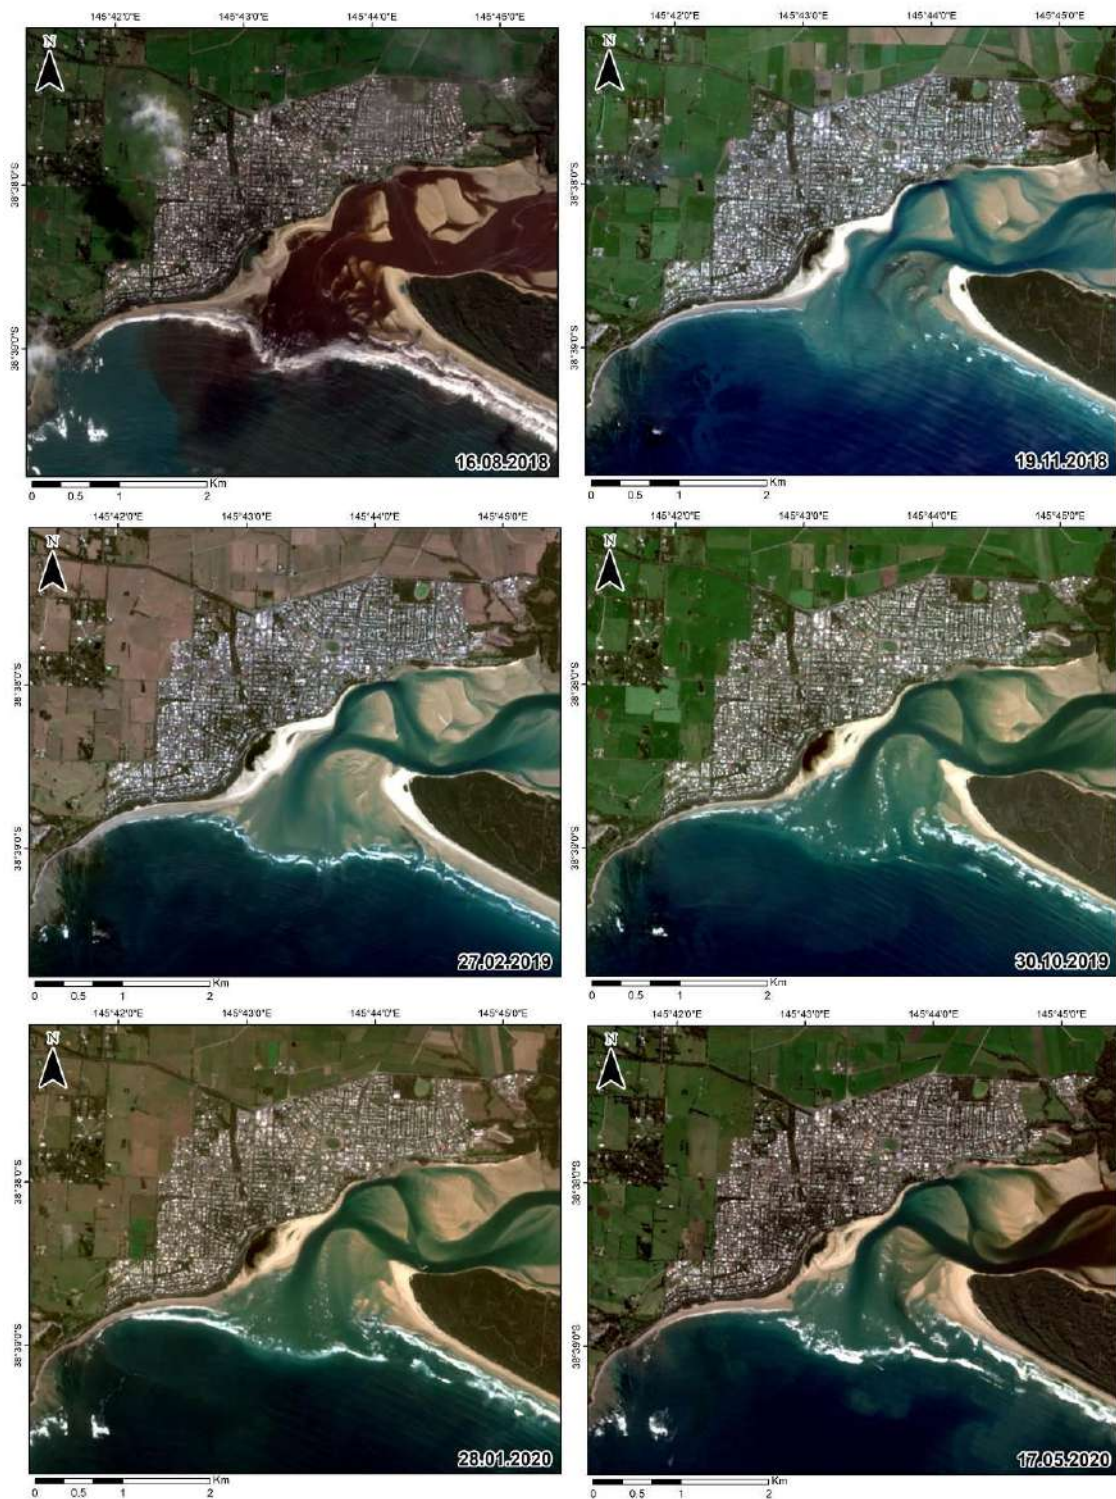
Figure 10: Satellite images showing the river system variability between 2018 and 2020. In 2018, a flood broke through Point Smythe sand deposits and change the main channel position. Point Smythe started to grow towards west.

In August 2018, a freshwater flood event caused the channel to break through the Point Smythe sand deposit, modifying the inlet meandering system once again (Figure 10). Since then, Point Smythe has started to build up towards the west and the meandering system was smoothed. On the other side of the channel, erosion has been observed around Point Norman and towards the estuary sandy beach (Figure 10). It is not possible to confirm if Andersons Inlet will find its equilibrium

An erosion spot was detected around transect 40 from mid-2018 to early 2019 (Figure 12c) as a result of a freshwater flood (Figure 10). The area was infilled back by March 2019 (Figure 12c), which seemed to happen due to upstream migration of sand along the shoreline. Sand deposits around transects 50 to 55 (downstream), for instance, started to gradually erode since early 2019 (Figure 12d).

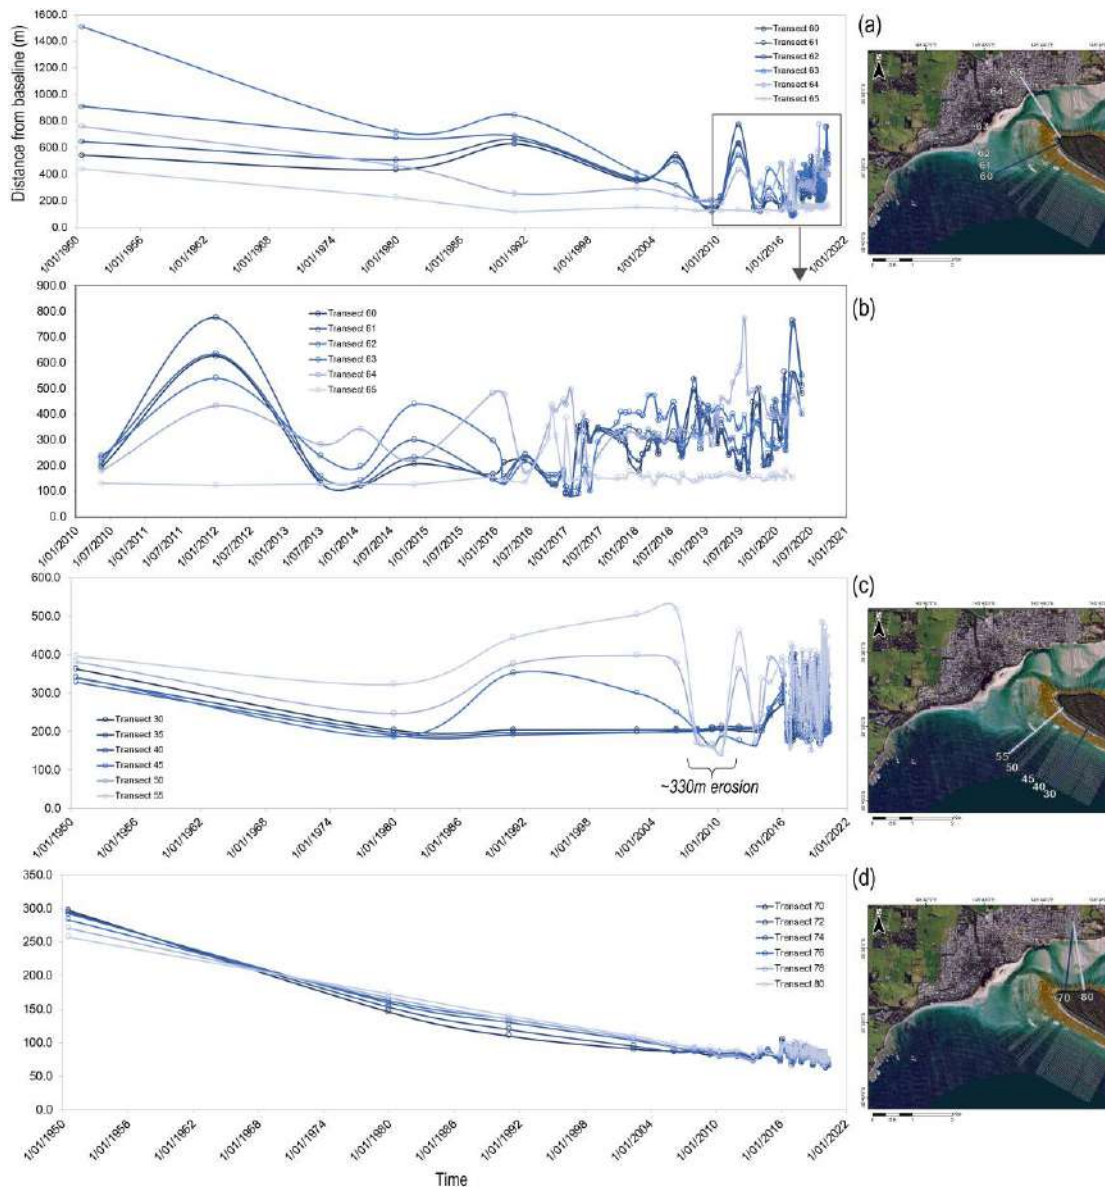
Figure 11: Shoreline position variability at Point Smythe. (a) time-series for transects 60 to 65 covering the period from 1950 onwards; (b) variability of the same transects for the period from 2010 onwards; (c) time-series for transects 30, 35, 40, 45, 50 and 55 covering the period from 1950 onwards; and (d) time-series for transects 70, 72, 74, 76, 78 and 80 covering the period from 1950 onwards.

The spit formation observed in Point Smythe has undergone substantial recession since 1950. About 1.3 km of shoreline retreat occurred from 1950 to 2009 (Figure 11a). From 2010 onwards, shoreline position started to oscillate with no significant trend (Figure 11b). As presented before in section 4.1 and Figure 3, Point Smythe has been gradually flooded which has caused shoreline recession, and transformed the sandy upper beach of 1950 into a flood-delta deposit that was detached from Point Smythe in 2009.

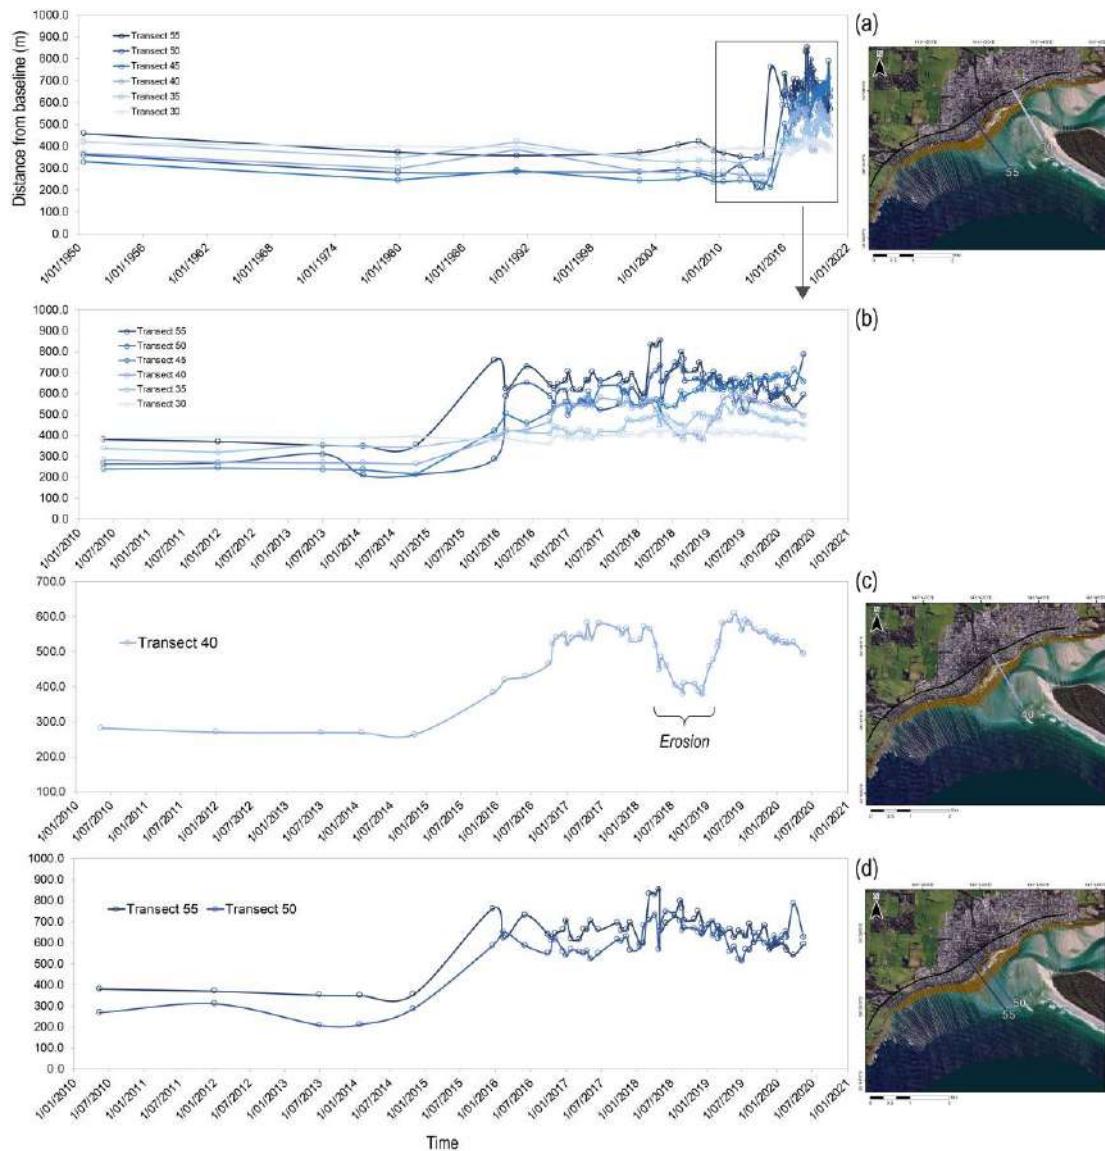
Figure 12: Shoreline position variability along Inverloch coastline. (a) time-series for transects 30, 35, 40, 45, 50 and 55 covering the period from 1950 onwards; (b) variability of the same transects for the period from 2010 onwards; (c) time-series for transects 40 covering the period from 2010 onwards; and (d) time-series for transects 50 and 55 covering the period from 2010 onwards.

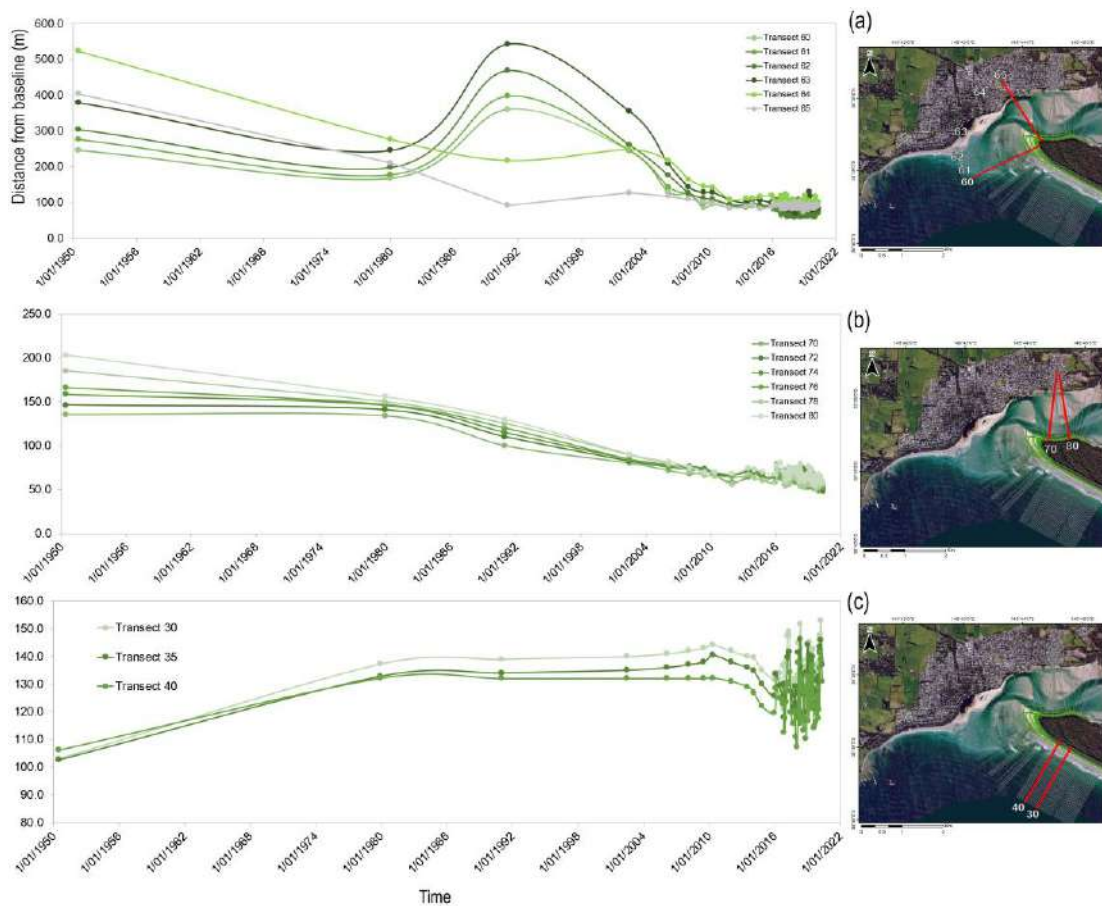
Figure 15: Vegetation line variability at Point Smythe. (a) time-series for transects 60 to 65 covering the period from 1950 onwards; (b) time-series for transects 70, 72, 74, 76, 78 and 80 covering the period from 1950 onwards; and (c) time-series for transects 30, 35 and 40 covering the period from 1950 onwards.

At the western limit of Point Smythe, shoreline retreat was observed already in the 1970's. The vegetation line, on the other hand, had a sustained growth from 1980's until early 1990's (Figure 15a). At this point, the beach width was drastically reduced, and shoreline recession reached the vegetation base. Between 1991 and 2009, the vegetation line in Point Smythe retreated by around 250 to 400m (Figure 15a). Over the following decade, the vegetation base persisted in a similar position (Figure 15a).

The inland side of Point Smythe has endured recession of the vegetation line since the 1970's (Figure 15b), as a result of the migration of the meander eroding the region. On the ocean side of Point Smythe, however, vegetation has grown between 1950 and 1970's, and maintained at a similar position since then (Figure 15c).

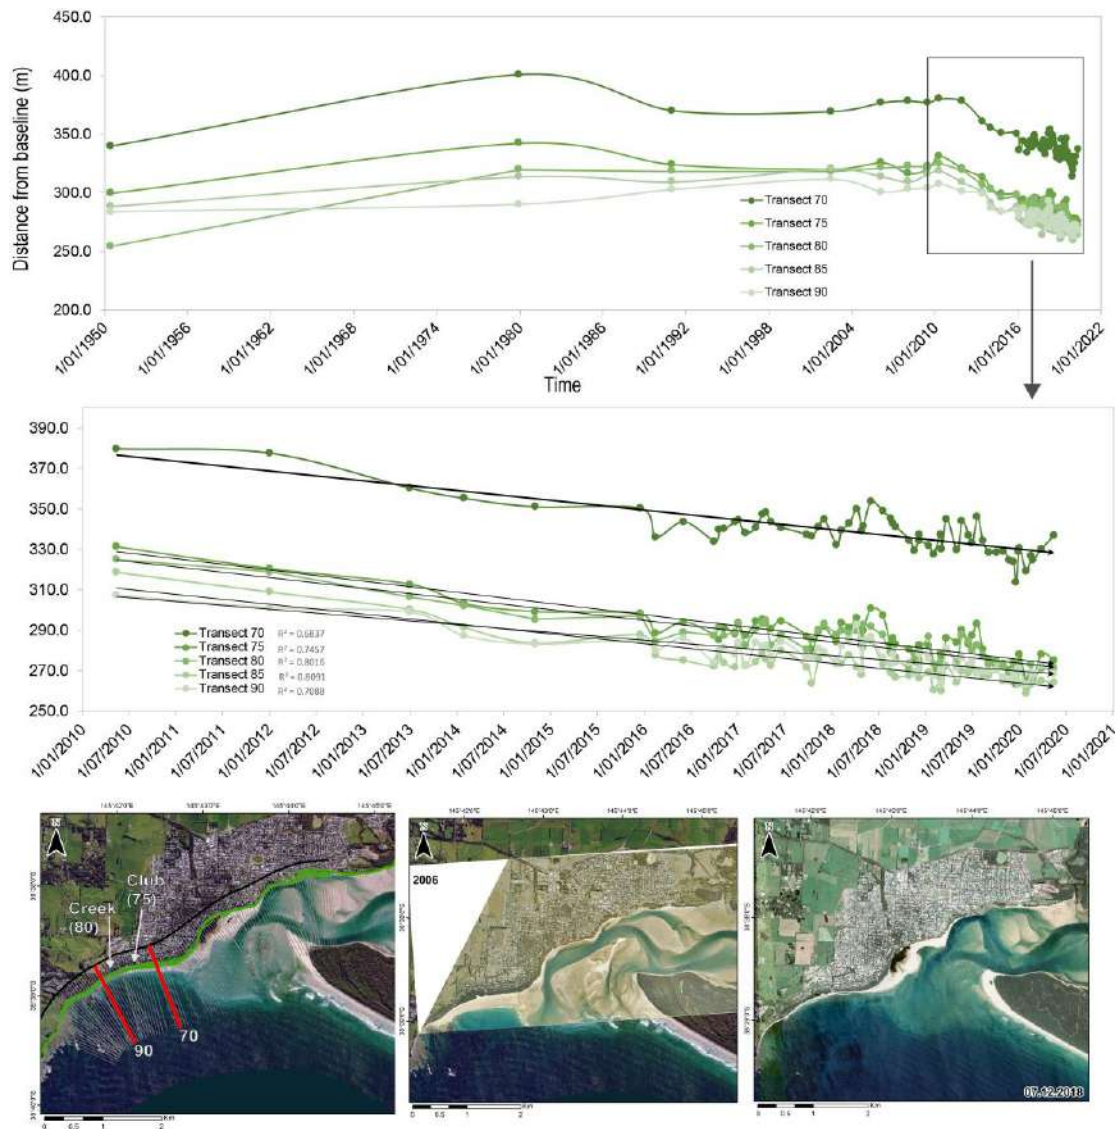
Figure 17: Vegetation line variability at Surf Beach. Above, time-series for transects 70, 75, 80, 85 and 90 from 1950 onwards. Below, variability of the same transects for the period from 2010 onwards. Black arrows indicate the linear trend for each transect time-series.

Surf Beach vegetation has changed remarkably, especially over the last decade. Between 1950 and 1970's, the vegetation line accreted around 40 m (Figure 17). A slight retreat of 10 to 20 m occurred between 1970's and 2010 (Figure 17). After that, a major erosive period started and persists until now (Figure 17). About 70 m of vegetated dunes have been eroded along the coastline of Surf Beach, receding the vegetation line to 30 m onshore from 1950's position. The significant erosion trend observed over last decade (average $r^2 = 0.75$) (Figure 17) indicates that Surf Beach vegetation area might still endure erosion over the near future.

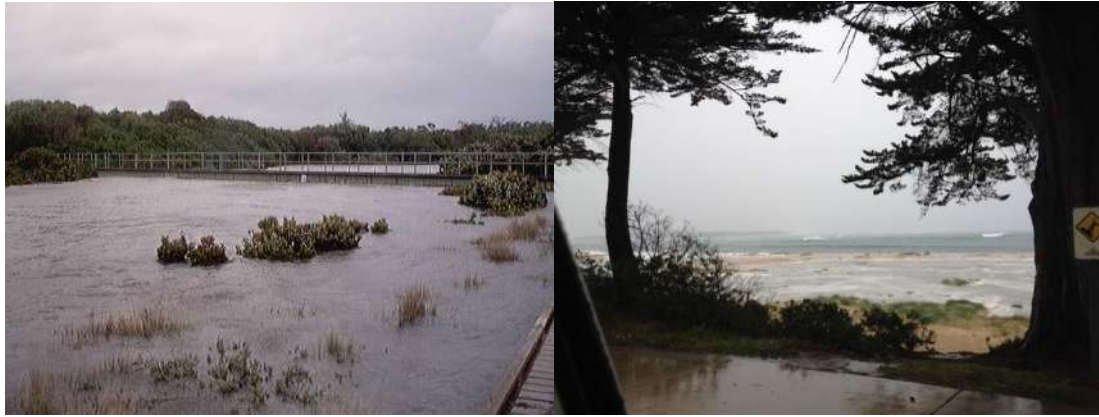
Figure 19: Photographs of the Screw Creek pedestrian bridge and from Surf Parade of the storm surge on 19 June 2004 (Courtesy of SGCS members).

- A second trigger could have been the exceptional storm surge that occurred on the 19th June 2004. Whilst full details of the storm (Wave height and direction, storm surge duration) have not been quantified, photographic evidence has been provided by SGCS members as shown in Figure 19. Interpretation of these photographs suggests a storm surge of around 1.5m.

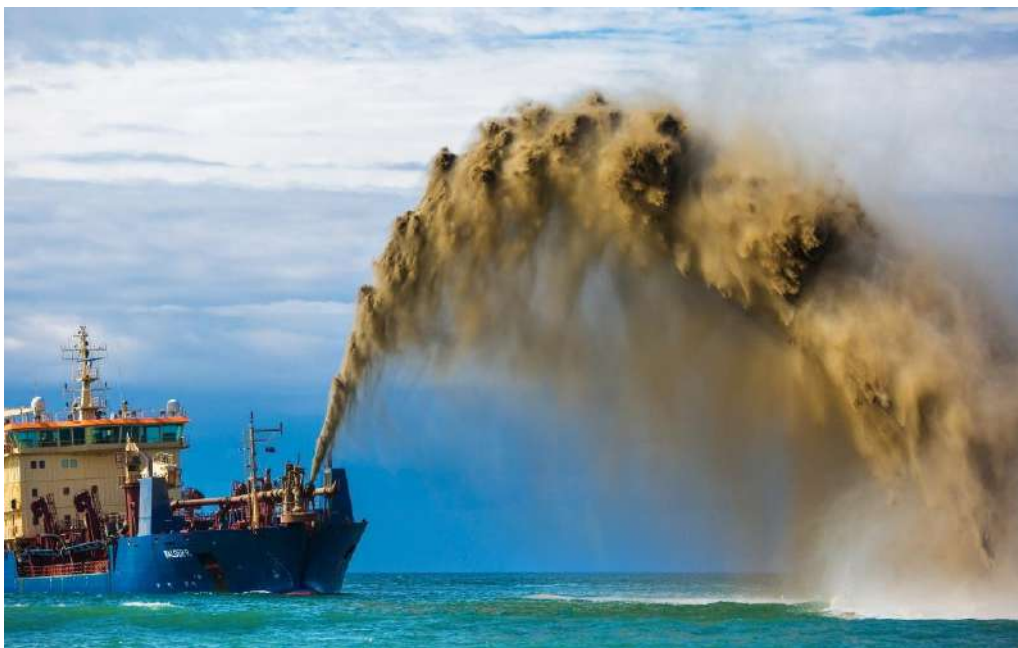
Figure 21: Nearshore nourishment on the Gold Coast.

Direct nourishment can be sourced from offshore as on Gold Coast which adds “new” sand into the compartment from non-active sources, e.g. from deep water offshore. It can also be sourced from non-active deposits within estuaries such as Andersons Inlet (Figures 20 and 21). Caution is needed in the latter case to ensure that the sand is truly “inactive” and not part of the dynamic equilibrium flood tide deposits. This method was used at Noosa until the deposits ran out and the backpassing system implemented. It was also used when navigation channels need to be maintained in the Gold Coast Broadwater. In this case, even though the sand is “active” there are other requirements for its removal.

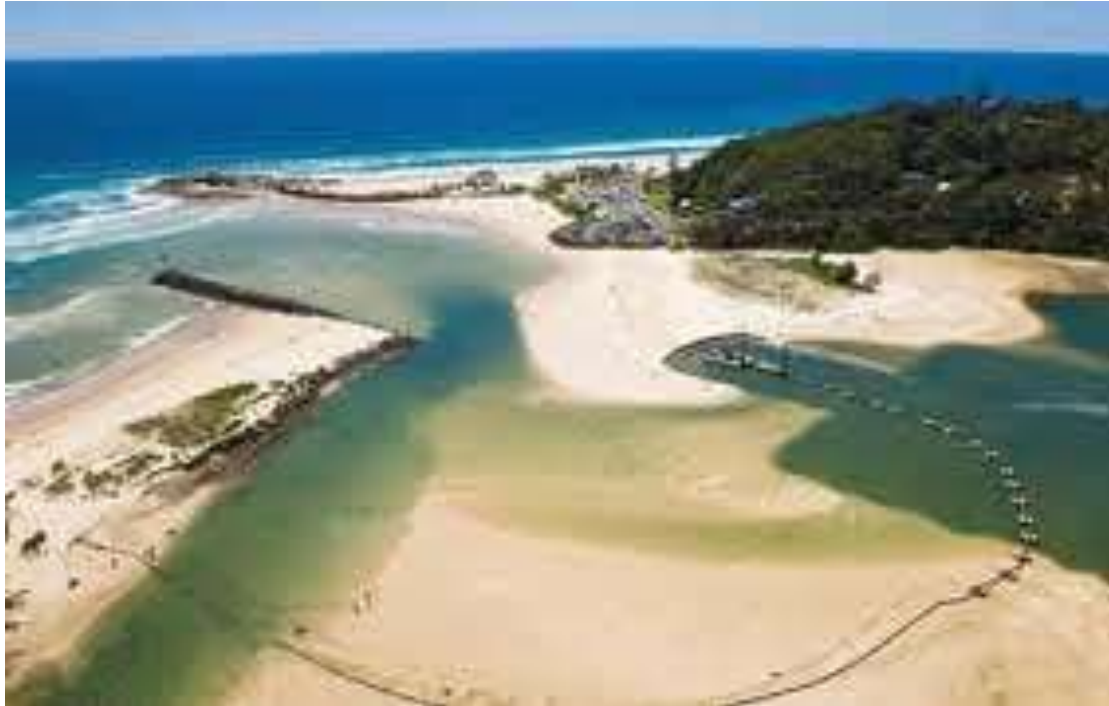
Figure 22: Currumbin Creek dredging to improve water quality and flooding. Natural longshore sand transport is “bypassed” or short-circuited onto Palm Beach.

Bypassing which ensures that blockages to natural sand supply to a coastal compartment such as Surf Beach are overcome. This has been employed at the Tweed River Entrance, the Gold Coast Seaway and Lakes Entrance for example. It can also be achieved by “short circuiting” the natural processes as occurs at a tidal inlet where natural infilling is countered by regular dredging of the entrance with placement on the downdrift side such as at Currumbin (Figure 22) and Tallebudgera Creeks and the Gold Coast.

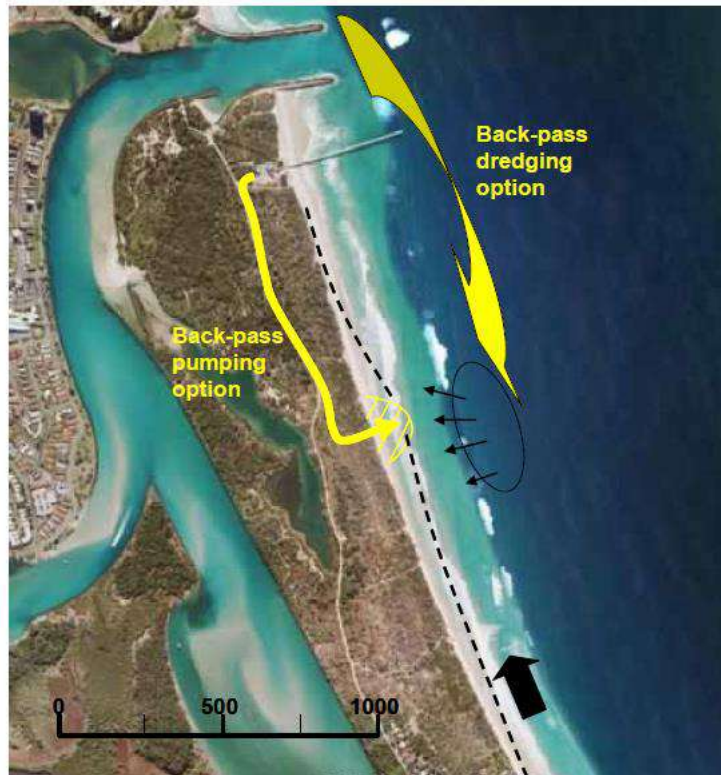
Figure 24: Backpassing proposal for the Tweed River entrance (Source: BMT (2010) for the Tweed River entrance Sand Bypassing Project)

Backpassing entails capturing sand on the downdrift end of a coastal compartment and returning it to the updrift end. This is being done for Noosa Main beach where approximately 25,000 m³ per year of sand is pumped from near the entrance to the Noosa River back to the eastern end of Main beach (Figure 23). A large-scale operation is planned for Surfers Paradise with approximately 120,000 m³ per year will be pumped from the Seaway Sand pumping jetty back to various location along Main and Surfers Paradise Beaches. A similar small-scale back-passing has been investigated for the Tweed River entrance (Figure 24) where piping and dredging were considered.

For Inverloch, backpassing would involve capturing sand from Point Norman, the inlet deposits or Point Smythe and depositing the sand at the western end of Surf Beach from where natural longshore process would appear to redistribute the sand along Surf beach. This could be via fixed pipe networks or specific dredging activity (as for Figure 24).

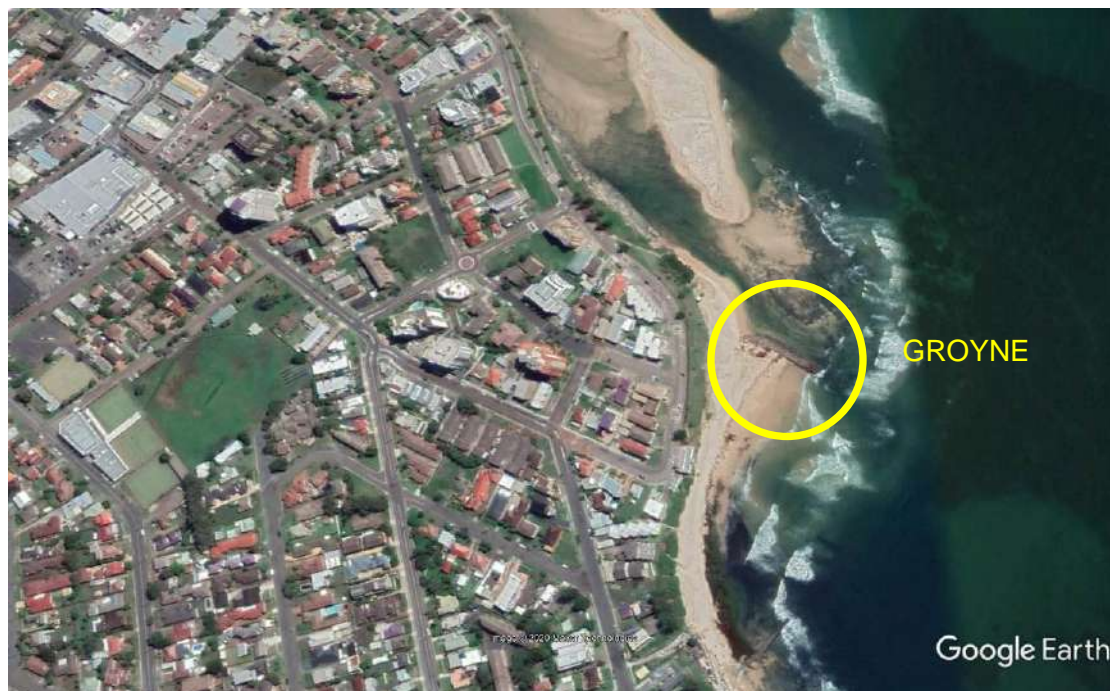
Figure 25: Groyne constructed at Tuggerah Lakes entrance to maintain the beach to the south

An example of a groyne near a tidal inlet is at Tuggerah Lakes in NSW (Figure 25). The groyne was built a couple of years ago to maintain the beach, however, there are strong suggestions that it is also acting as a training wall influencing the entrance channel configuration and may be leading to increased flooding inside the Lake.

Should a detailed hydrodynamic and sediment transport assessment of channel characteristics demonstrate that Surf Beach erosion is directly related to the orientation and location of the ebb-tidal channel, then there is the opportunity for a management strategy which will mitigate the erosion by artificially manipulating the channel based on an understanding of the overall inlet dynamics. This has been proposed and/or implemented at a number of locations such as the Noosa and Maroochy river entrances on the Sunshine Coast, and at the Tuggerah Lakes entrance. For example, at Tuggerah, following a major flooding event within the lake system early this year, a channel was somewhat belatedly dredged through the sand spit to the north of the entrance (evident in Figure 25).

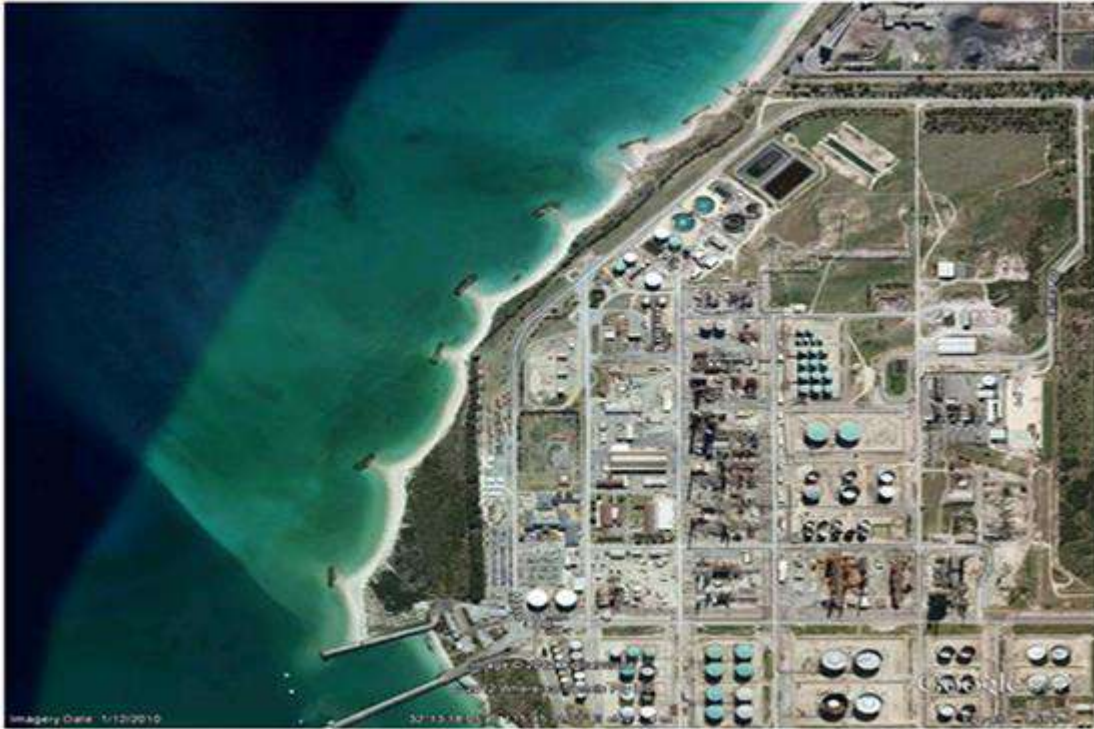
Figure 26: Offshore emergent structures creating tombolos - Western Australia

There are a range of hard engineering structures such as offshore breakwaters that are used worldwide to protect infrastructure. These tend to be emergent and overall are not aesthetically pleasing and significantly change the alignment of the coastline. An example of this type of structure from Western Australia is shown in Figure 26. This type of structure would not be suitable at Inverloch, mainly as they are emergent and not aesthetically pleasing from the shore. In a longshore transport environment such as Surf Beach they also act to trap sand and while this would have a positive impact on Surf Beach width, there may be impacts on the overall dynamics of the beach/inlet system by limiting the movement of sand towards the inlet.

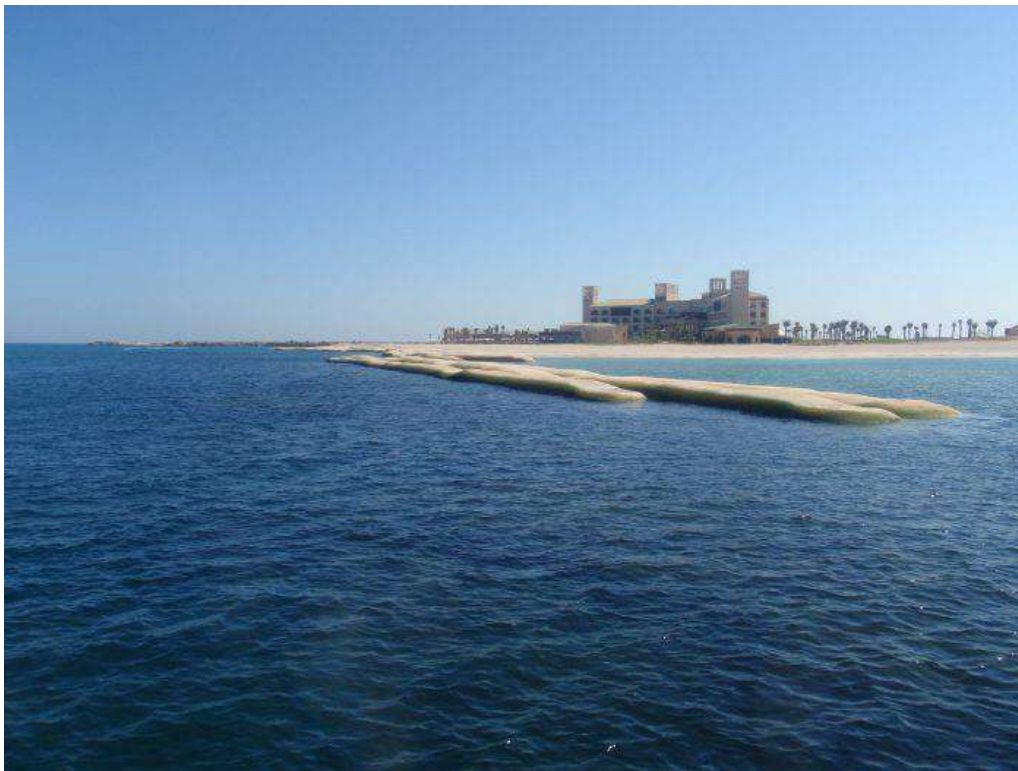
Figure 28: Shore parallel geotextile container structure - Sir Baniyas Island UAE (International Coastal Management P/L).

At a much smaller scale, geotextile containers can be used as shore-parallel berms, emerged or submerged as shown in Figure 28 where the structure protects a 5-star hotel.

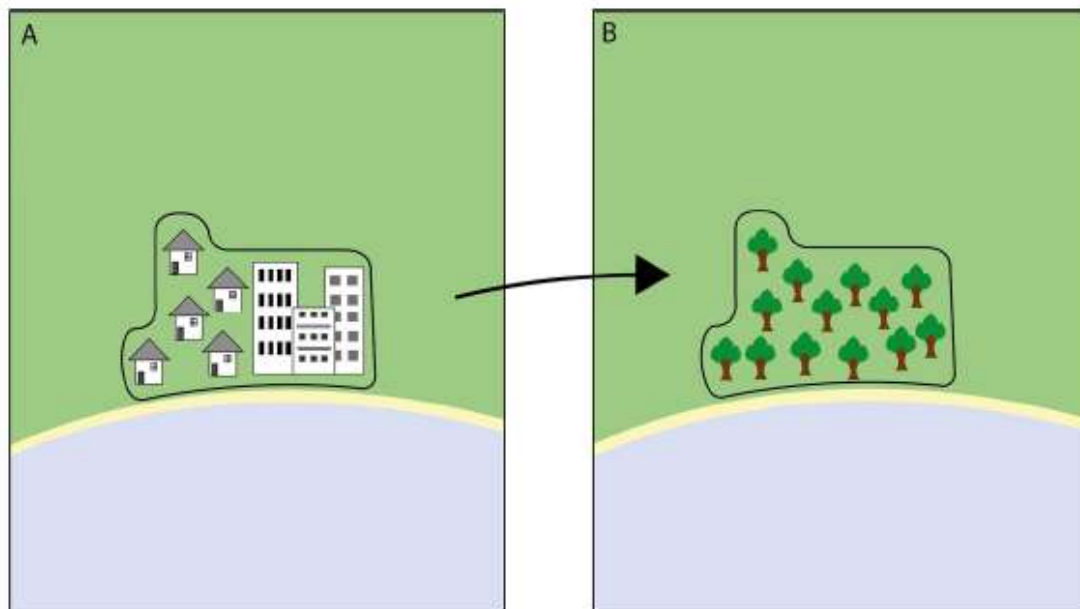
Figure 29: Land-use change through land purchase or swap.

Should the erosion issues at Surf beach be found to be long-term (mainly in response to climate change), then the community may need to consider transforming the urban footprint to remove assets from the erosion zone and create sufficient buffer to enable the natural dune ecosystem function. There are number of options available to achieve this (Figure 29), such as:
