Inverloch Coastal Resilience Project

Project Report

South Gippsland Conservation Society Inc.
August 2019

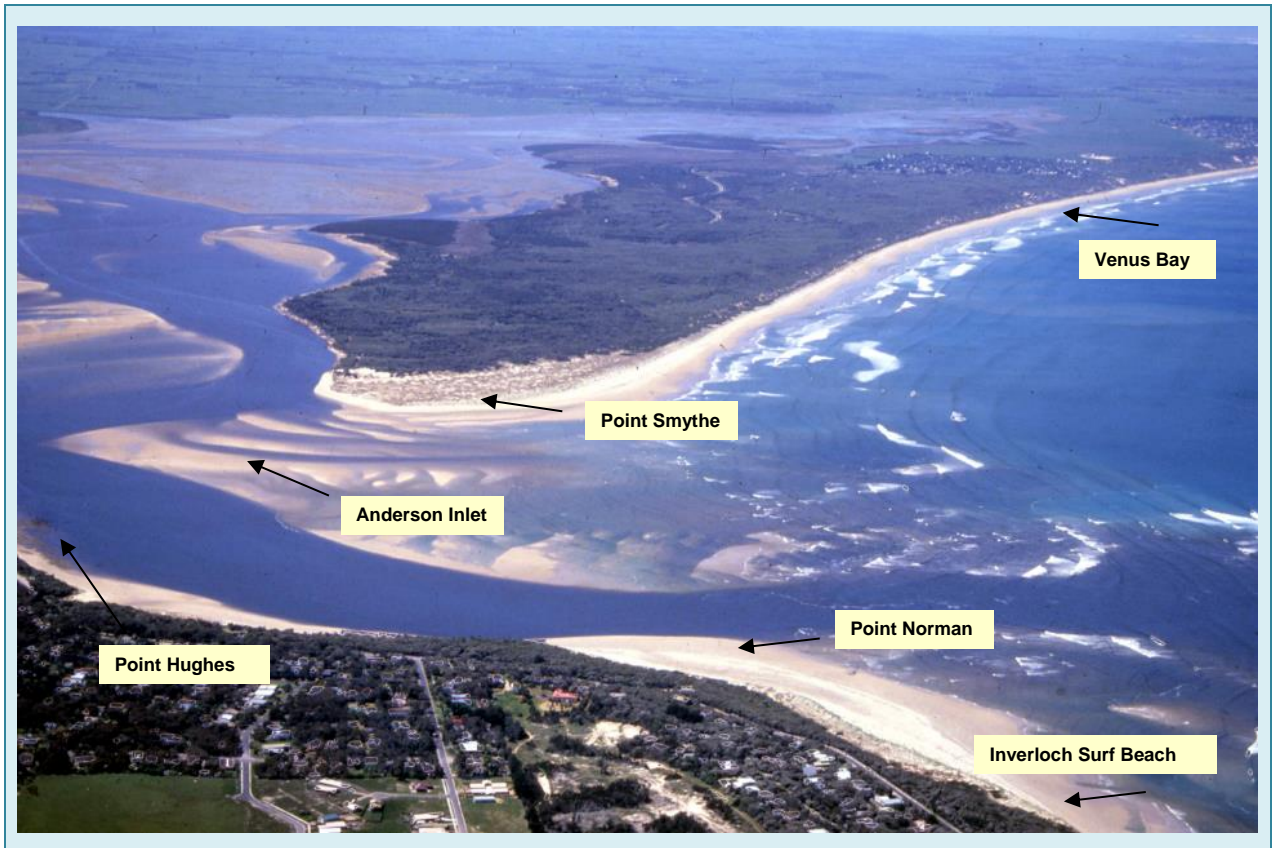
Figure 1 Study Area

South Gippsland Conservation Society (SGCS) initiated the Inverloch Coastal Resilience Project in late 2018 in response to the sustained coastal erosion that has occurred at Inverloch surf beach since 2013. Inverloch is situated on the Bass Coast, between Western Port Bay and Corner Inlet, approximately 140 kilometres south east of Melbourne. Its coastline is located within Venus Bay, between the headlands of Cape Paterson and Cape Liptrap. *Figure 1 - Study Area* captures the project study area, featuring Inverloch surf beach, Point Norman, Anderson Inlet, Point Hughes and Point Smythe.

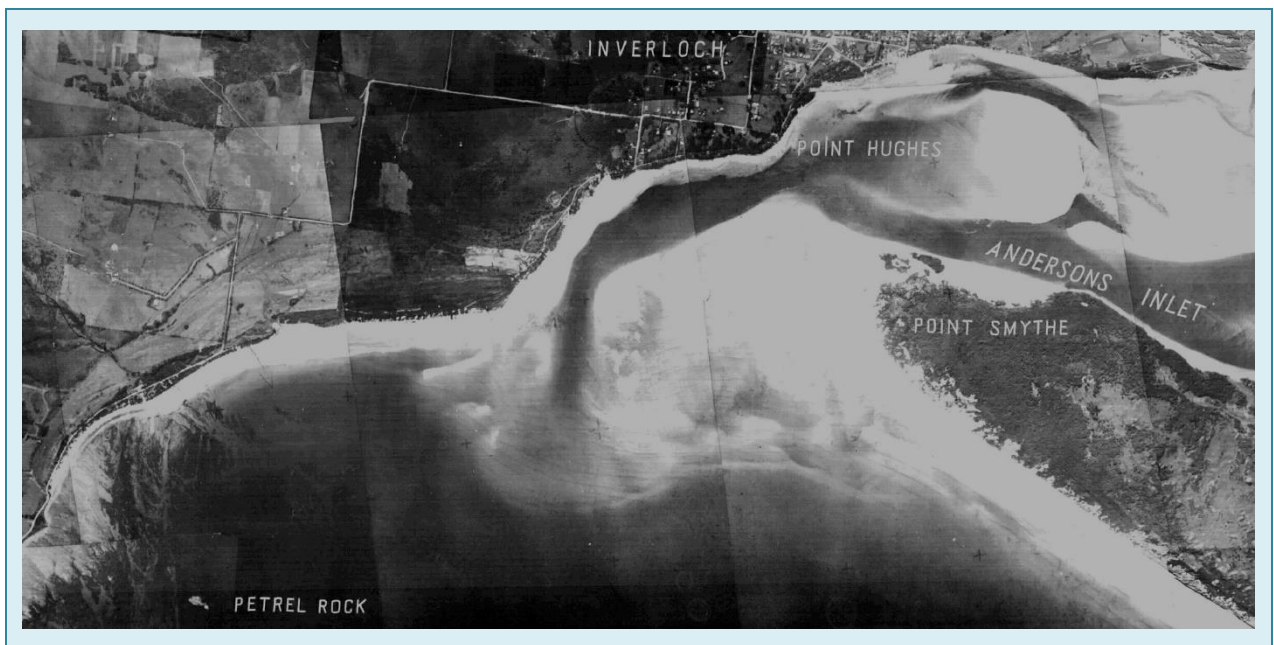
Figure 4 1950 Aerial Photograph

Figure 4 - 1950 Aerial Photograph is the earliest available aerial photograph of the Inverloch foreshore. It shows a much-reduced extent of Point Smythe (compared with the George Smythe map), but with an extensive mass of sand adjacent to it, as well as the main channel into Anderson Inlet located close to Point Norman, and a wide, sandy surf beach.

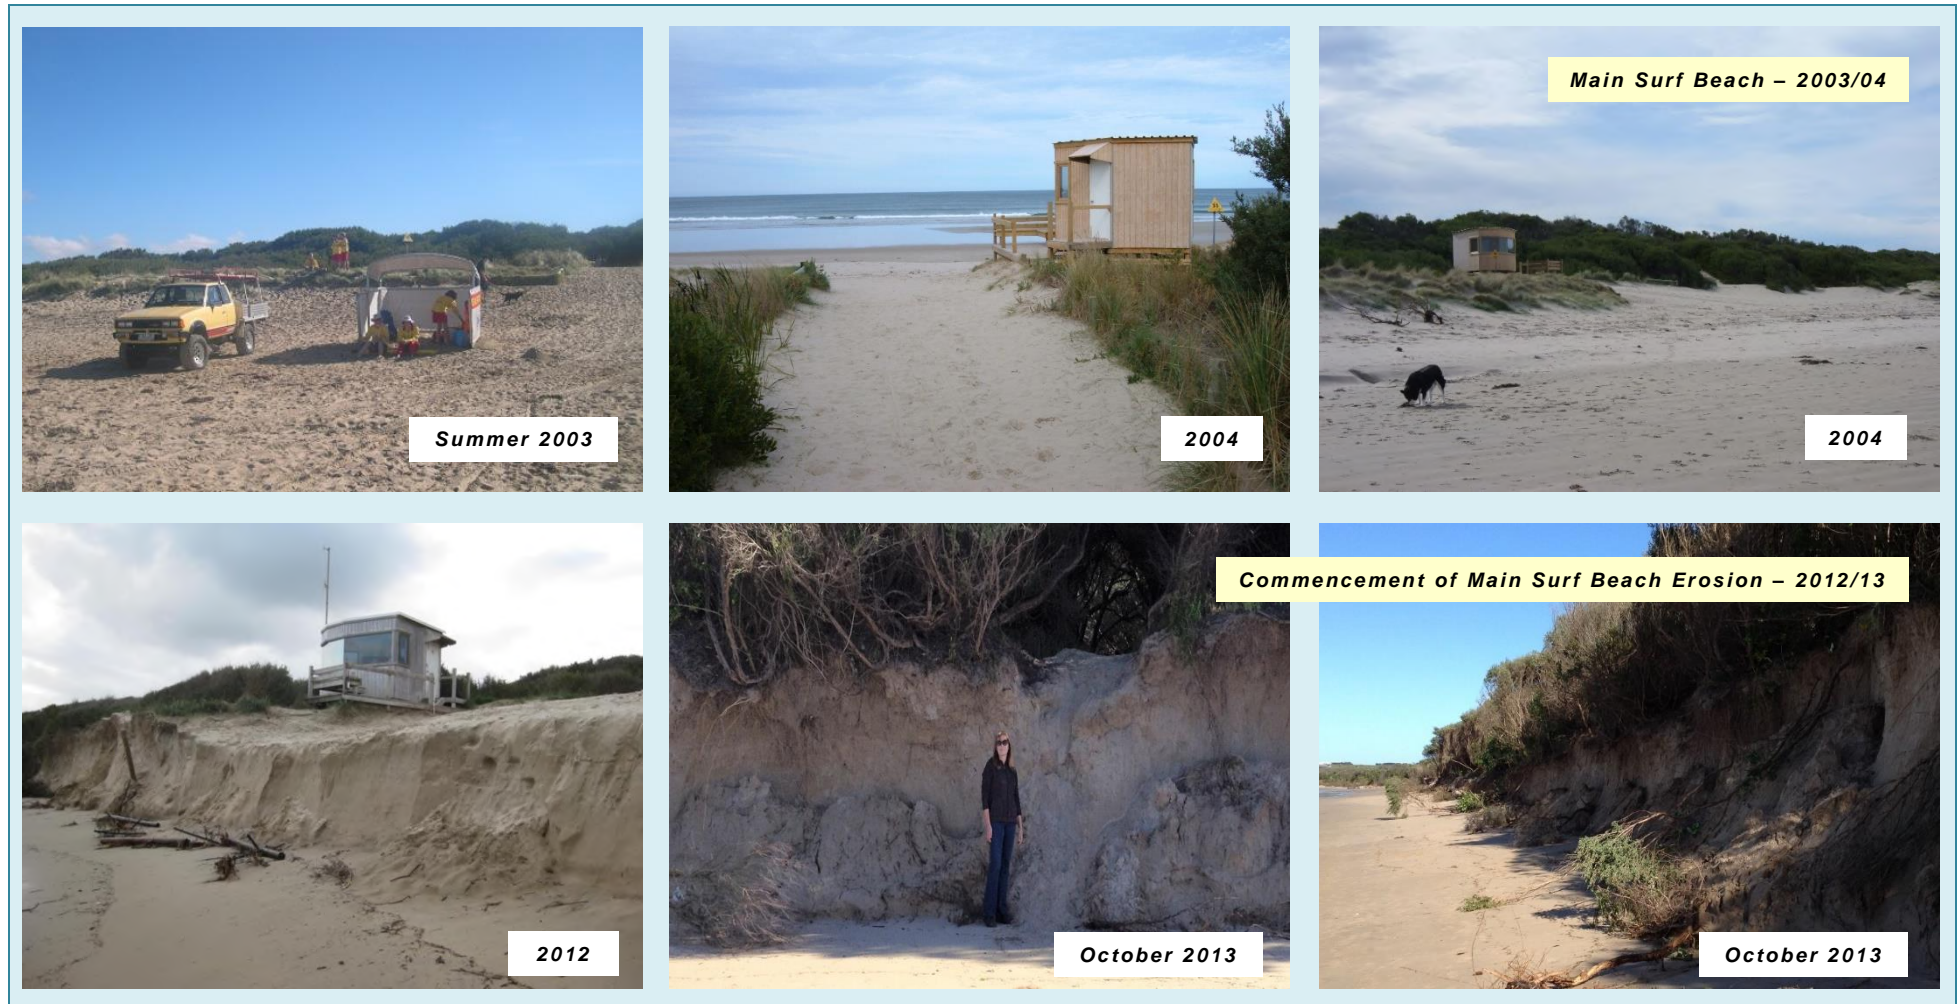
Figure 8 Surf Beach Changes: 2003 - 2013

Figures 8 - 11 provide a pictorial chronology of the changes that have taken place at Inverloch Surf Beach between 2003 and 2019. In summary, since 2013, Inverloch surf beach between Flat Rocks and Point Norman has lost more than 40 metres of the width of its vegetated dunes, with an average rate of six metres per year, over a two kilometre length of the beach. The current shoreline position between Flat Rocks and west of Wreck Creek, and between the Surf Club to west of Ozone Street, is at the most landward location recorded. Over the same period, the beach has lowered by more than 1.5 metres, with low tides occurring much closer to the shore than previously (based on observations).

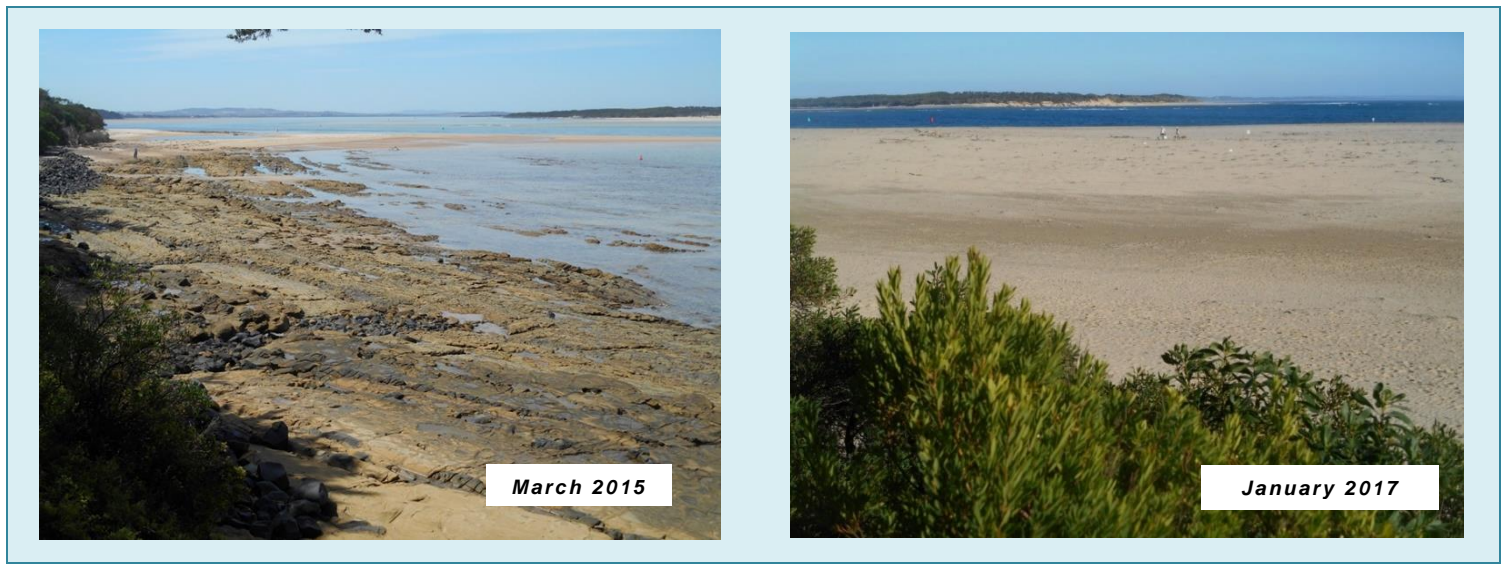
Figure 13 Anderson Inlet changes 2015-2017

Figure 13 - Anderson Inlet changes 2015-2017 shows the continuous coastal barrier has formed between Point Norman and Point Hughes, with a now-enclosed lagoon behind the barrier. The barrier appears to be progressively extending east into Anderson Inlet. The photographs also show how the former exposed rock platform west of Point Hughes has been completely covered by sand between 2015 and 2017.

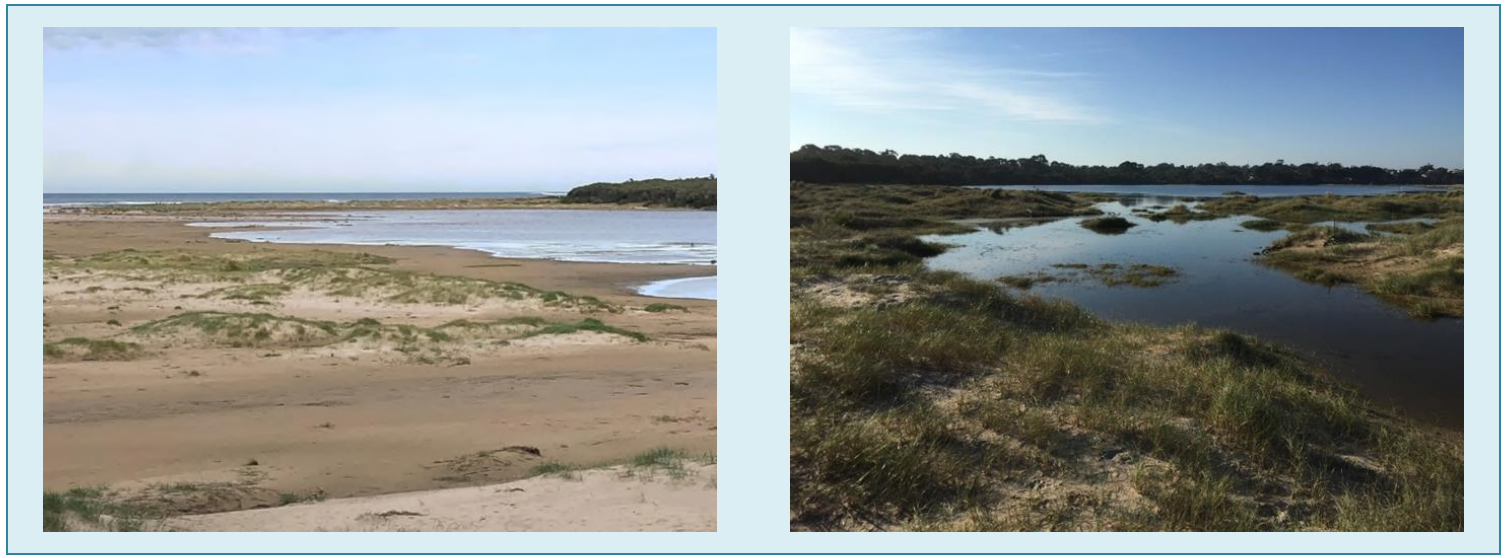
Figure 14 Ayr Creek Lagoon and Coastal Barrier

Figure 14 - Ayr Creek Lagoon and Coastal Barrier highlights the colonisation of newly-deposited incipient foredune sand on what was the former main channel. Analysis undertaken for this project indicates that this sand can only be removed by a westward (shoreward) migration of the ebb-tide channel eroding the accumulated barrier.

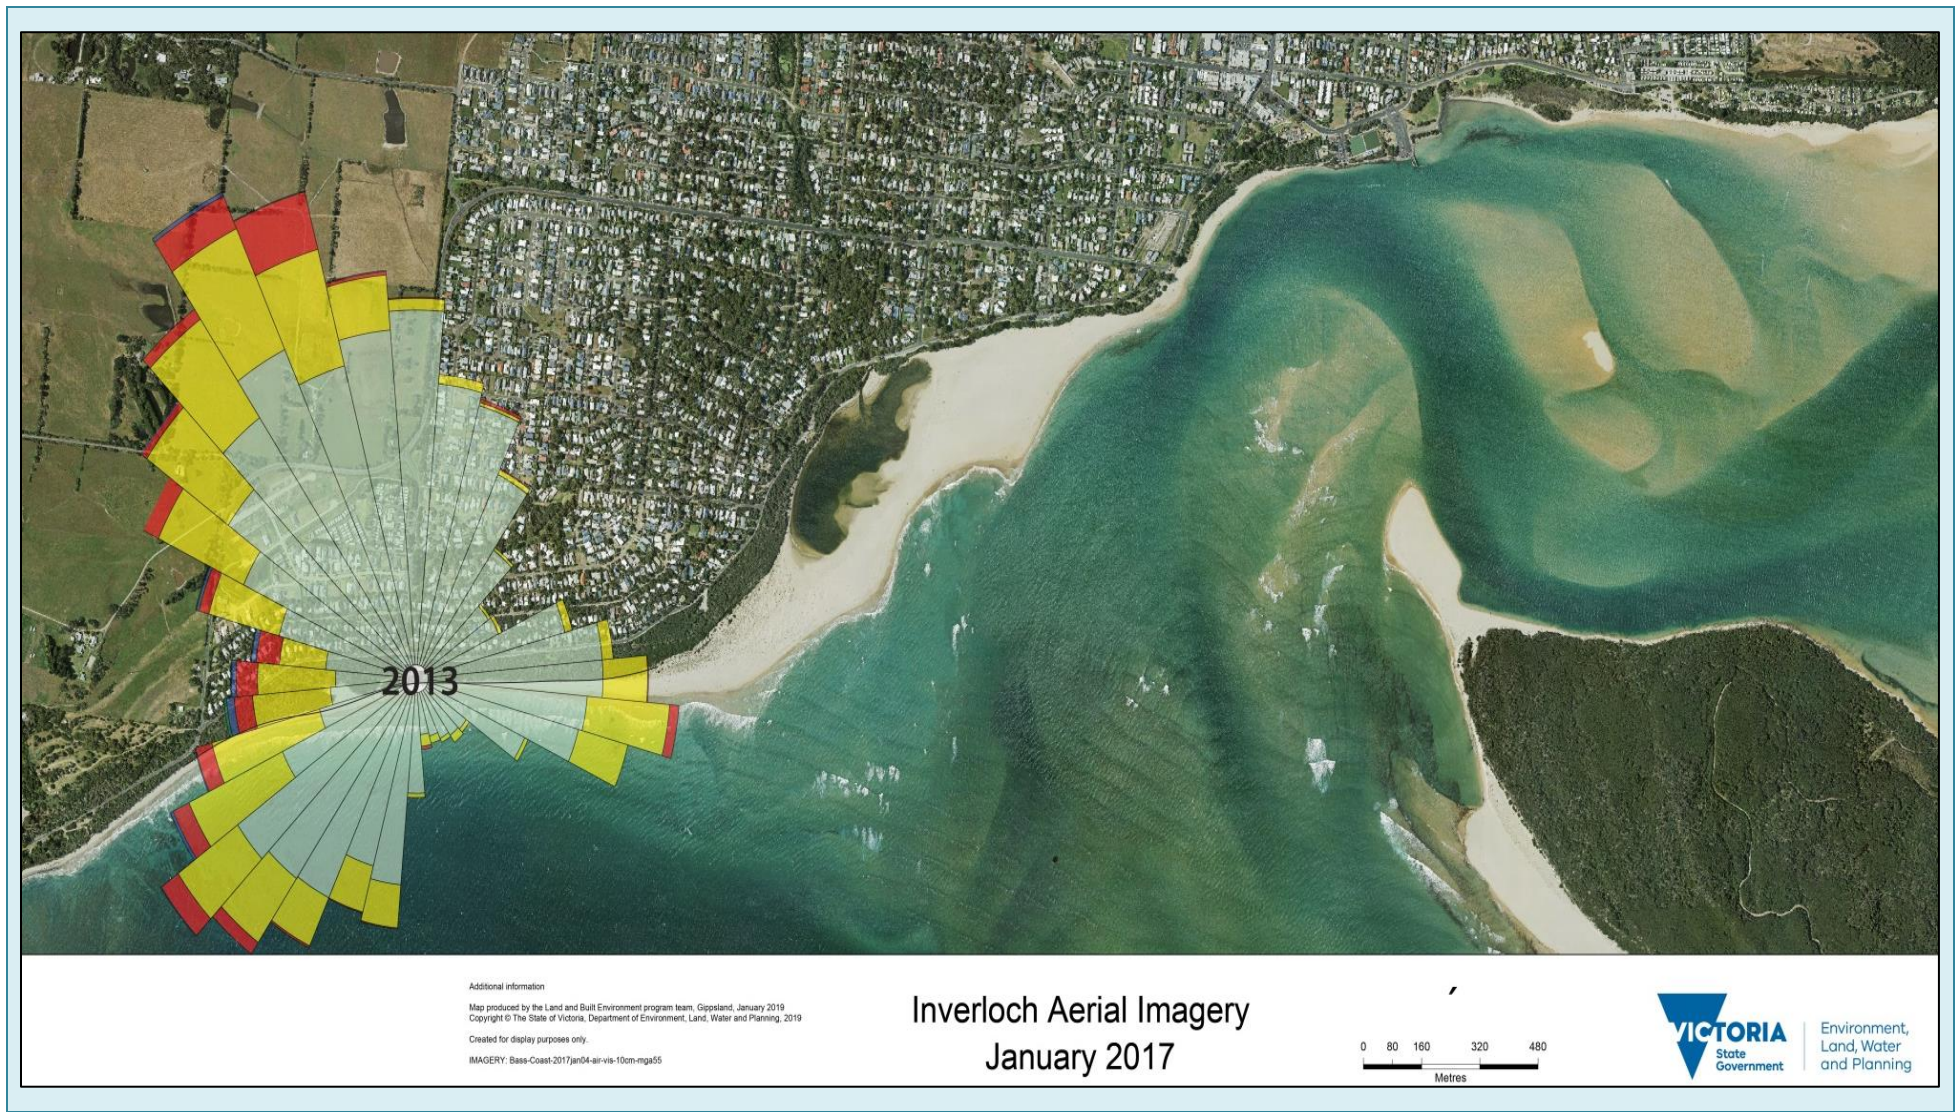
Figure 16 Annual wind rose overlay

Figure 16 - Annual wind rose overlay shows how the most frequent N and WNW winds are offshore. WSW to SW winds are strong and relatively frequent, which further assist the wave break to be oblique to the coast. These winds are stronger and more frequent than waves influenced by easterly winds.

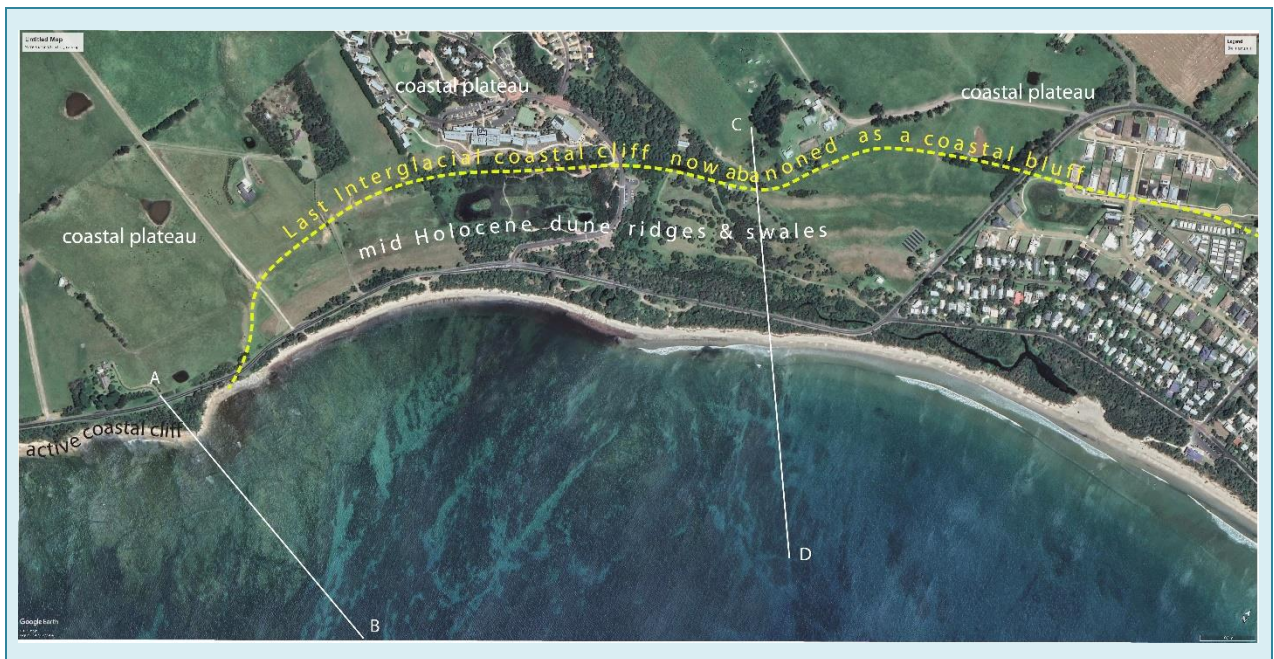
Figure 17 Coastal Bluff and Dune Ridges

Figure 17 - Coastal Bluff and Dune Ridges highlights the former sea cliffs, now an abandoned coastal bluff, and the Holocene dune ridges and swales. The geomorphology of the backshore sand ridges and dunes between Flat Rocks and Pt Hughes records a history of accretion and recession extending across the late Pleistocene and Holocene, over more than 10,000 years.

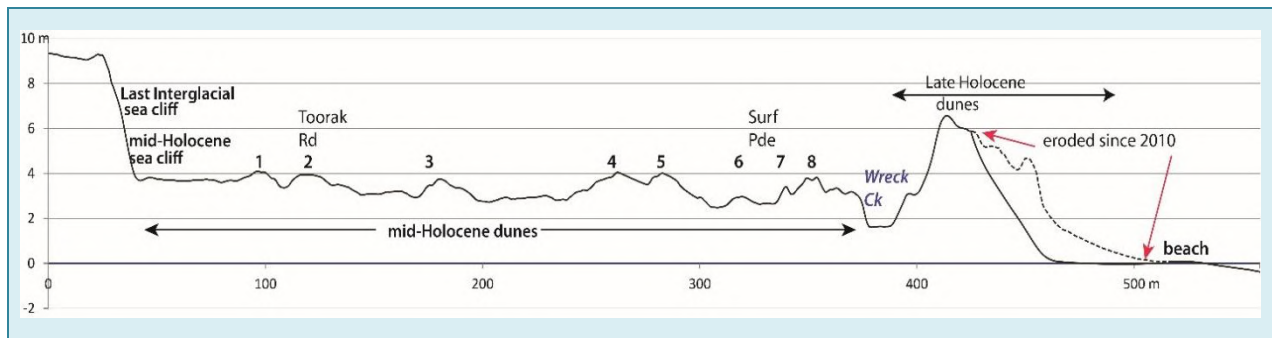
Figure 18 Dune Ridges Cross-section

The ocean coast is backed by a continuous zone of late Holocene to modern established vegetated foredunes, formed by wind action over the last 3,000-4,000 years, once the previously higher sea levels (about one metre higher than present) fell and stabilized. As indicated in *Figure 18 - Dune Ridges Cross-section*, almost 50% of the volume of these dunes have been removed since 2013 as a result of shoreline recession:

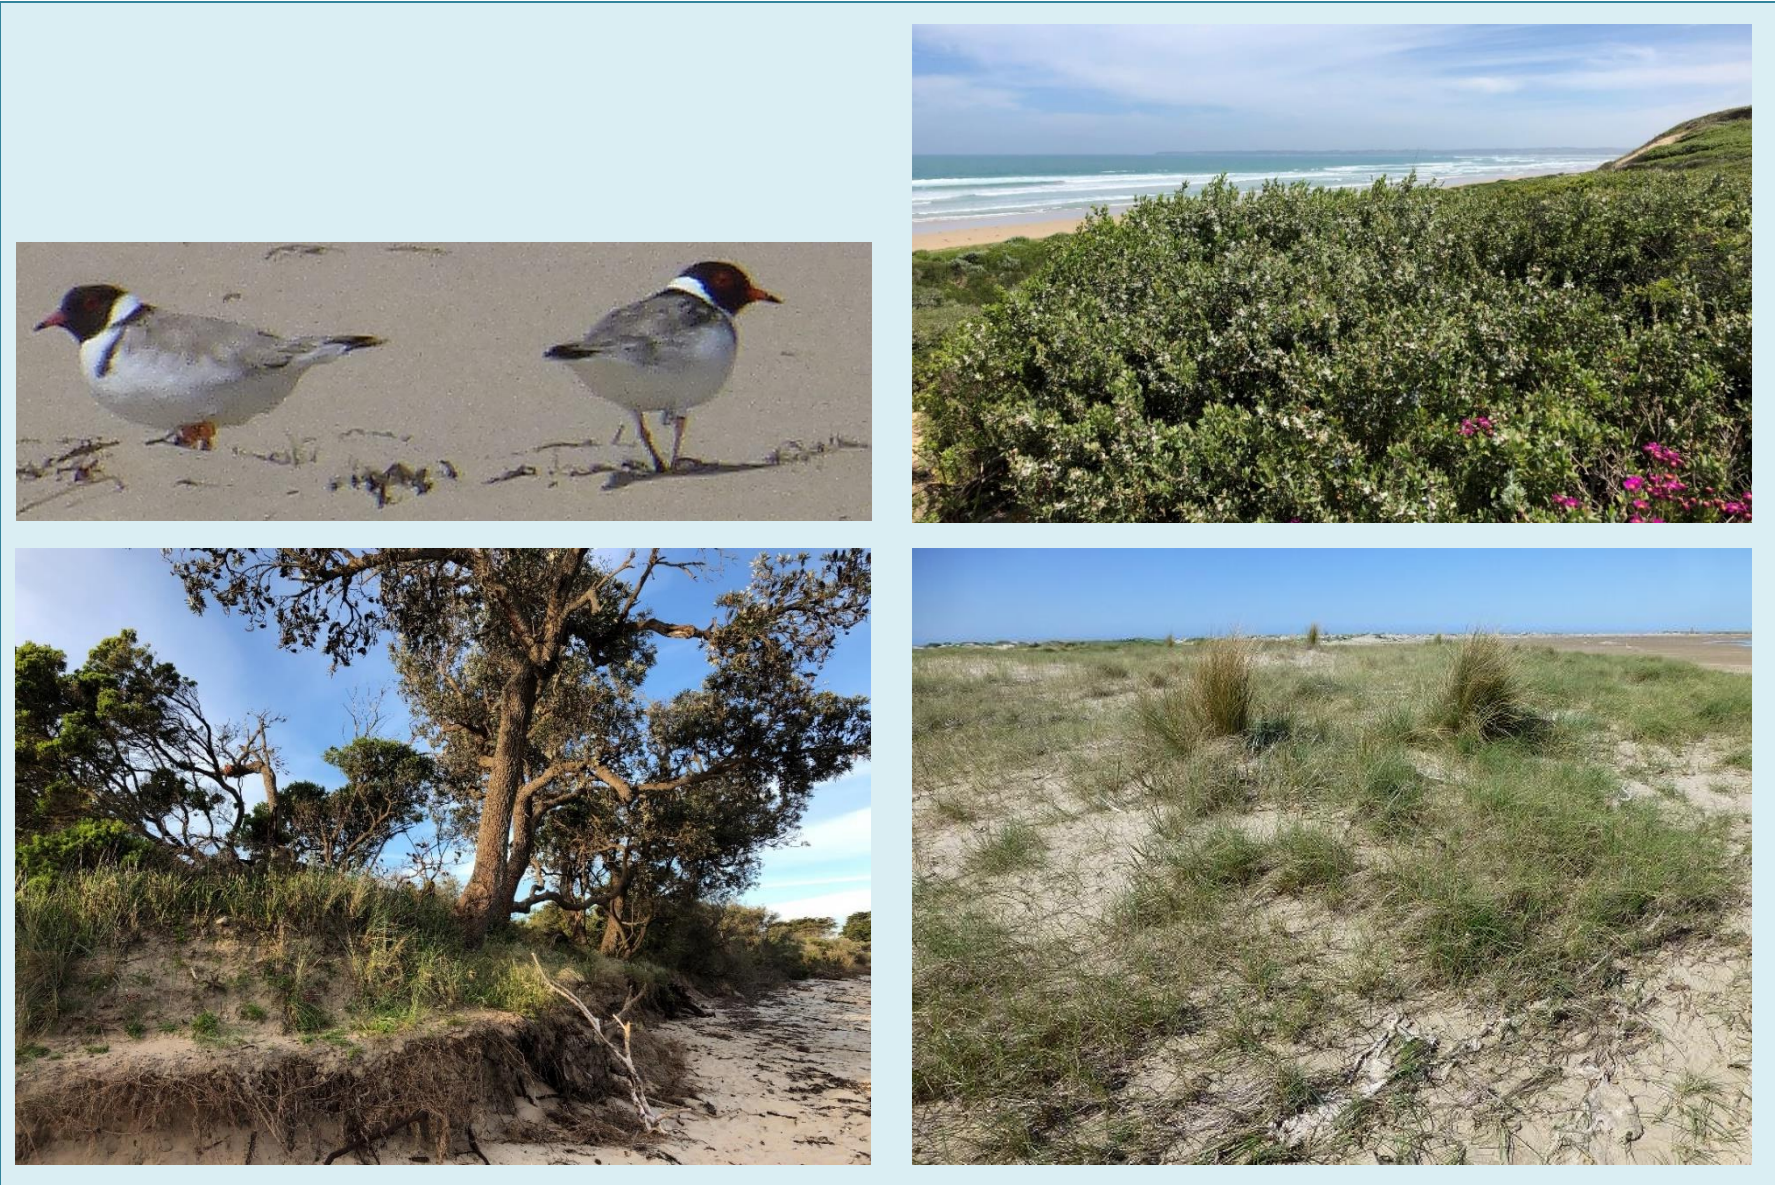
Figure 19 Dune Ecology

As shown in *Figure 19 - Dune Ecology*, the newly-formed dune system at Point Hughes is mainly being colonized by Marram Grass and Sea Wheat-grass which form steep-sided dunes that are unsuitable for beach-nesting shorebirds.

- Significant depletion of the mature Coast Banksia Woodland community at Flat Rocks
- Incipient dunes (foredune) no longer exist between Flat Rocks to just west of Point Norman, resulting in complete loss of suitable nesting habitat for vulnerable shorebird species.

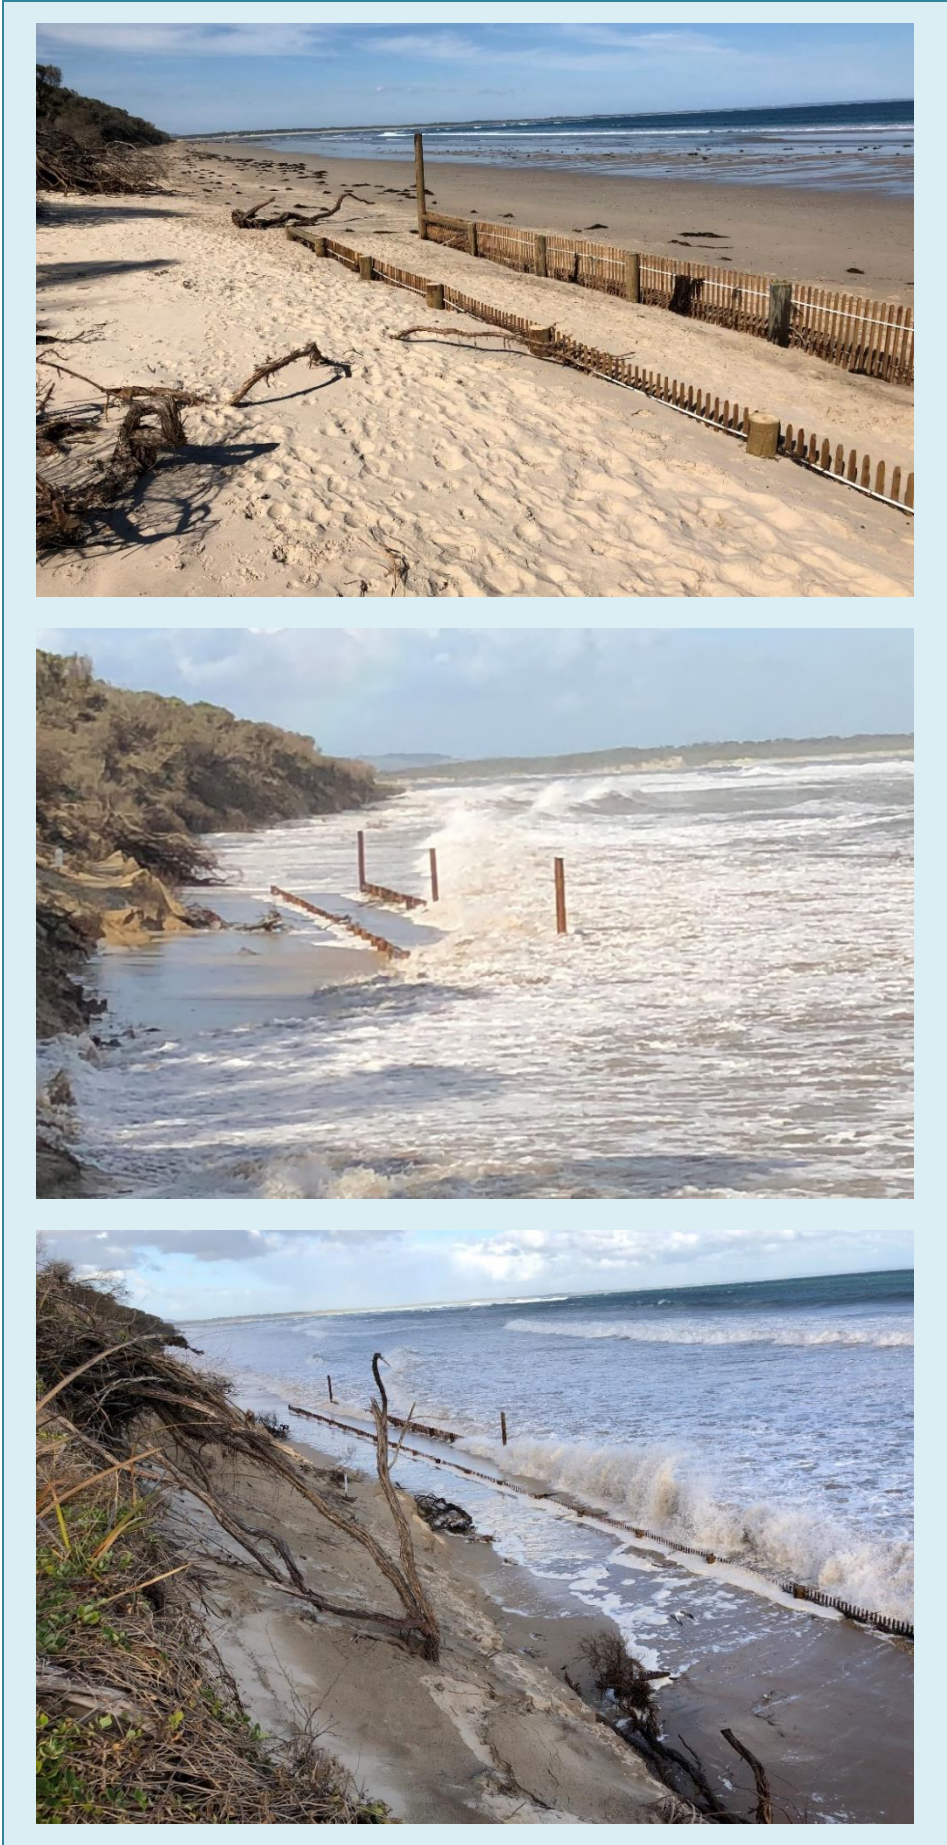
Figure 23 Wet-sand Fence Trial

At installation, the tops of the fences were positioned below the level of the beach. At the time of writing (July 2019), the tops of the surf-side rows of fencing are more than one metre above the current beach level, with four storm surge events between April and the end of May 2019 having resulted in substantial additional beach erosion. The storms also caused considerable damage to the fences, with the pickets of both surf-side rows of fencing having been removed from the fence supports and a number of the supporting posts being lifted.

Notwithstanding these set-backs, early indications are that the fences are providing a degree of protection to the dune faces, with some accretion apparent behind the fences, prior to the dune renourishment. However, it was also clear that a noticeable end effect was occurring at the western ends of both sections of fencing, caused by the oblique angle that SW waves reach the beach.

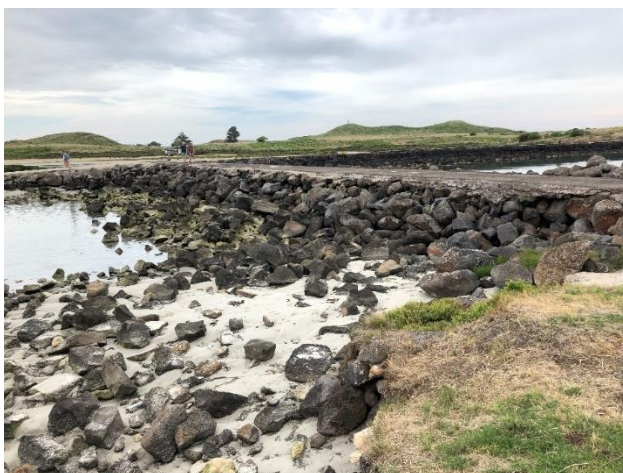
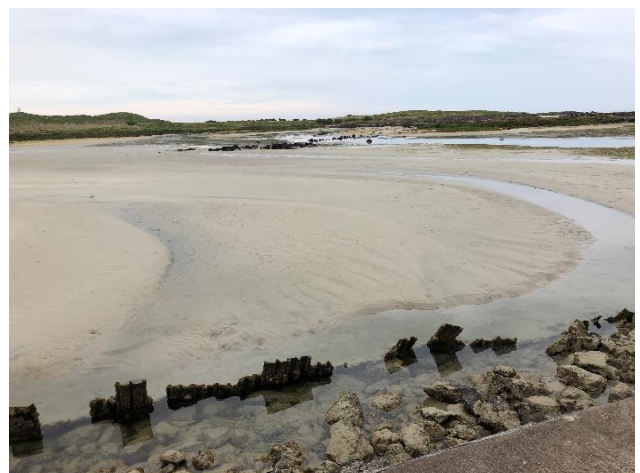
Inspection of the South West Passage

The South West Passage was a seaway connecting with the Moyne River with an adjacent wetland. In 1913 a causeway was built across the passage to enable access to the lighthouse. This has resulted in the accumulation of sand in the passage (and constant need to dredge the passage) and has also been linked to increased erosion on East Beach.

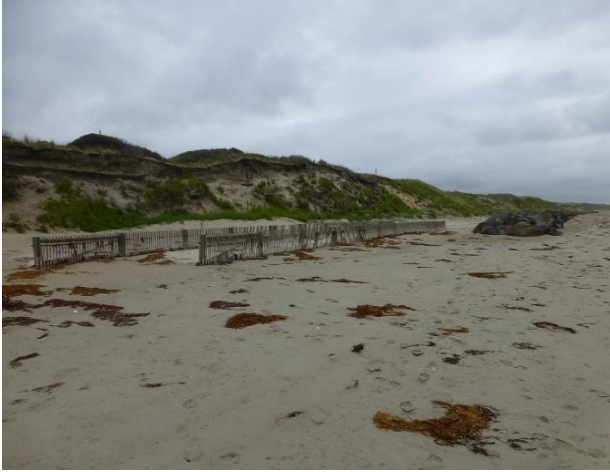
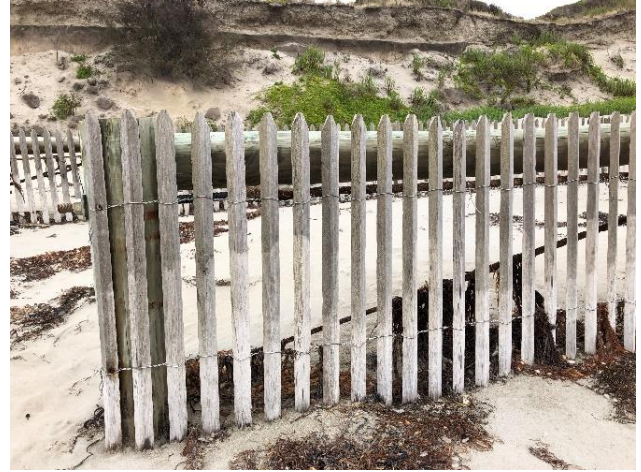
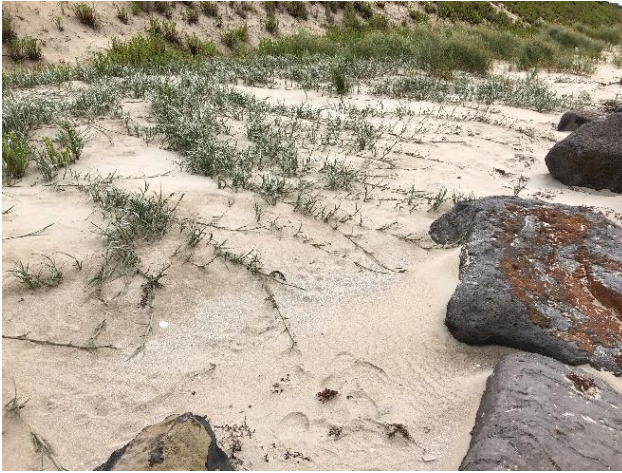
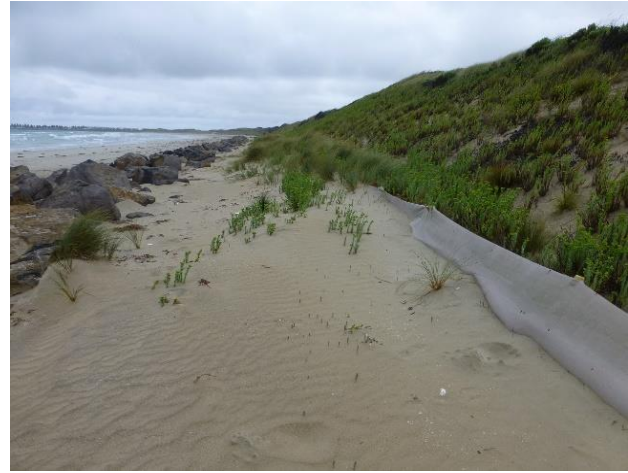
In some areas, a low fence has been installed in front of the toe of the dune with 1m stakes and covered with a geofabric material to provide shelter at the toe of the dune and encourage plant growth. Sand has built up to form a dune to approximately 1-2m in height behind these fences.

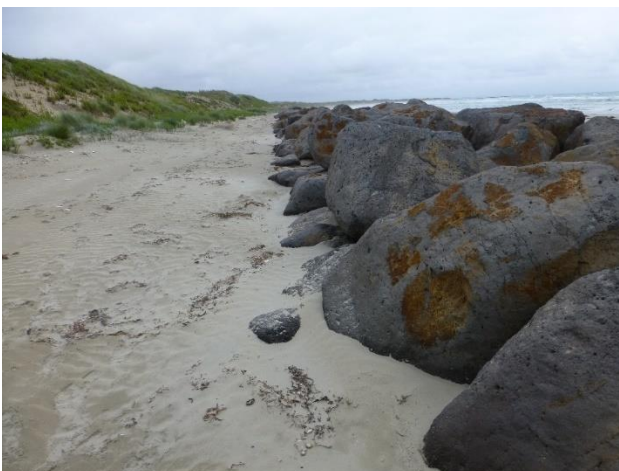
Monitoring undertaken by PFCG has shown the WEDs to have provided effective protection of the dune toe from further erosion.

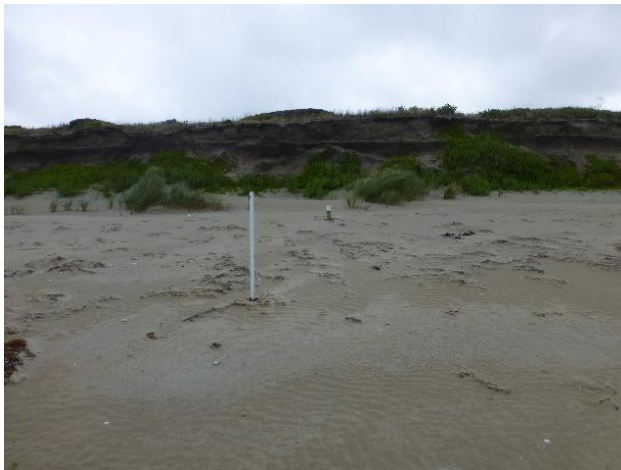
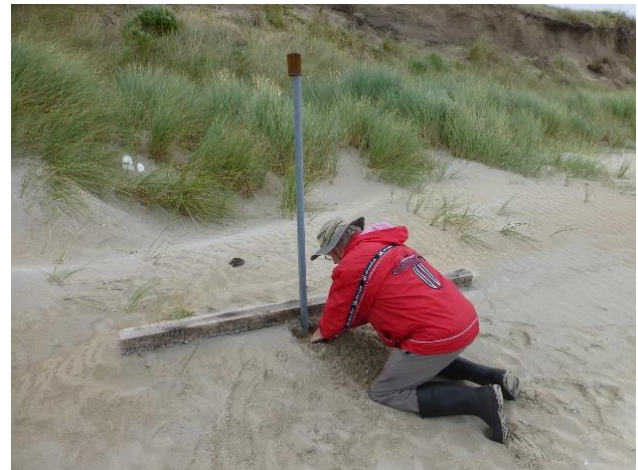
Moyne Shire Council installed the monitoring posts.

Data from monitoring is recorded in Excel in a database developed by David using Excel's 'conditional formatting' program. David has kindly offered to use his spreadsheet to record our laser level monitoring results.

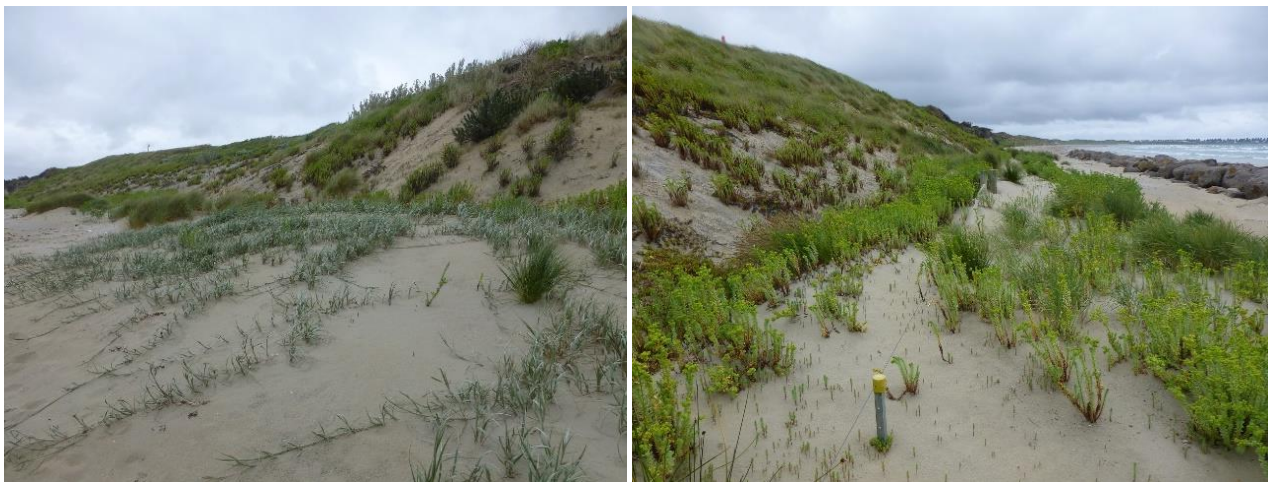
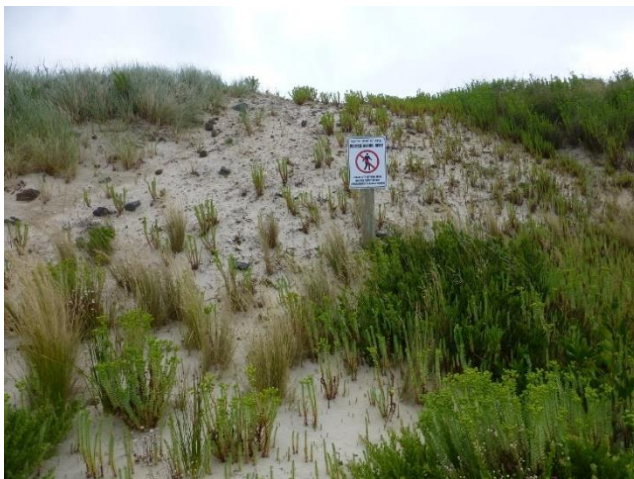
Moynes Council carried out a revegetation program on the dune slope behind the sand fence but the dune is now dominated by Marram Grass and Sea Spurge. It is not known what species were originally planted by the Council.

Very little Hairy Spinifex (*Spinifex sericeus*) was apparent. It has been outcompeted by introduced Marram Grass. Occasional Coast Fescue (*Poa labillardierei*) is present. Scattered patches of Coast Everlasting (*Ozothamnus turbinatus*) bushes were spotted.

Patches of Bower Spinach (*Tetragonia implexicoma*) are colonising the dunes in some areas.

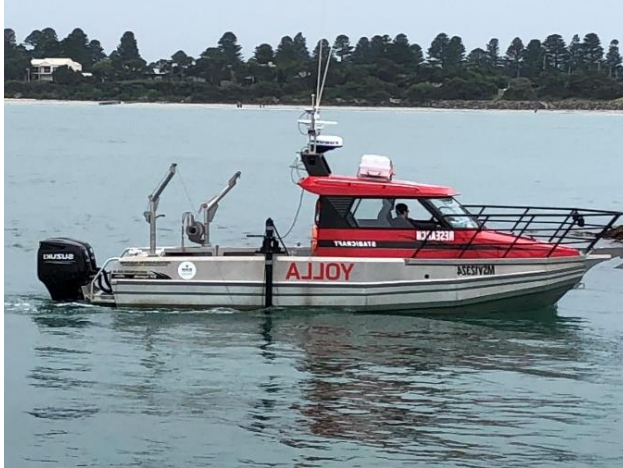
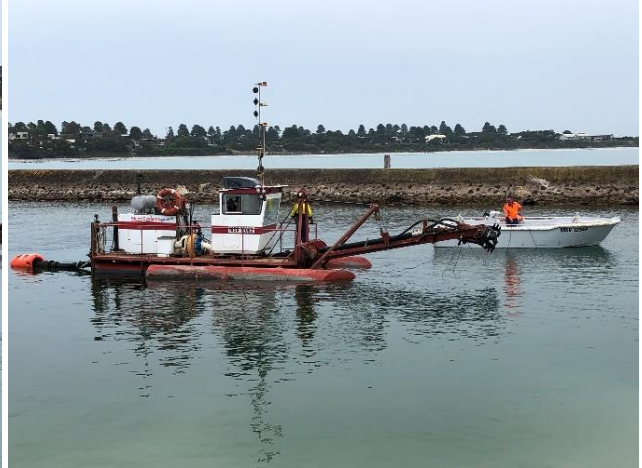
Sand re-nourishment has not been carried out at East Beach. Sand has accreted naturally on East Beach in recent times as evidenced by some of the monitoring posts and one of the sand fences being buried by sand.

Dredging and pumping of sand slurry from the South West Passage appeared to be taking place, with the slurry being piped over the rock wall and onto the beach.

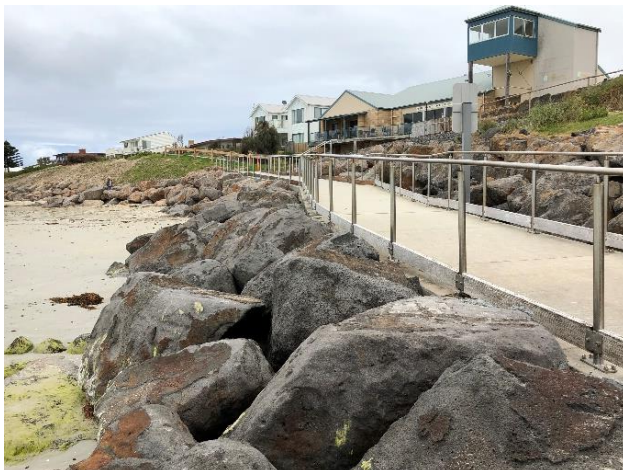
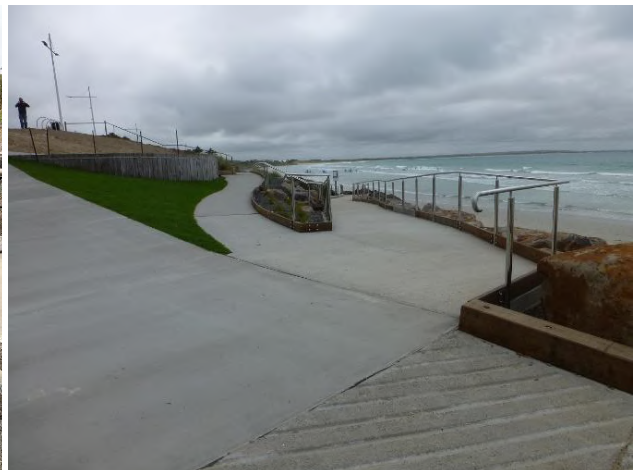
The construction of a new concrete disability pedestrian path and an ATV access path to the beach outside the Surf Lifesaving Clubrooms has just been completed. As indicated in the photographs, the rock walls and concrete paths present as an urbanised character, compared with the current situation at Inverloch surf beach.

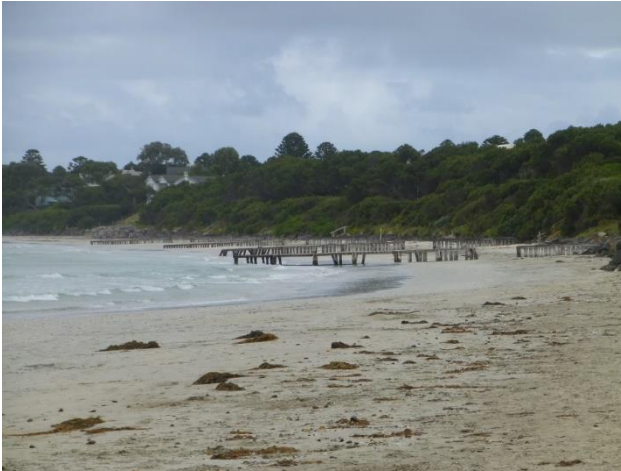
Timber groynes

A number of old timber sand groynes are still in existence to the west of the Lifesaving Club.

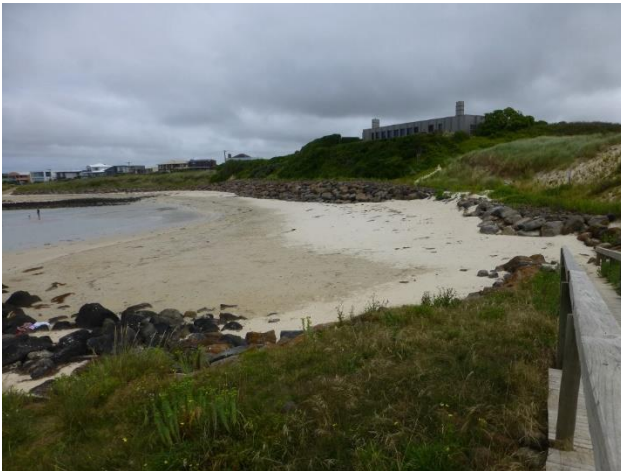
Pea Soup Beach

A large rock wall has been constructed at Pea Soup beach to protect private houses with contributions for funding from both the Council and private landholders. The revegetation area consists almost entirely of Sea Spurge and Marram Grass.
