INVERLOCH COASTAL RESILIENCE PROJECT

COASTAL GEOMORPHOLOGY

GEOMORPHOLOGICAL VALUES

VERSION 7: June 2019

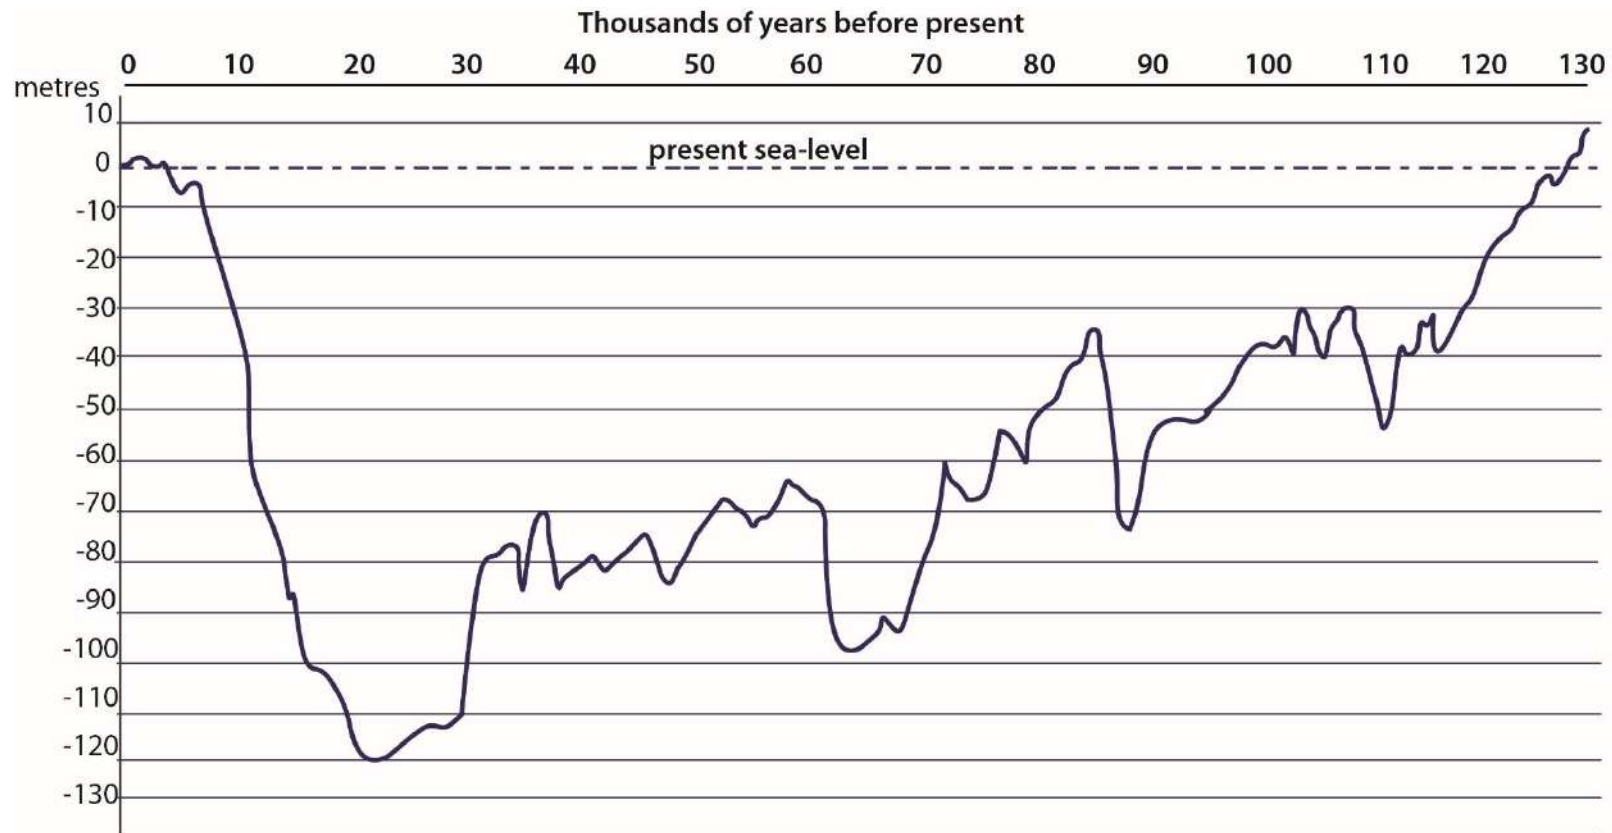
Figure 10. Graph of sea-level changes last 130,000 years (after Brooke *et al.* 2017).

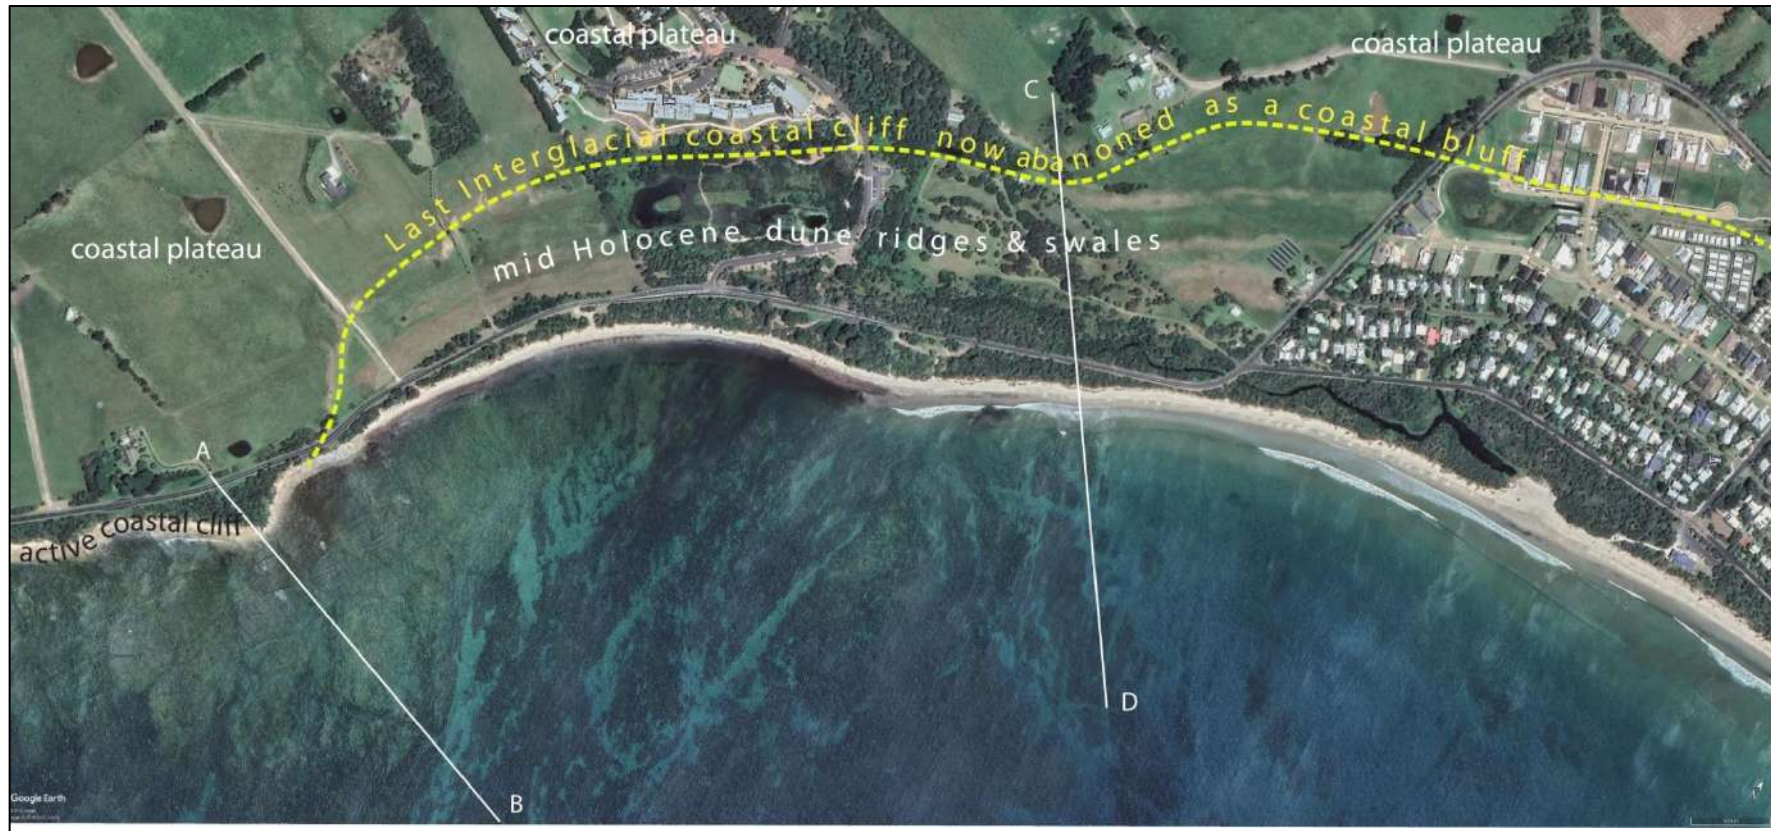
Figure 14. Active cliffs, Last interglacial bluff, older and modern Holocene dunes west of Inverloch. Location of profile A-B (Figure 12) and C-D (Figure 13). (Image from Google Earth Dec 2018).

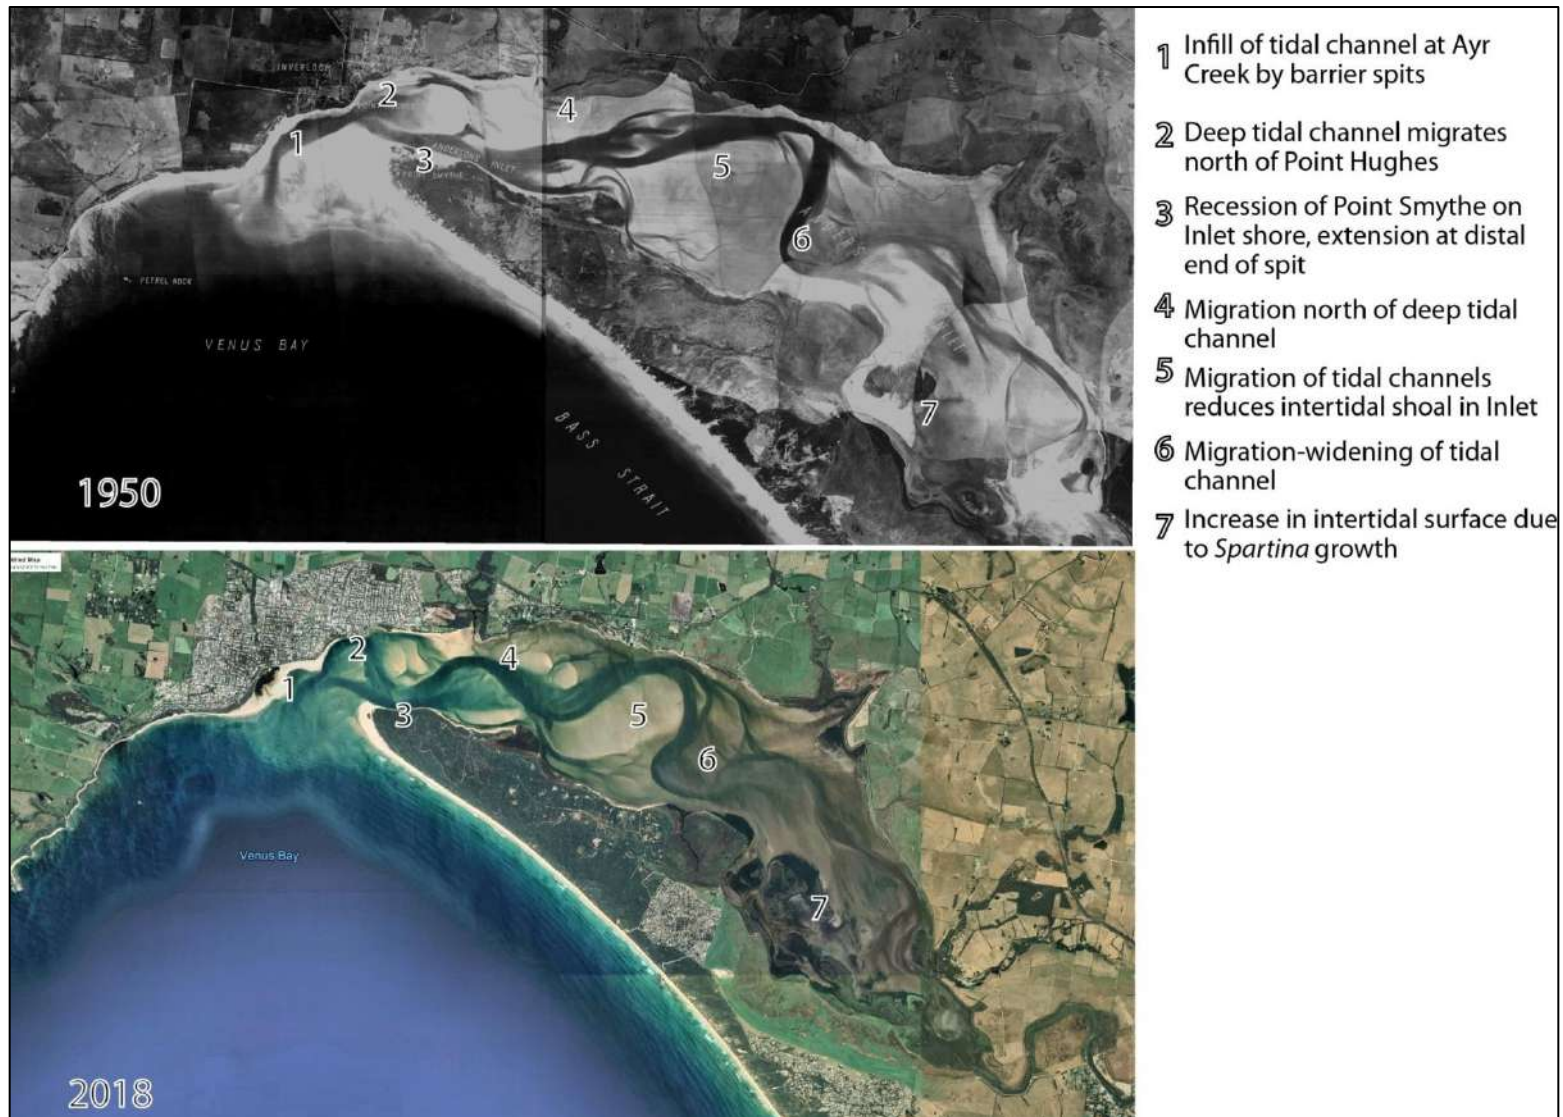
Figure 24. Physical change in Andersons Inlet 1950 (aerial photo - Adastral Airways) and December 2019 (Google Earth).

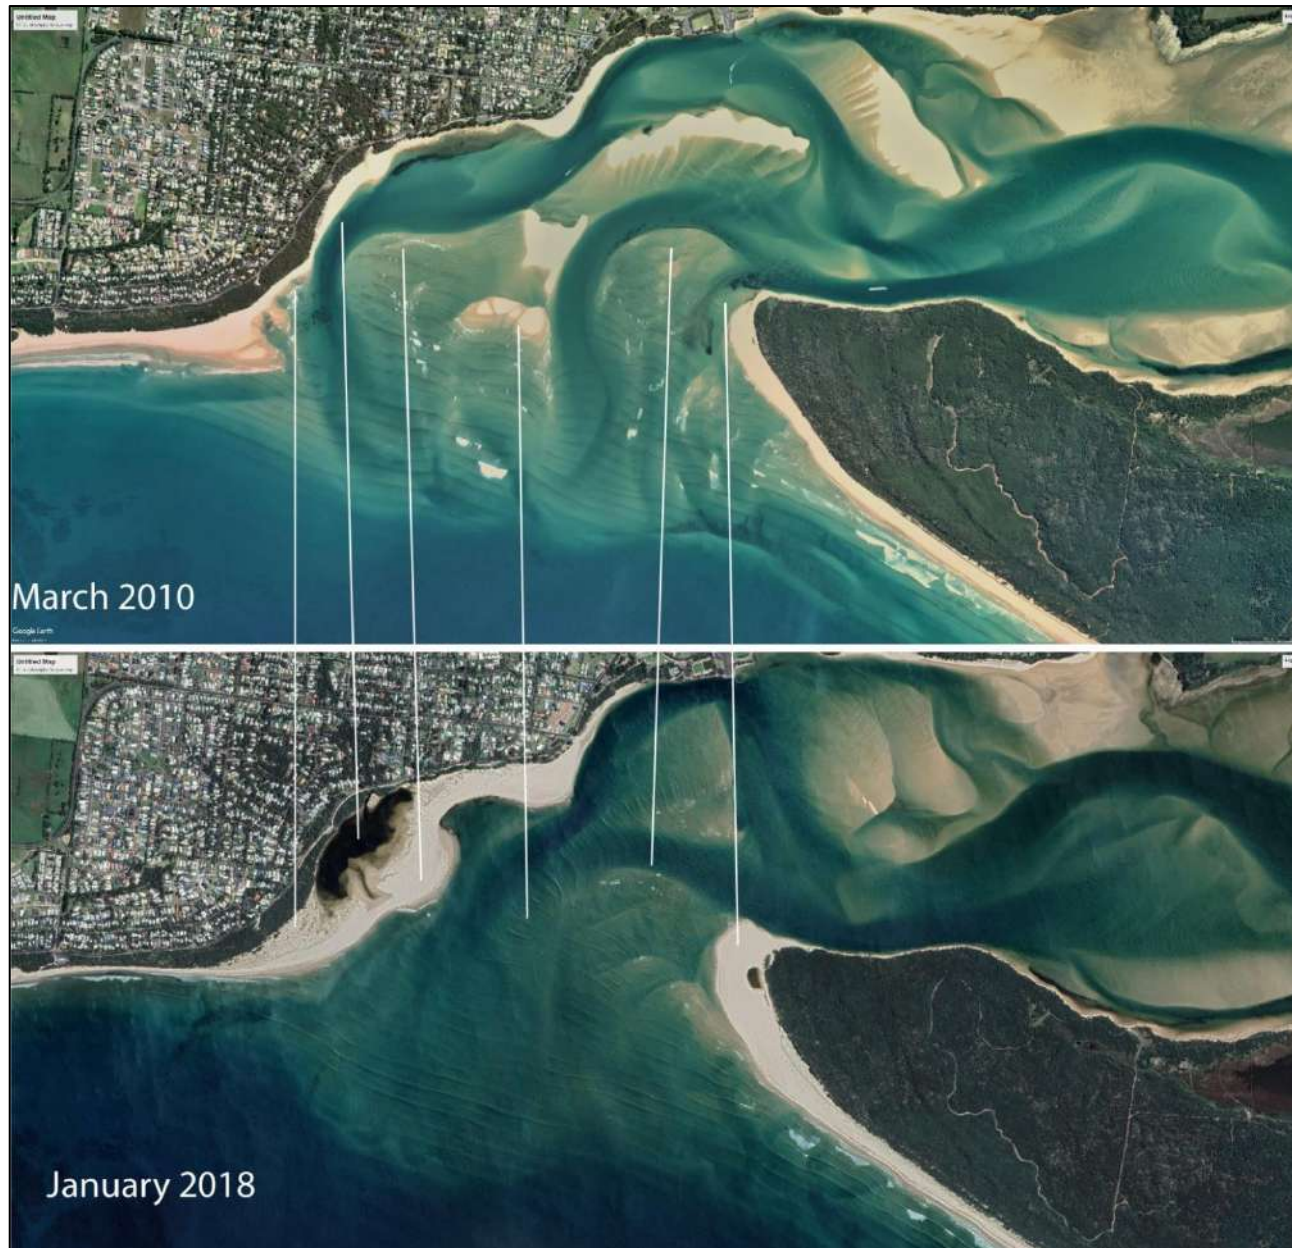
Figure 25. Ebb tide delta and channels 2010 and 2018. Multiple ebb-tide channels in 2010 are replaced by a single ebb-flood channel in 2018. Lines join same point on both images (Google Earth)

- A now enclosed lagoon behind a looped and lobate sand barrier/spit
- Present configuration developed since 2013 (Figures 25 - 26)
- 2010: sand accumulated initially in as a spit extending SSE from the southern side of Point Norman
- 2014: spit began to recurve into Andersons Inlet moved by wave-currents augmented by flood tide current
- 2015: paired spit developing towards SSW from southern side of Point Hughes
- 2016: paired spits overlap and coalesce enclosing a lagoon - tidal washover frequently occurs
- 2017: coalesced spits form a continuous low tide coastal sand barrier linking Point Norman to Point Hughes
- 2018: rapid sand deposition as a lobate bulge extending E into Andersons Inlet
- Wind action builds hummocky dunes on the main southern foreland - pioneer grasses and now shrubs establish (Figure 27)

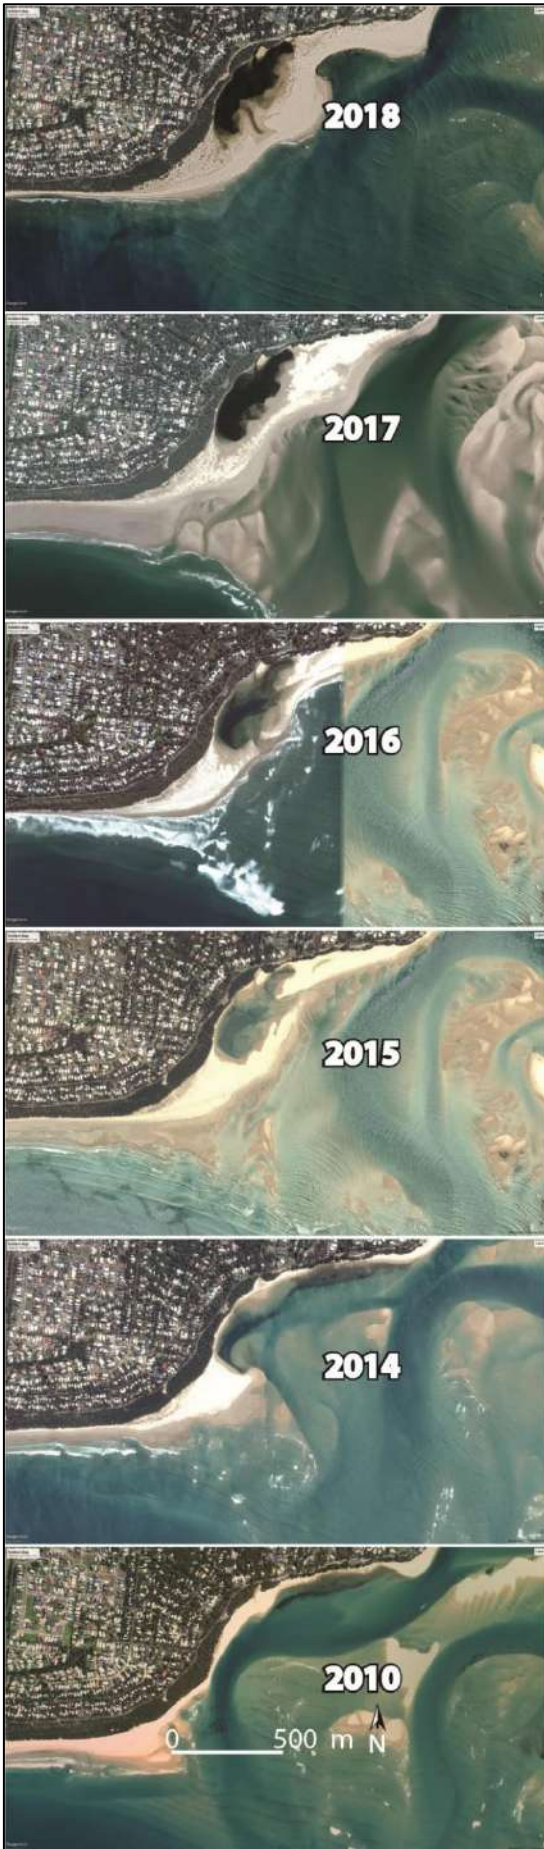
The rapid development of two spits forming a continuous barrier between Point Norman and Point Hughes results in the migration of the main tidal channel to the east and enclosing of the mouth of Ayr Creek forming a lagoon.

Figure 26. Sand accumulation at Point Norman enclosing the outlet of Ayr Creek creating a lagoon (Google Earth 2013 -2018).

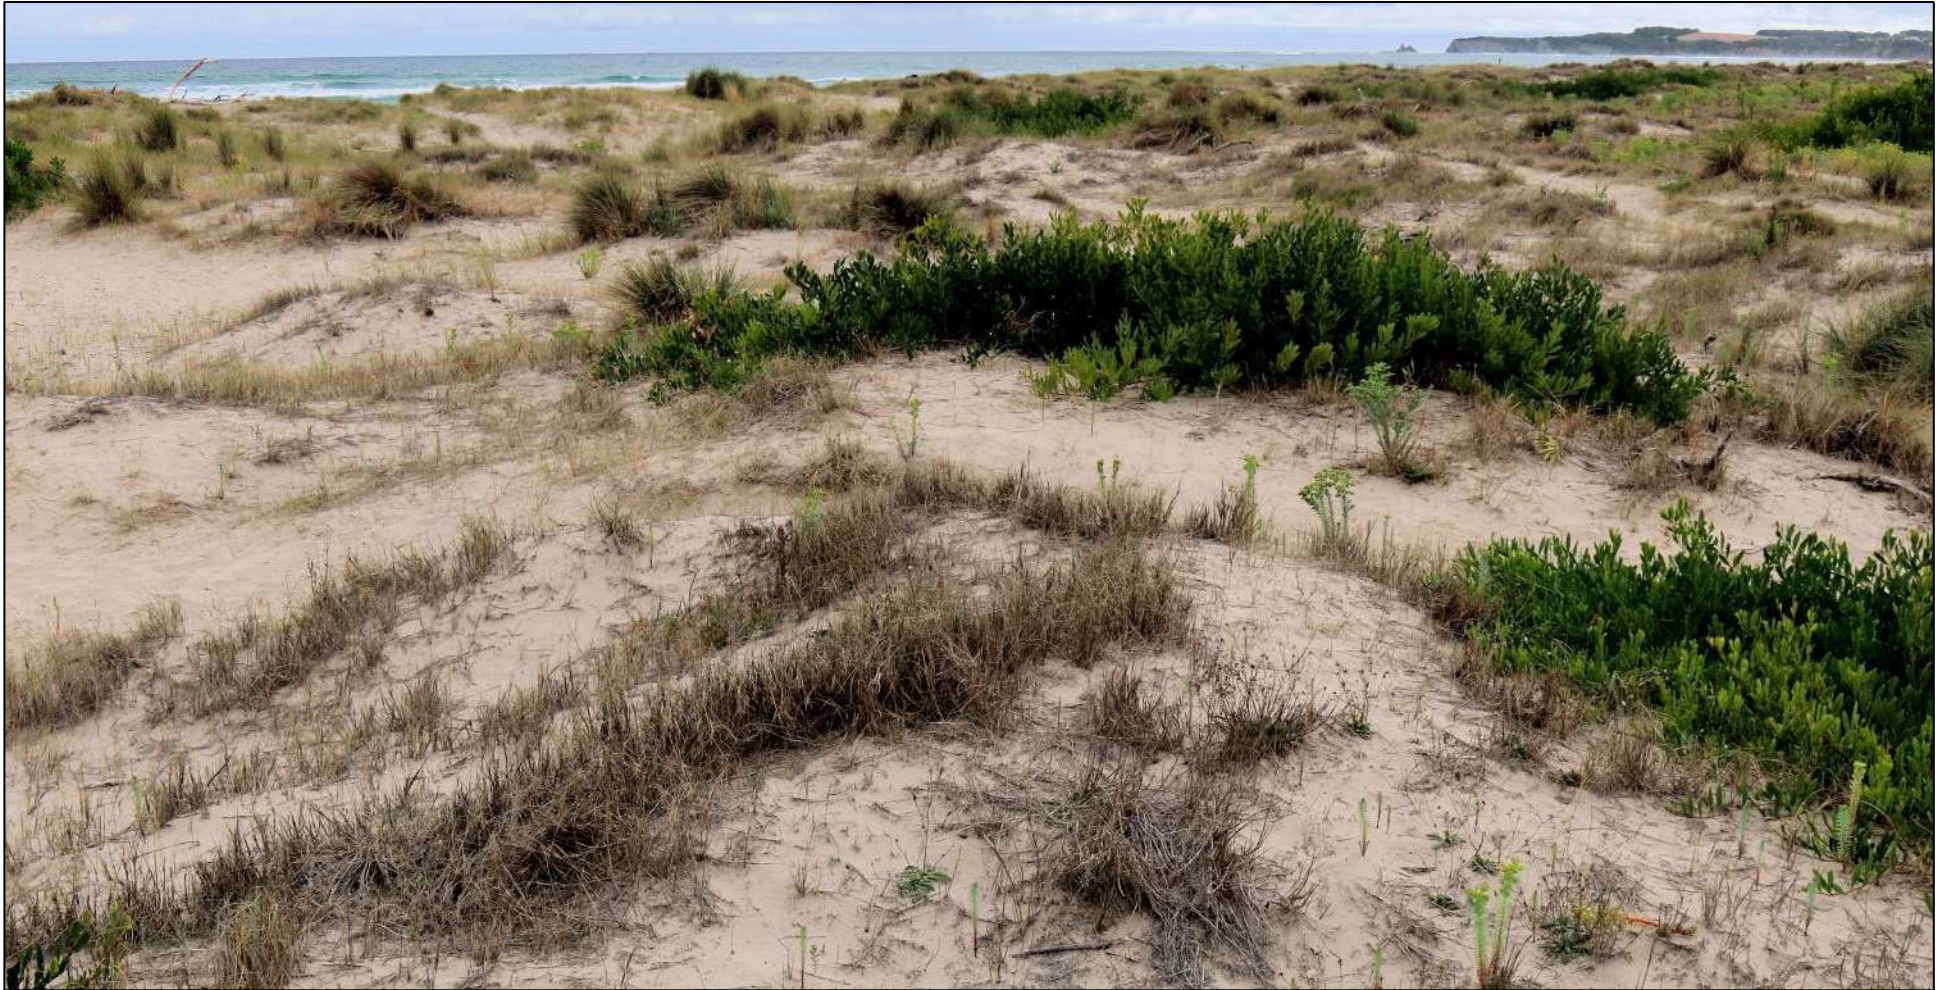
Figure 27. Pioneer species and dune plant succession on newly deposited incipient foredune sand south of Point Norman (Feb 2019).

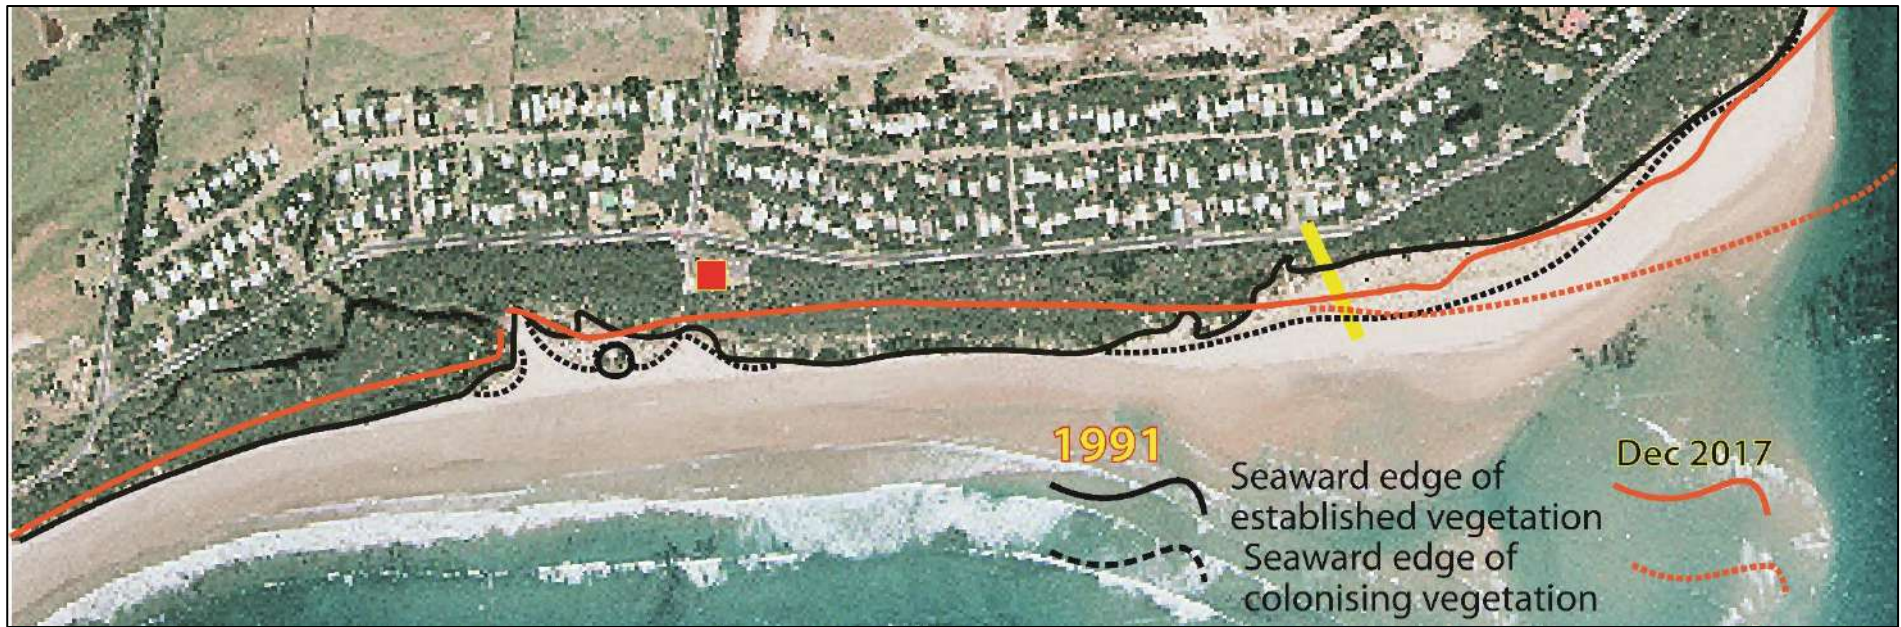
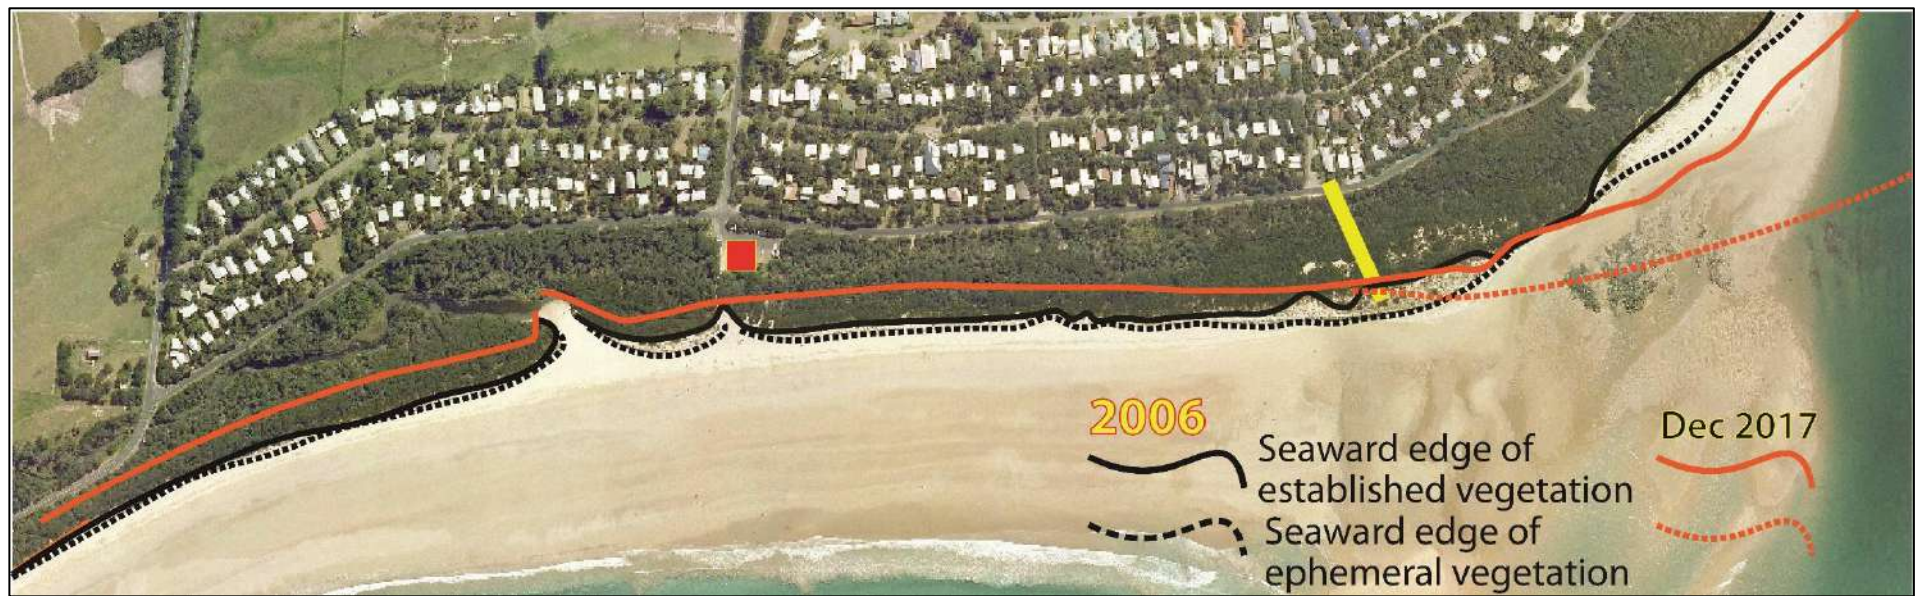
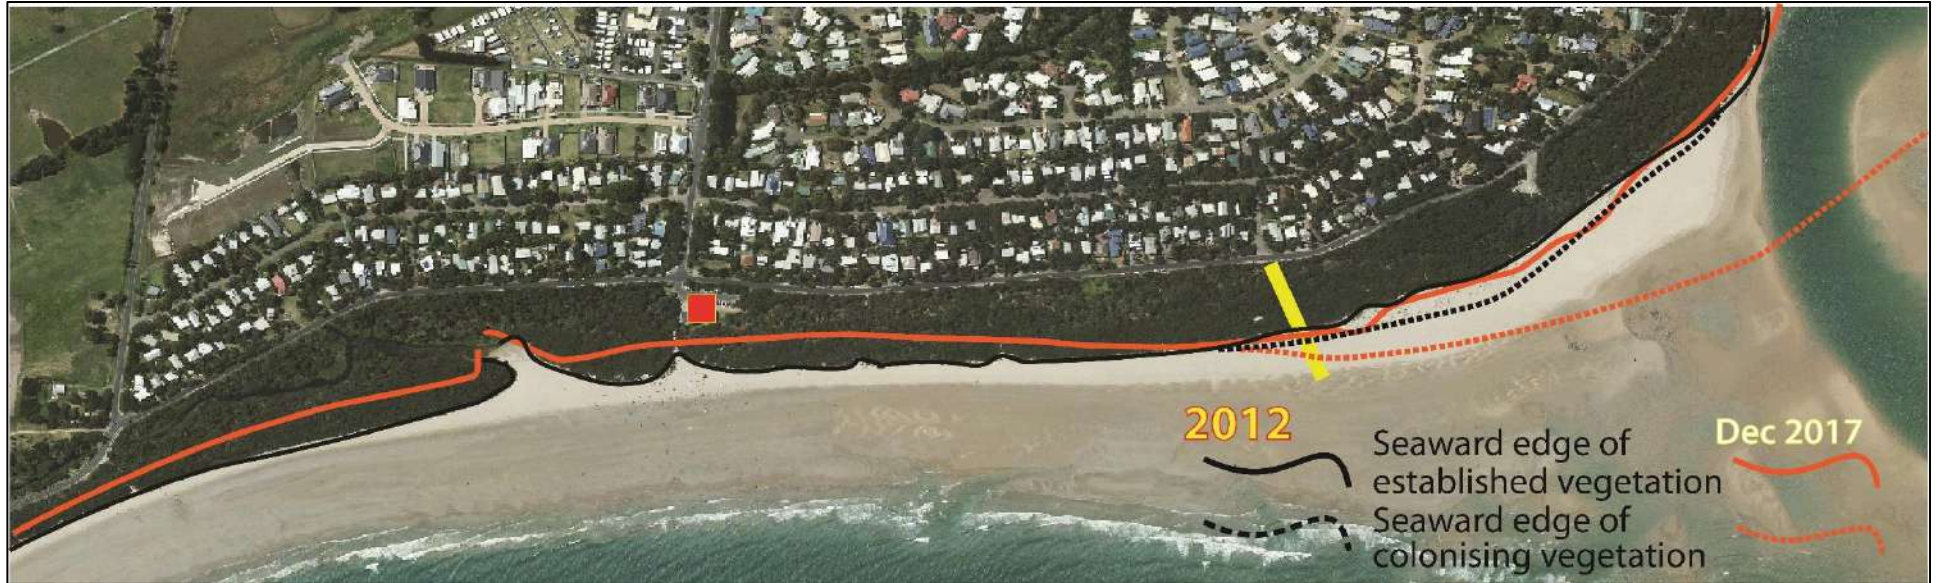
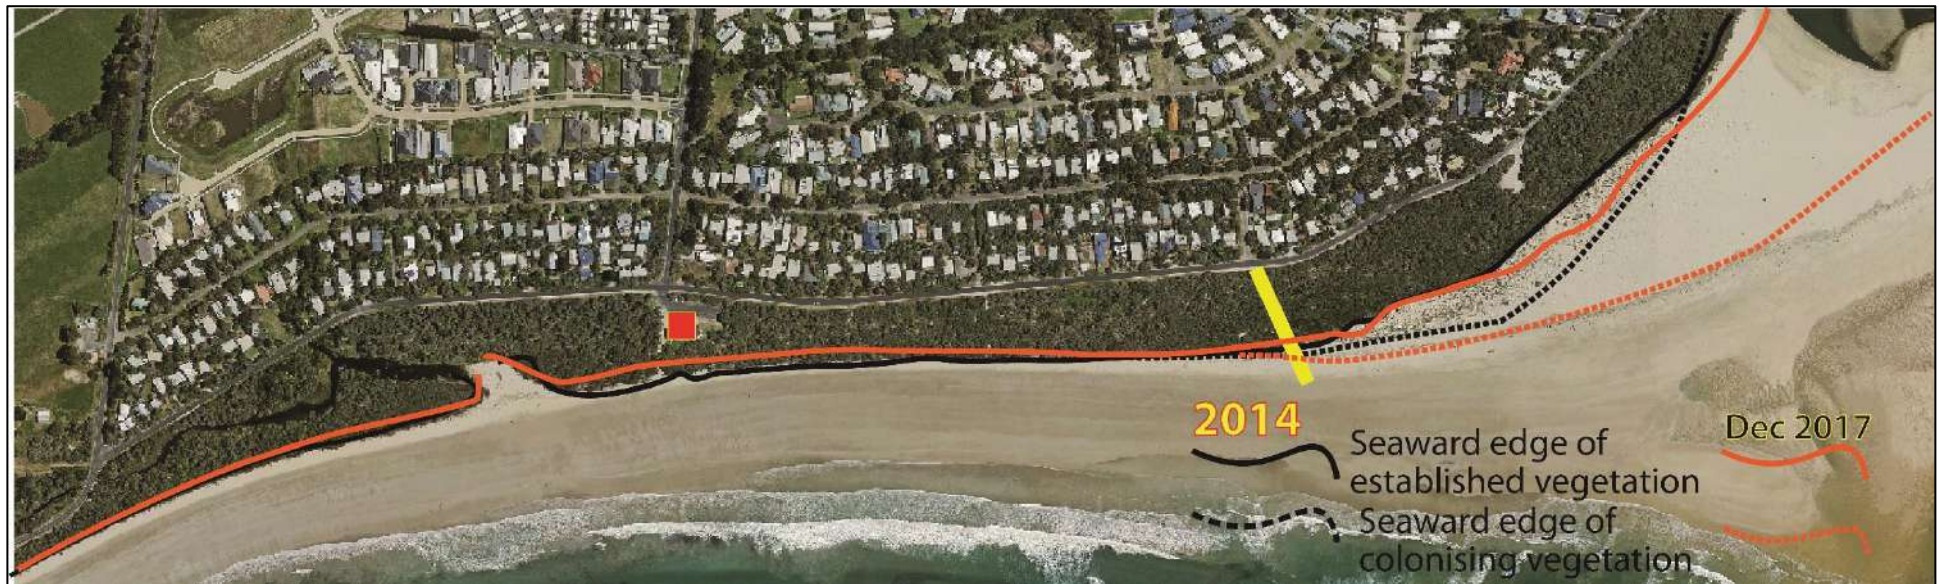
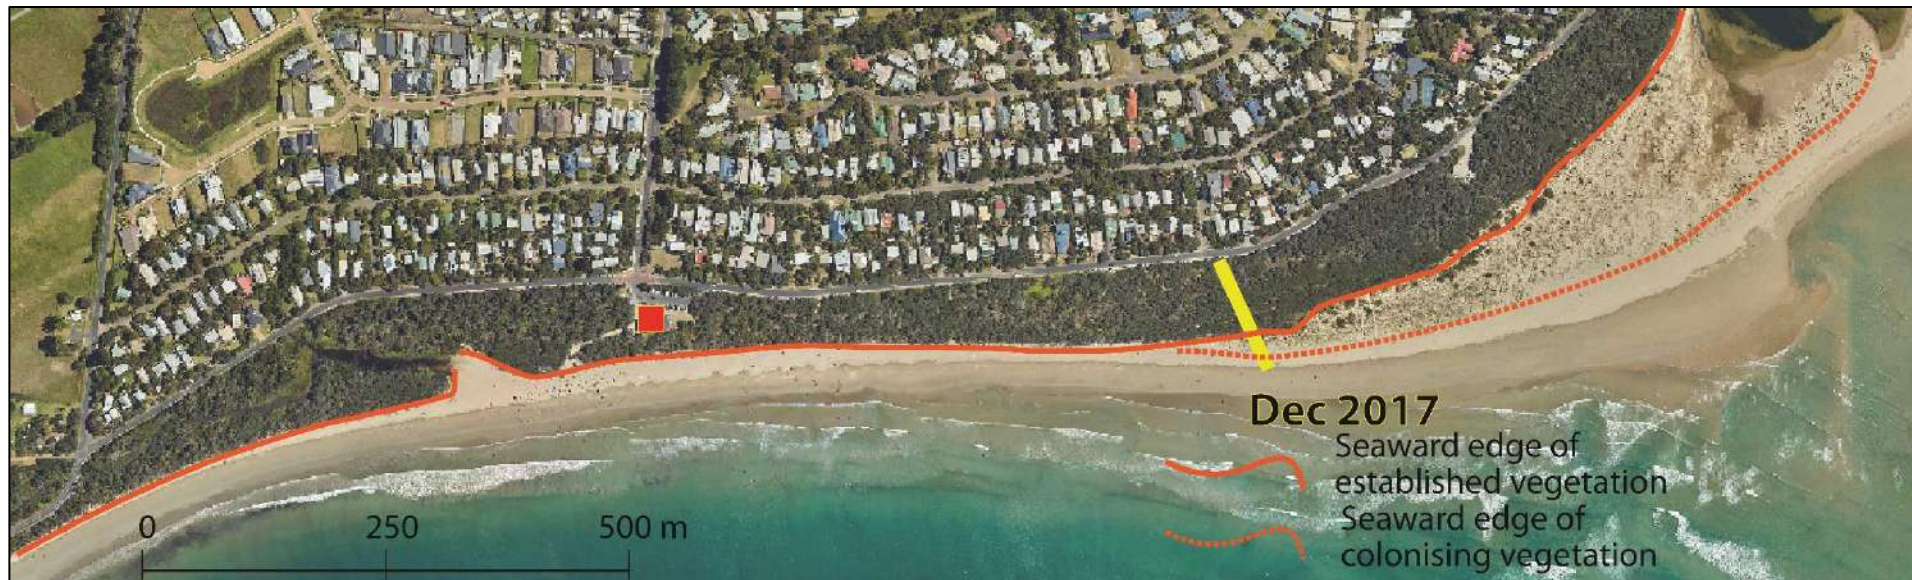
Figure 33. Shoreline changes at intervals 1956 - 2017 east of Wreck Creek and near Ozone Street, (Source: vertical aerial photography LandData Vic)

- Figure 33 (pages 45 to 49) is georectified extracts from aerial photographs 1956, 1968, 1977, 1985, 1991, 2006, 2012, 2014, 2017 with an overlay of the edge of established vegetation (woody) and pioneer colonising (grassy) vegetation

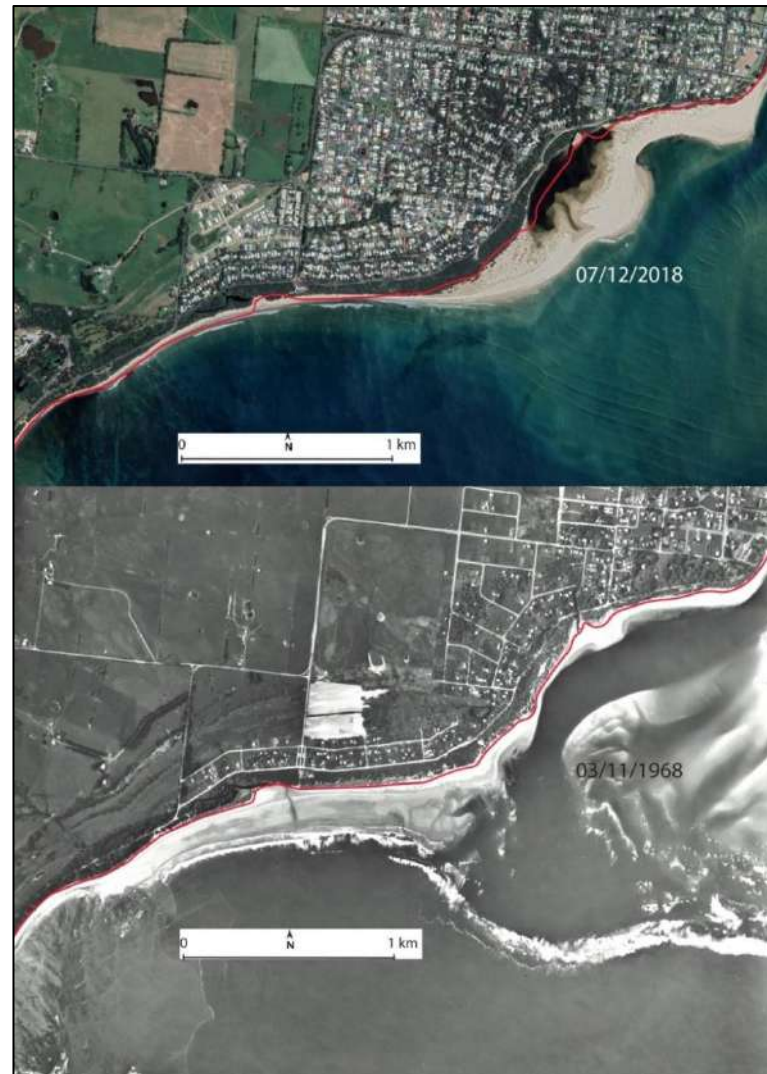
Figure 35. Backshore position in 1969 (red line on both images) between 1968 and 2018. (1968 from aerial photograph, 2018 Google Earth)

- Figures 34 and 35 (based on aerial photograph) show changes over the periods 2009 to 2018 and 1968 to 2018

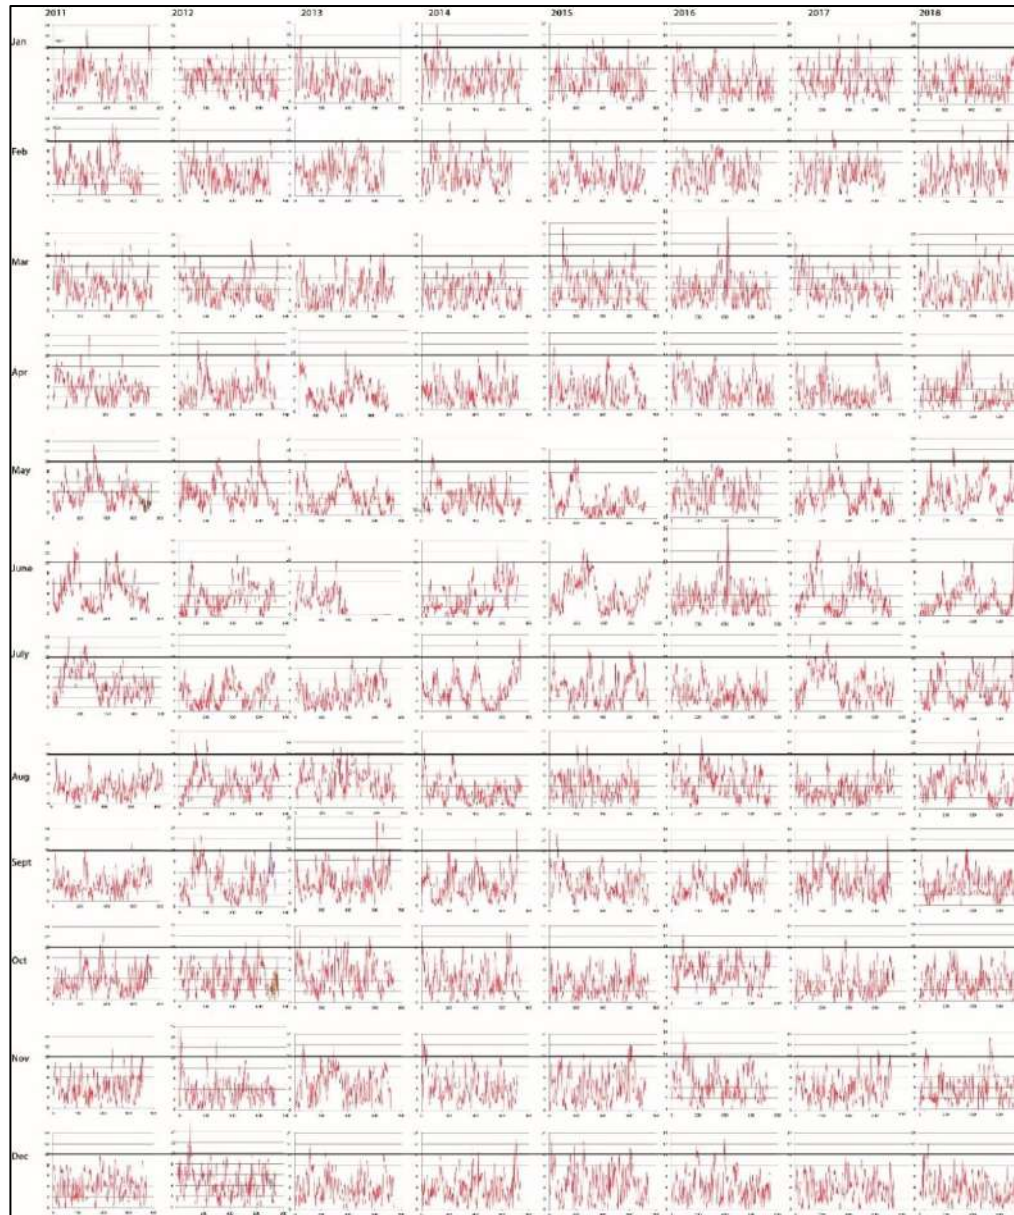
Figure 38. Average wind speed of previous 60 minutes all months January 2011 to Dec 2018. Heavy black line shows 10 m/sec to allow comparison of wind strength across the period of record.

- The data comprised extracts of continuous observations of wind velocity and direction based on hourly summaries of the conditions of the previous 60 minutes
- Data of hourly observation of average wind speed (m/sec) was plotted for all observations (24 x no of days each month) for all months 2011 to 2018 inclusive (Figure 37 is an example of January 2011 to 2018). Figure 38 shows all months for 2011 to 2018.

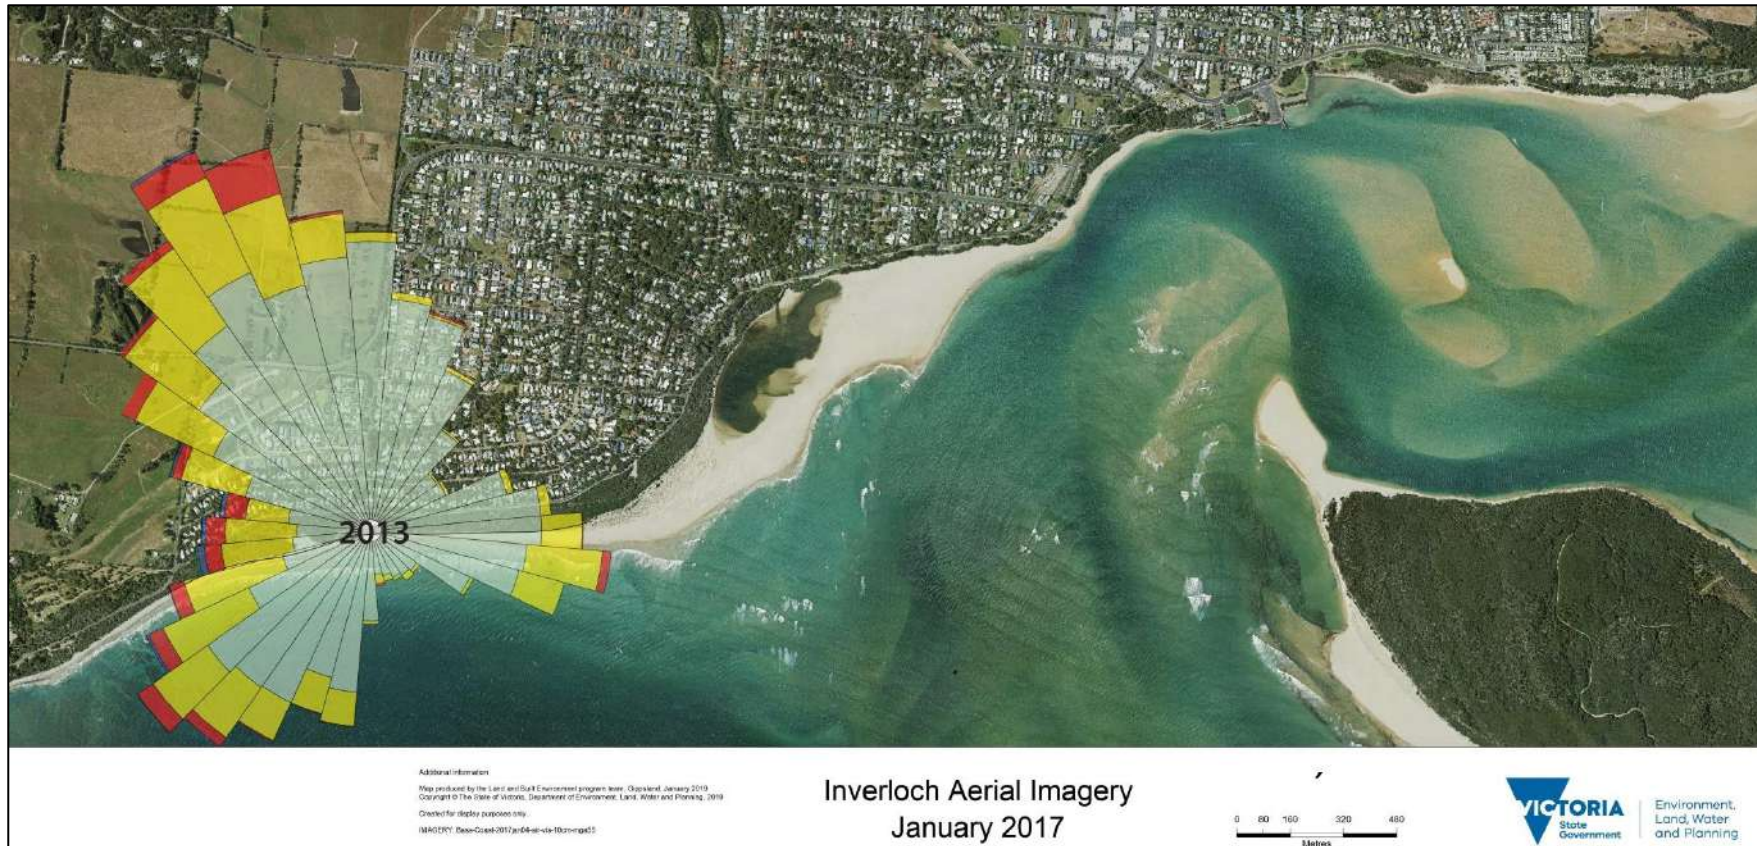
Figure 40. Vertical aerial photography Jan 2017 with 2013 annual wind rose overlay.

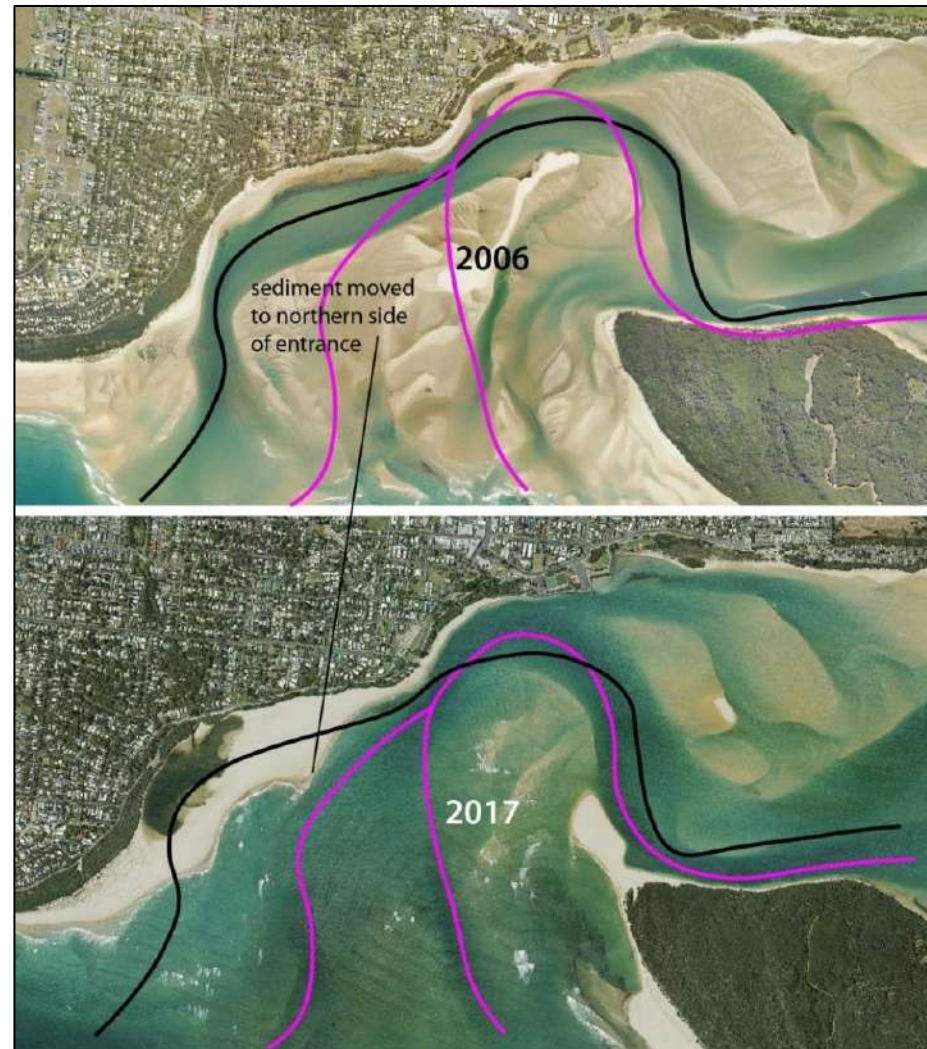
Figure 41. Migration of tidal channels and associated accretion (Point Norman to Point Hughes and recession Point Smyth
